# Council Business Meeting

<b>Agenda Item</b>	Community Center and Pioneer Hall Ad-Hoc Committee Recommendations	
<b>From</b>	Scott Fleury PE Kaylea Kathol Rachel Dials George Kramer	Public Works Director Senior Project Manager Recreation Superintendent Historic Preservationist
<b>Contact</b>	<a href="mailto:Scott.fleury@ashland.or.us">Scott.fleury@ashland.or.us</a> <a href="mailto:Kaylea.kathol@ashland.or.us">Kaylea.kathol@ashland.or.us</a> <a href="mailto:Rachel.dials@ashland.or.us">Rachel.dials@ashland.or.us</a>	541-552-2412 541-552-2419 541-552-2260

## **Winburn Way Community Center/Pioneer Log Cabin**

**REPORT TO THE ASHLAND CITY COUNCIL**  
**21-September-2021**

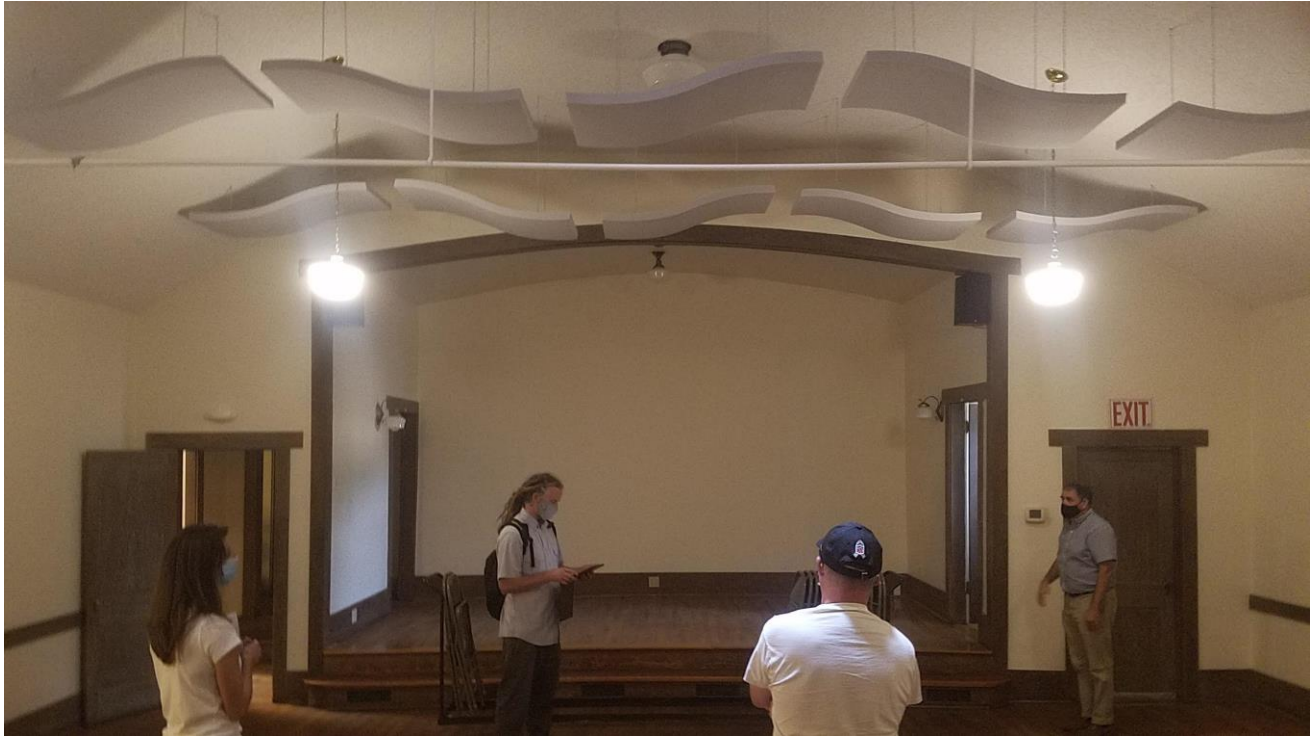
The roof is idiosyncratically framed and subject to multiple recommendations for improvement as per Eric Snyder, P.E. and detailed in his memo, attached. The primary solution involves the construction of a steel moment frame to span the main auditorium and create additional support for the existing timber trusses. This will involve installing a series of columns along the perimeter of the auditorium, with steel beams below the truss and phantom bearing wall at the rear (west) end of that space, with new footings at grade, through the existing wood floor. Installation of the moment frame will be mitigated by painting all elements white, to blend into the ceiling, and applied trim to match existing treatments. All verticals here will be plumb, meaning that some form of tapered blocking will be needed between the columns and the north wall for aesthetics. Careful evaluation of the westernmost beam run to minimize impact to the proscenium is recommended (see Figure 1).

Figure 1. Winburn Way Community Center, Main Space, Proscenium Arch

Additional beams, pony walls and other modifications will occur above the ceiling, in the attic area, with minimal visual impact to the historic spaces below. This work will provide additional support for the existing rafters and hips, augmenting or replacing existing members (see Figure 3). As per Eric Snyder, P.E., this proposed work will increase the capacity of the roof to code for snow loads, 25 psf, identified as an issue in 2019.

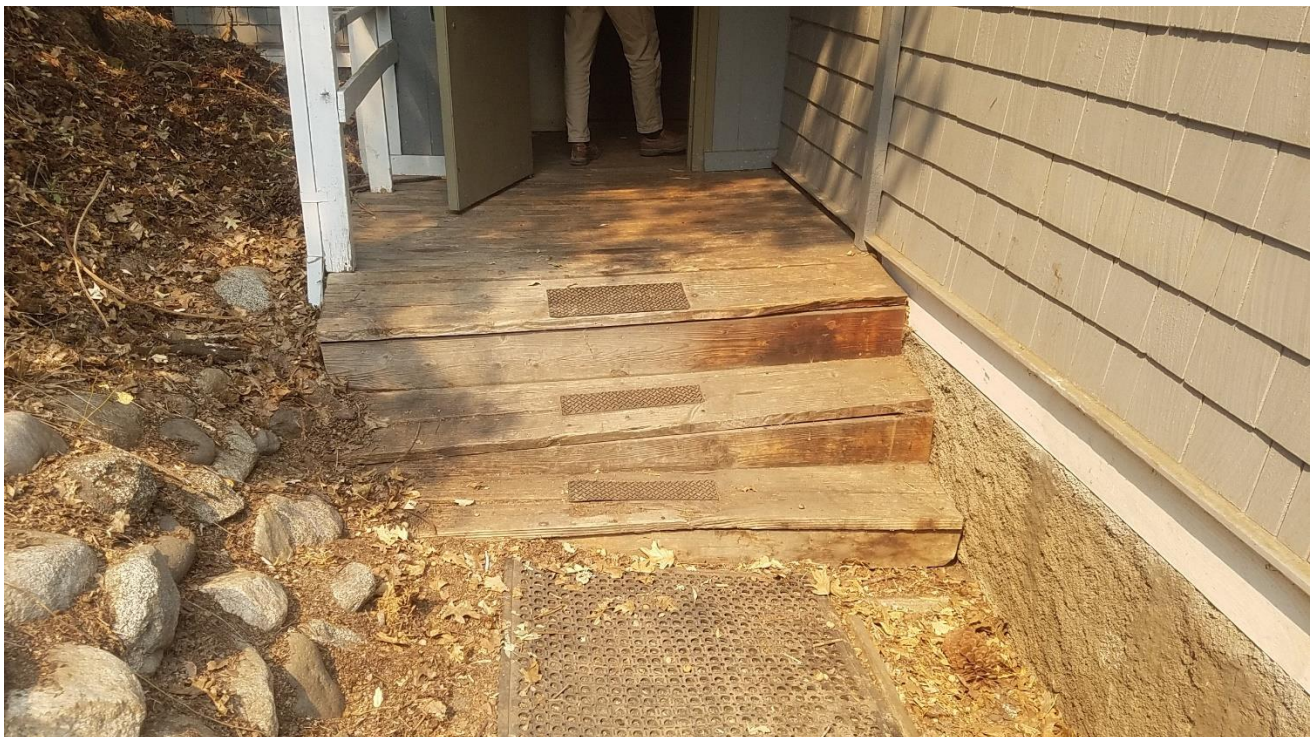
- D. Rear Entry Steps: The existing rear entry steps are of 2x wood on an unknown foundation with severe settlement and deterioration. These steps should be removed and replaced with new work, either cast concrete or pressure-treated wood and non-combustible deck material (Trex, or similar) (see Figure 2)

Figure 2. Winburn Way Community Center, Rear Entry Stair (note hillside at left)

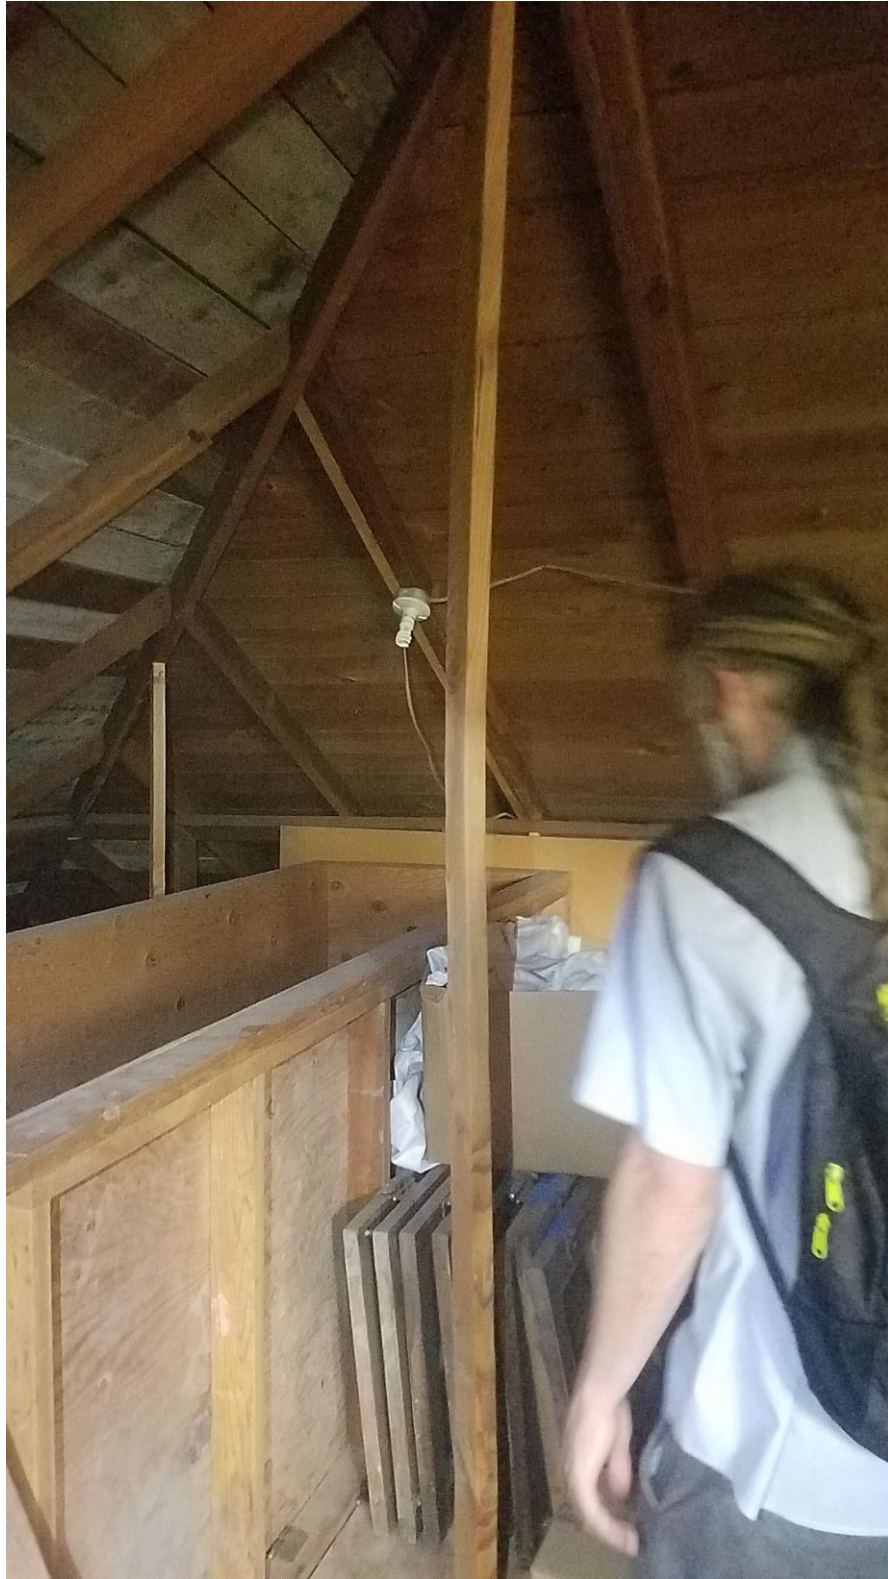
Figure 3. Winburn Way Community Center, Over-stressed hip support

Existing supports for hips are insufficient.

Strengthen or replace existing 2x4 support post(s) below hips. It is likely that adding additional plies and creating a "Tee" shape will be sufficient.

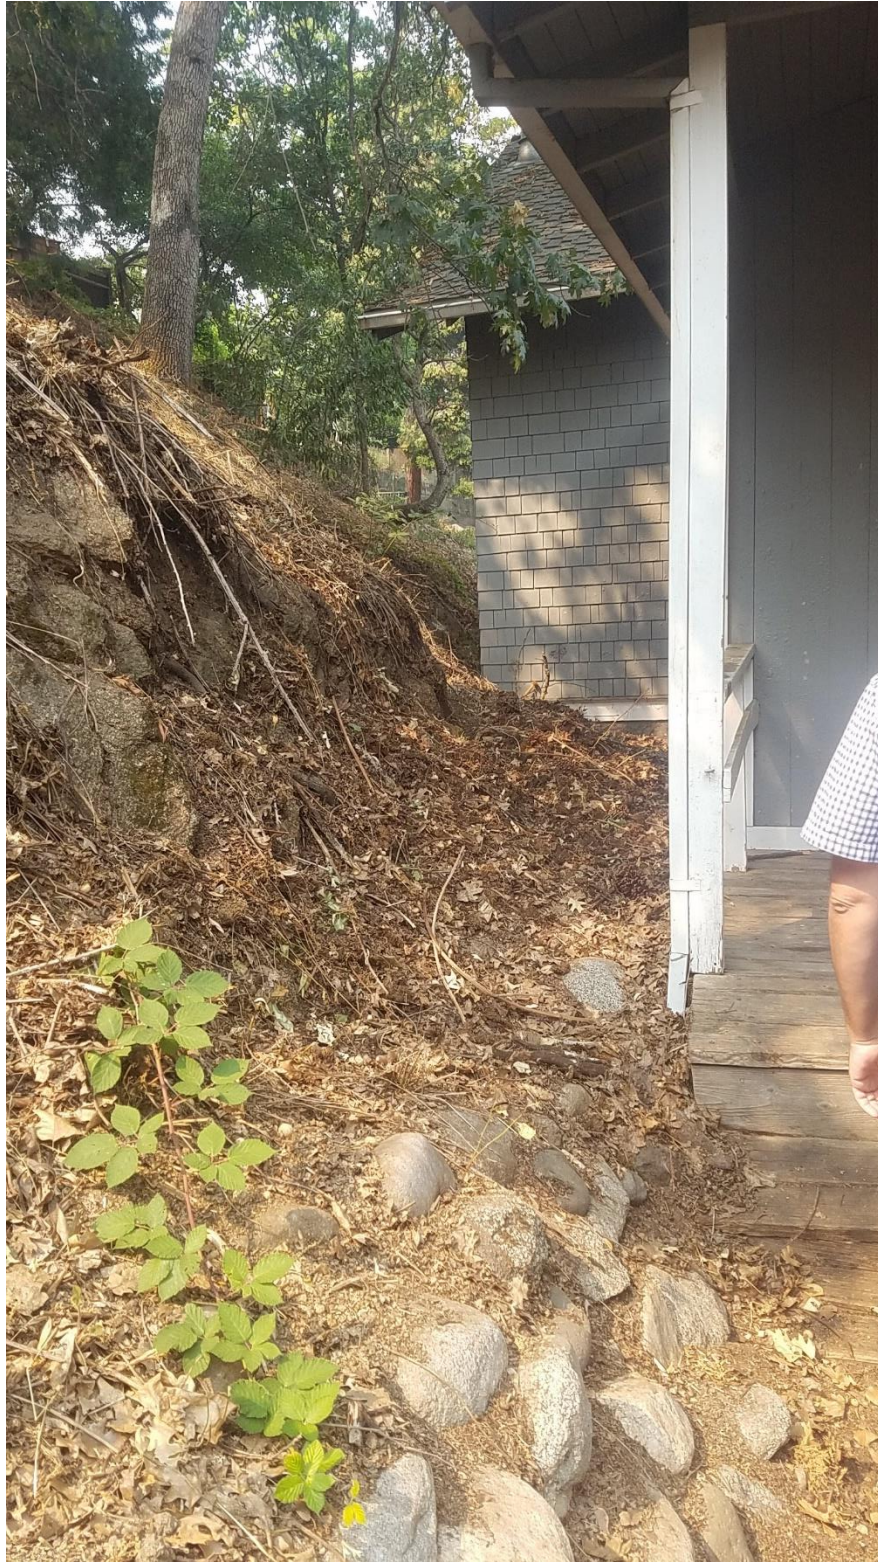
- E. Retaining Wall & Fire Break: The sloped site at the rear of both buildings creates a sloughing issue that leads to large debris piles of dirt and leaves (see Figure 4). Staff reports that this area is also prone to unauthorized access, creating a hazardous situation that complicates debris removal and maintenance. The banked debris against the wood foundations of both the Community Center and Log Cabin increase decay by trapping moisture, provide an access point for vermin, and, most importantly, represent a significant fire danger. All of these issues are further exacerbated by unauthorized access. The Ad Hoc Committee strongly recommends that the slope be excavated, and an engineered concrete retaining wall be installed approximately three feet (36") away from the foundation, with a new concrete slab/walkway to provide separation (see Figure 12). The slab will be designed with drainage to reduce water into the basement/foundation and should extend at the northwest corner to correct and improve access to the WWCC basement.

Figure 4. Winburn Way Community Center, Rear Sloughing Conditions

*Reducing unauthorized access and removing debris/fire hazard from the rear of the buildings is considered the single most important element of securing the future of these historic structures. The Ad Hoc Committee unanimously recommends that this work item be pulled from the larger repair project and contracted **as soon as possible** to reduce fire risk.*

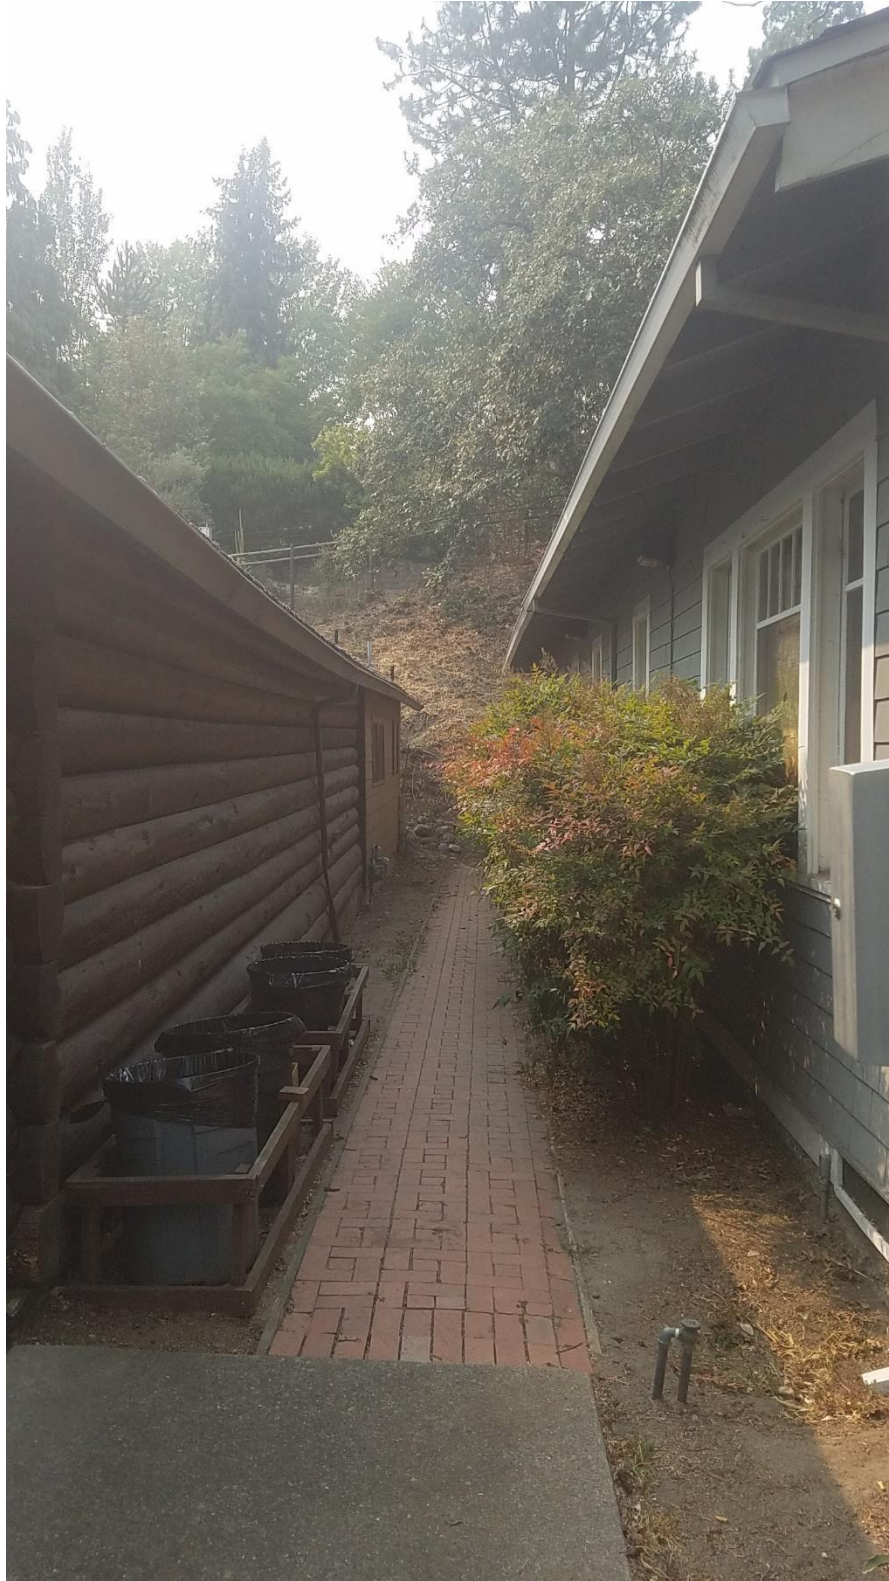
Figure 5. Winburn Way Community Center, Proposed Gate Location

To reduce unauthorized access behind both buildings, new security gates (black steel, of suitable design) should be installed at the NW and SW corners with a shared gate to be located between the facades on Winburn Way (see Figure 5).

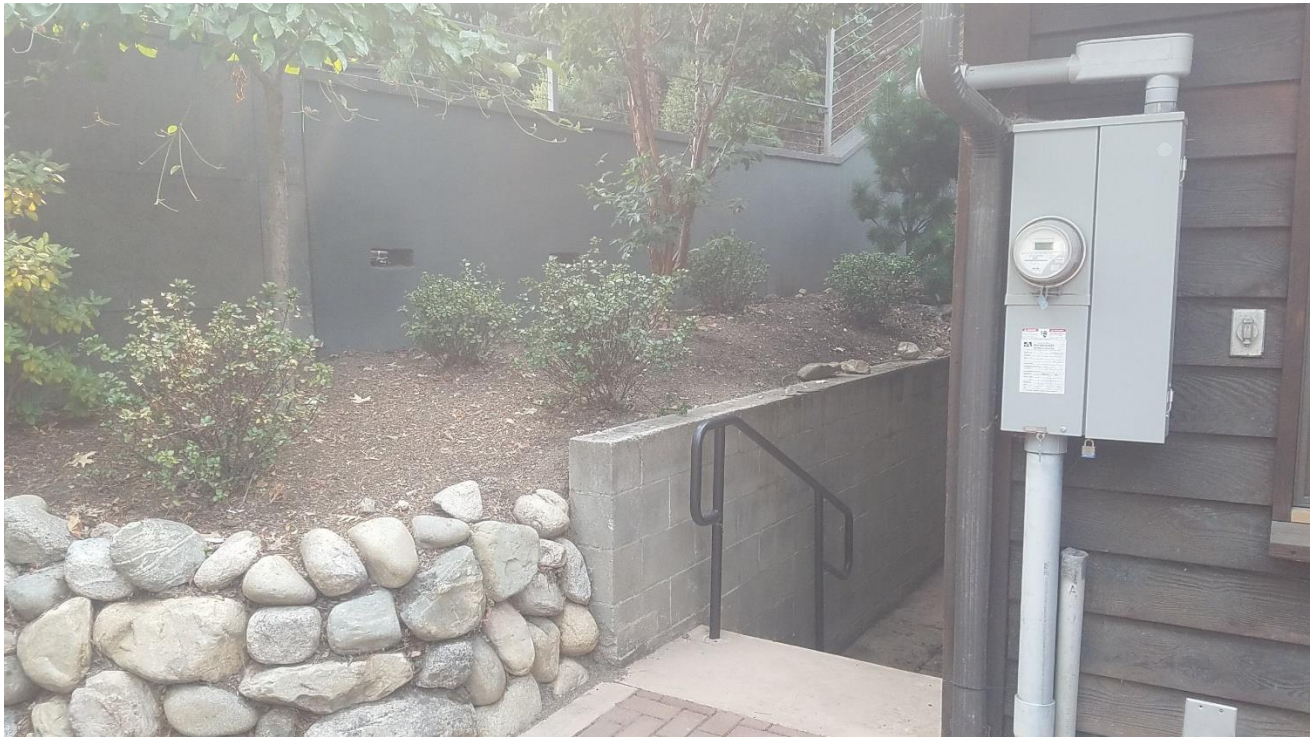
Figure 7. Pioneer Log Cabin, Proposed Gate Location

C. Retaining Wall & Fire Break: (see E, above, as this recommendation should continue the entire length of the Log Cabin as well). A new gate/fence should be installed between the adjacent neighbor wall and the SW corner of the Log Cabin addition to reduce access to the rear and side areas of the building (See figures 7 and 8).

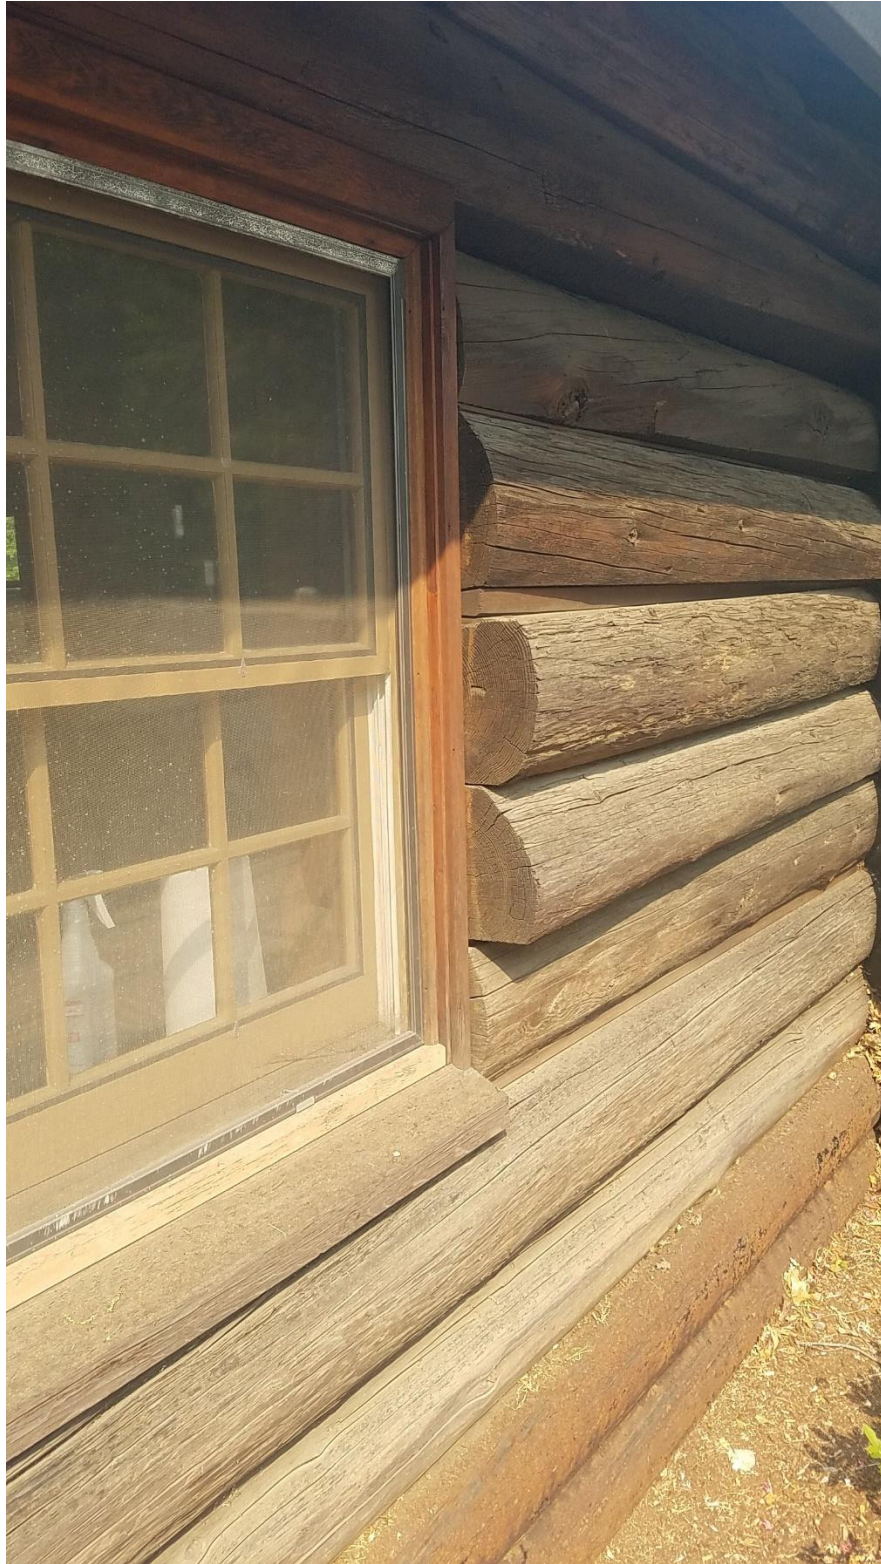
- B. **South Wall Window:** Log movement at the SE corner apparently results from the installation of a new window, installed without sufficient pinning to keep the logs in place. As per the engineer, this should be corrected with an inserted steel bar or a PT 4x4 on each side of the window rough-opening, screwed and clipped into place to inhibit further movement. The existing window can be reinstalled into the reinforced opening (see figure 9)

Figure 9. Pioneer Log Cabin, "Unpinned" Logs at SE Corner Window

One additional item that I did not see in the Marquess report, but has been raised, is that on the south wall, there was a window cut into the existing log framing, and the cut logs are now bowing out at the window, as they apparently were never, or were insufficiently pinned together. To correct this, I would recommend removing the existing window, and notching into the ends of the cut logs so that a 4x4 pressure treated trimmer can be in-set on each side of the window. This trimmer should be anchored at the top and bottom to continuous log framing with RSS screws at a 45-degree angle, as well as with a Simpson angle clip at each window opening corner. The 4x4 should be tied to each cut log with an RSS screw.

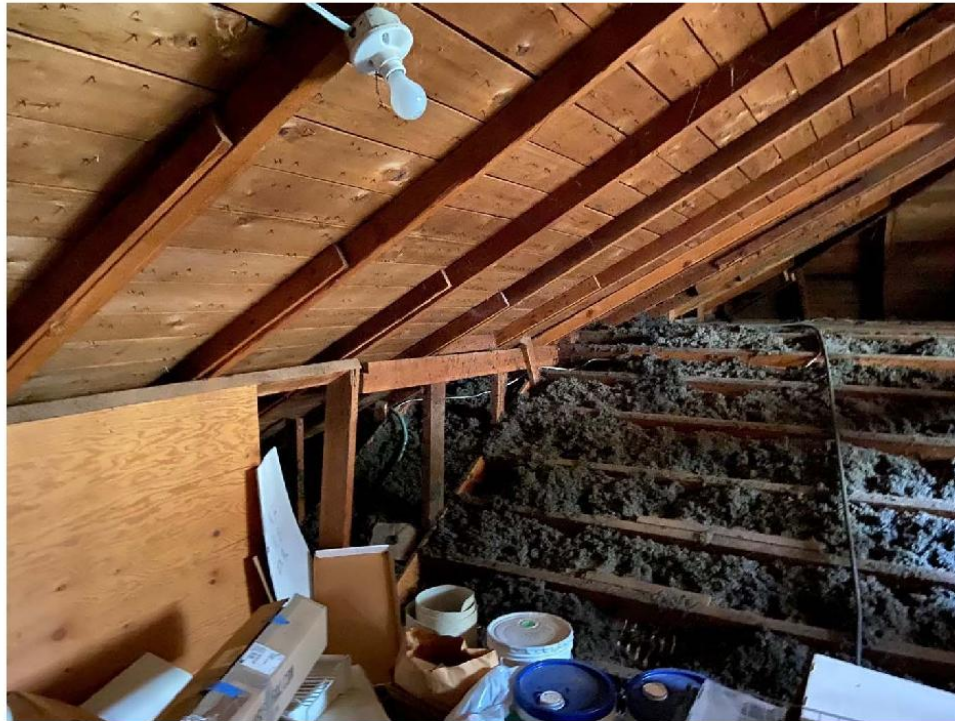
### 3: Existing Phantom Bearing

There is a phantom bearing wall in the vaulted ceiling of the Main Hall, a couple of feet back from the stage. This phantom bearing occurs where ceiling joists have insufficient length to extend to the intended support beam, spanning over the stage, because of a spacial conflict with the roof framing. In addition to the ceiling joists, some rafters on the south end of the Main Hall are also “supported” along this phantom bearing line. This condition is causing the ceiling to sag below, and is potentially dangerous.

Similar to my previous recommendation, there is a lack of sufficient space in the ceiling and roof cavity to address this structural deficiency above the ceiling. Therefore, I'm recommending another beam to be located below this phantom bearing line (E) in the Main Hall below. This beam should be supported by

new steel columns in the north and south walls (C), and have a pony wall constructed above to meet the ceiling, and support the insufficiently-supported roof and ceiling framing above. Effort should be made to lift the sagging ceiling with jacks, before constructing the pony wall. As with the above recommendation, support (C) will be placed to the interior of the north wall, and extend through the existing floor to a new pier pad below. To avoid obstructing the stage, the cross beam Gil Livni and I have discussed options to either arch the cross beam, or to otherwise step it up higher toward the interior of the room.

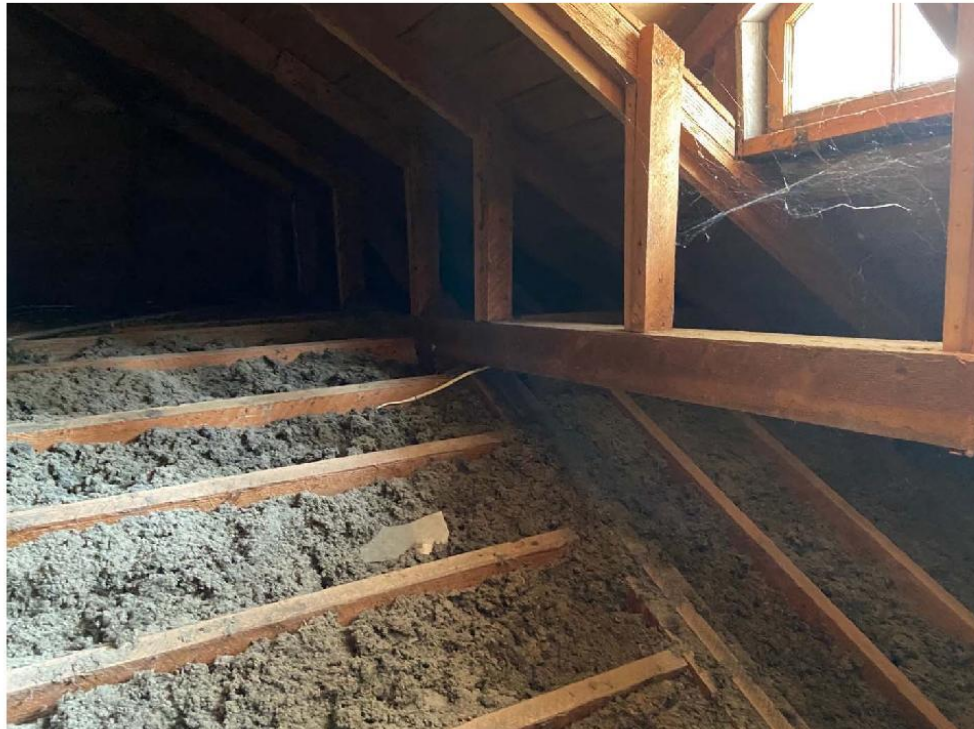
#### 4. Sloped Ceiling Joists with No Support

Several of the sloped ceiling joists over the Main Hall appear to rely on existing 2x4 rafters for their top support. This occurs at the south-east end of the Main Hall, just to the east of Truss (1), where ceiling joists run up the vaulted ceiling slope, and somehow tie into rafters. Based on my initial analysis, it appears that a similar condition is likely occurring (although is not visible) where the northeast dormer intersects the ceiling of the Main Hall. The load path of this framing, from ceiling joist, into rafters, into hip/valley, to wall, should be simplified as much as possible, as the valleys and rafters are already over-spanned.

For general added roof support in this area, I'm recommending adding some new wooden beams (G) to span between the trusses. These beams can be used to support the over-spanned rafters on the north side of the Main Hall. I would have them extend to the east, cantilevering over Truss (1) to support a perpendicular beam (H) to support rafters.

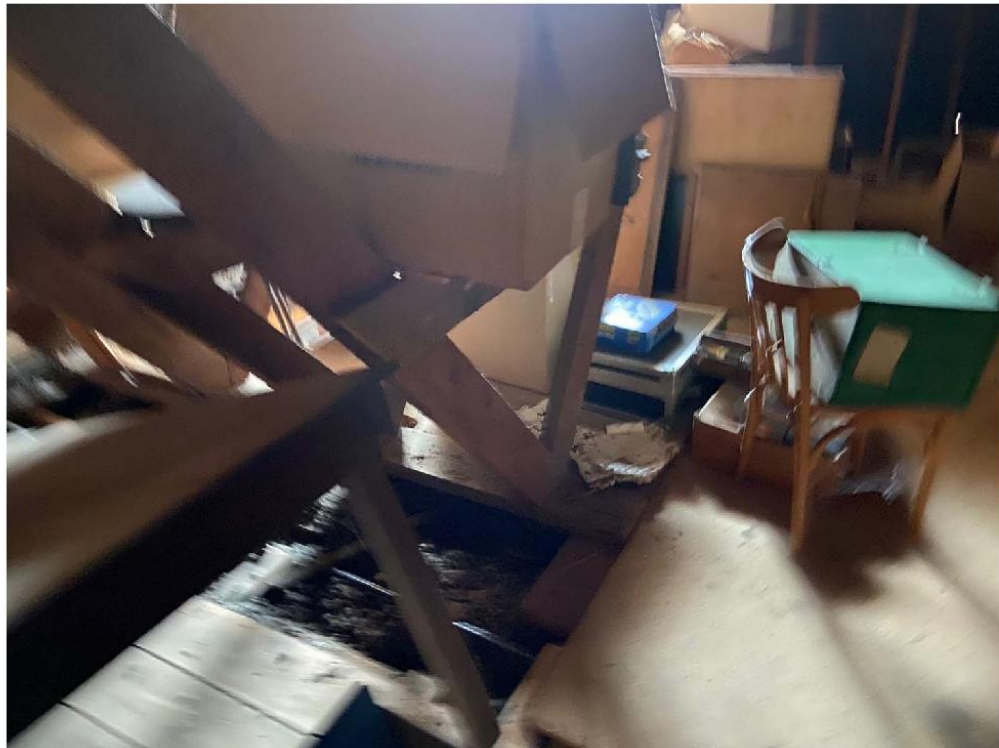
5 & 6: Existing Attic Pony Walls and Diagonal Kickers

Between my site observations and CAD sketch, it is unclear that existing pony walls (5) or diagonal braces (6), that have been constructed in the attic space to support the rafters have a load path below the ceiling. They appear to span across open rooms, with no clear load transfer to the foundation below that.

It may be necessary to add a support beam (F) along the side of these pony walls. This can be done in the attic space, above the ceiling, and will likely consist of 2x12 members spanning between walls below. Further investigation is required to determine the exact recommendation.

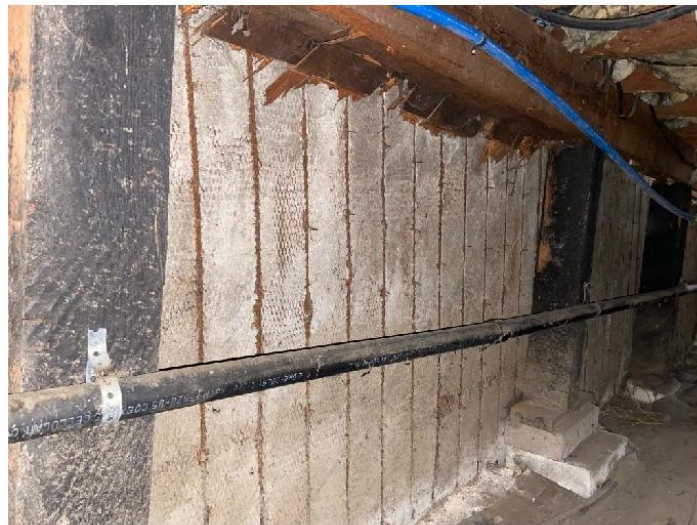
Dale Shostrom, a General Contractor familiar with this building has expressed a concern that the exterior diagonal wall sheathing has been previously cut, and there is no longer shear transfer from the walls to the foundation. Upon gaining access to the crawl space, below the building, it was revealed that, with the exception of the rear (west) wall of the building, there is no lateral shear transfer from the main floor to the earth. The perimeter of the building sits on posts that I'd estimate to be approximately 48" tall. There is a stucco façade on the exterior, but it offers no lateral strength.

In speaking with Gil Livni, we discussed that a continuous footing and either concrete stem walls or plywood-sheathed pony walls would need to be added to meet current code. If this is not a requirement, then at a minimum, we could vastly improve the lateral-force resistance of the perimeter wall by bracing between posts. At a minimum, I would recommend installing diagonal X-Bracing between columns, consisting of 2 x 6 flat members, and strapping these to the existing 6 x 6 columns using Simpson strapping.

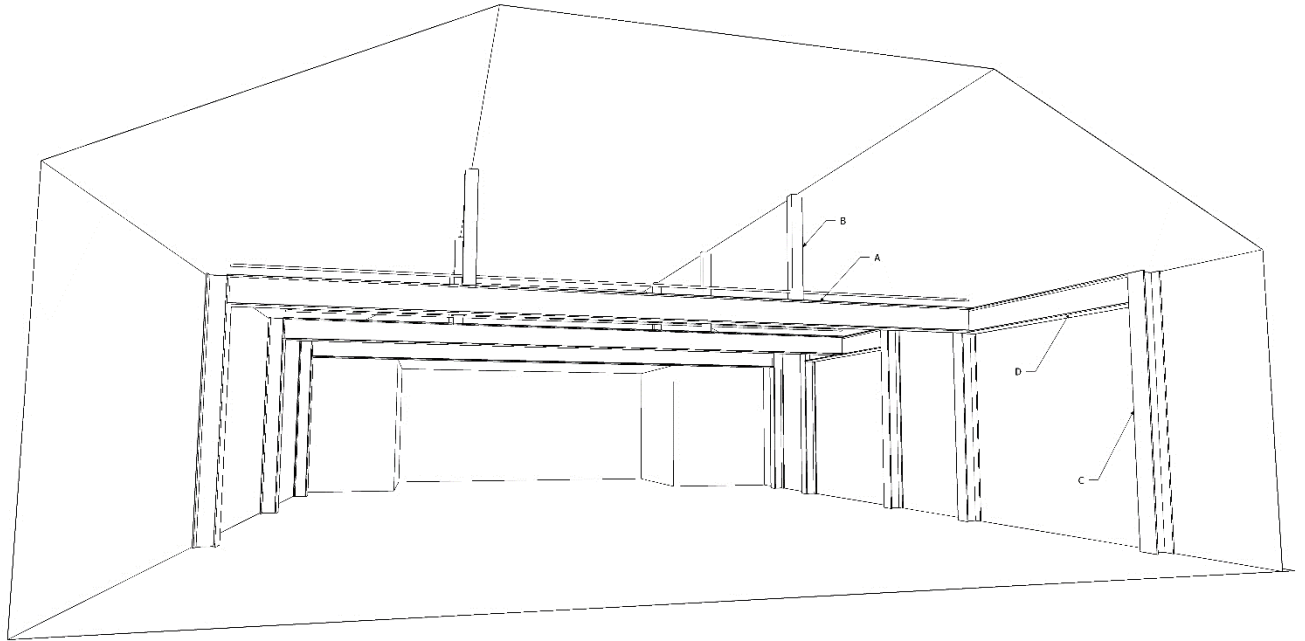
Figure 10. Winburn Way CC, Proposed Moment Frame, View Towards Stage/Proscenium  
(Arkitek, 2021)

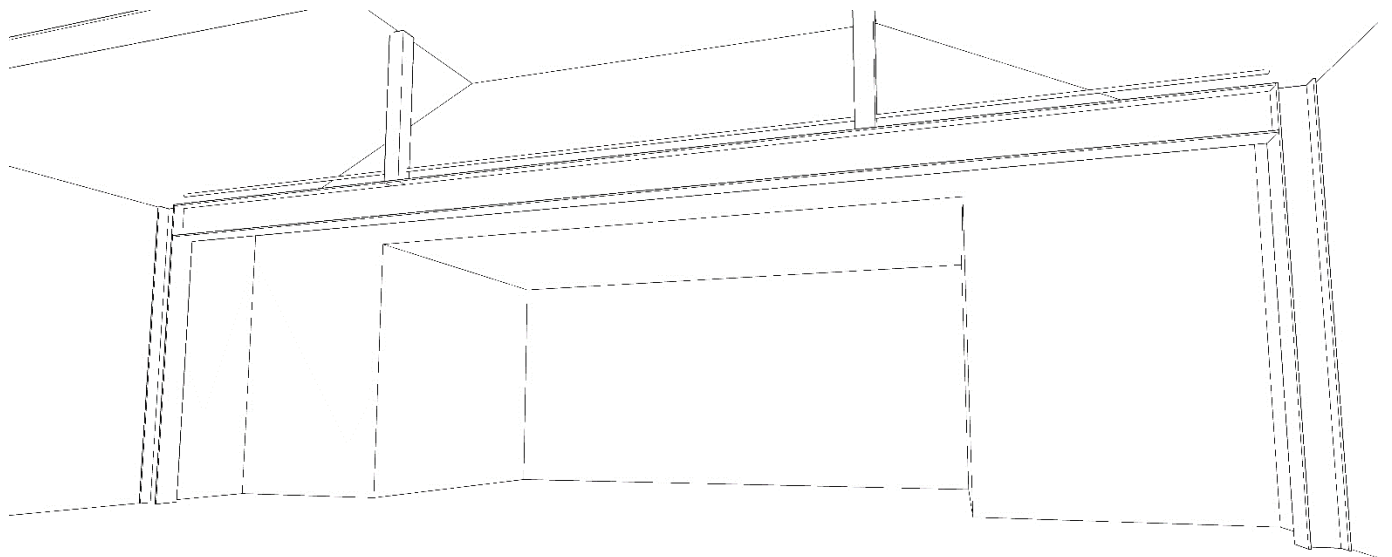
Figure 11. Winburn Way CC, Proposed Moment Frame. View at Stage/Proscenium  
(Arkitek, 2021)

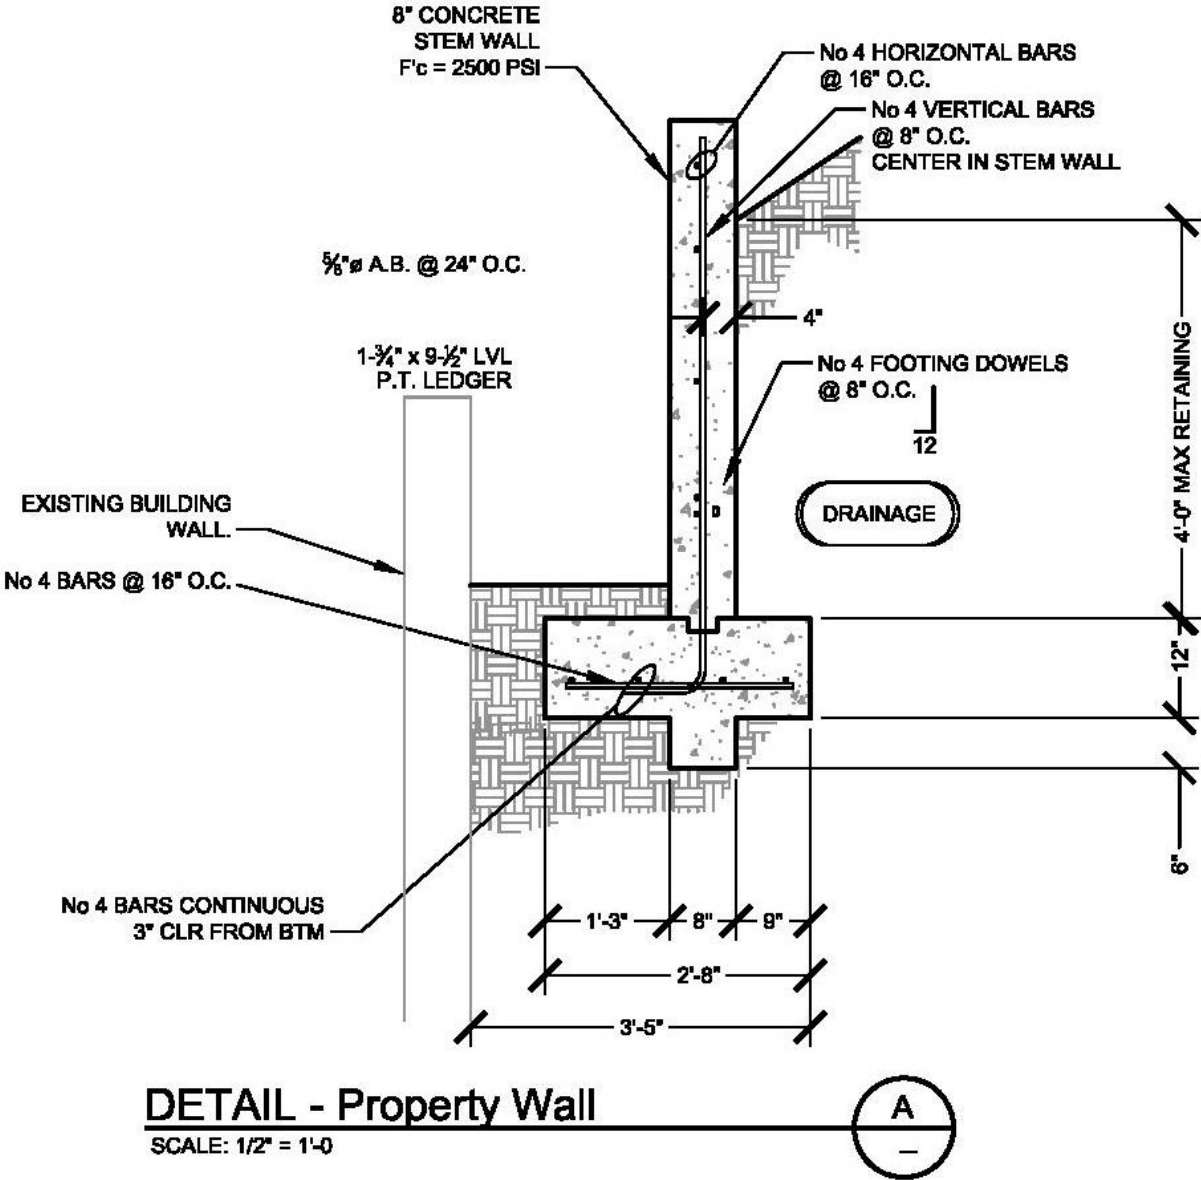
Figure 12. Proposed Retaining Wall, to be constructed at rear of both Winburn Way CC and Pioneer Log Cabin (Section), Snyder Engineering, 2021
