Council Business Meeting

Agenda Item	Update on City Hall, Community Center, and Pioneer Hall	
From	Adam Hanks Scott Fleury	Interim City Administrator Interim Public Works Director
Contact	adam@ashland.or.us ; (541) 552-2046 scott.fleury@ashland.or.us ; (541) 552-2412

Structural Investigation Report

Ashland Community Center: Structural Investigation Report

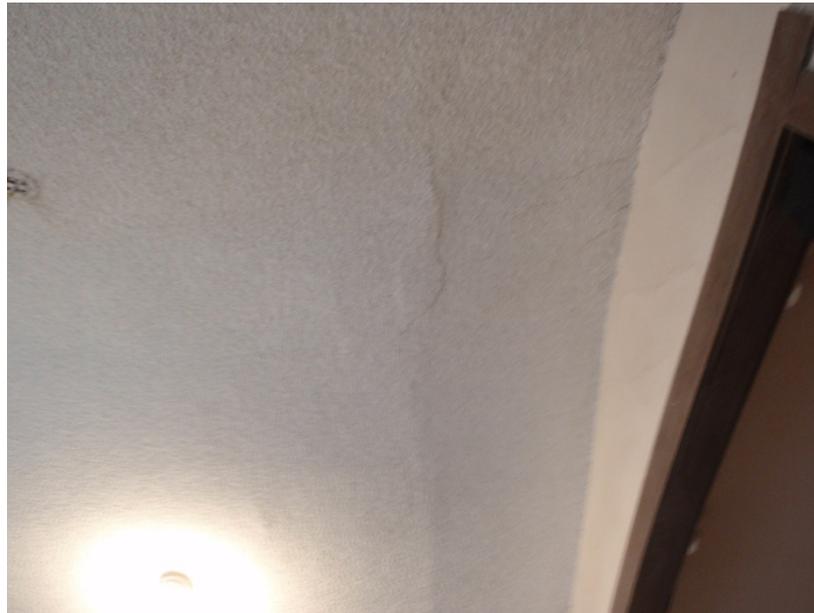
Structural damage refers to excessive deflection in the ceiling on the west end of the Main Hall, near the stage. A member across the width of the Main Hall has deflected downward. The north exterior wall of the Main Hall is also not plumb; there is noticeable deflection of the top plate outward. The floor is also noticeably not level.

**Figure 1: Downward Deflection of Ceiling
at West End of Main Hall**

Conclusion – The best way to address all of these issues over the Main Hall would be to completely remove and replace the existing roof and ceiling structure over the Main Hall with new wood trusses. Each system (roof rafters, trusses, tie rods, and ceiling joists) is too flexible, and it will be very difficult to retroactively stiffen each one. In our opinion, it is not feasible to try and re-use the existing roof structure over the main hall.

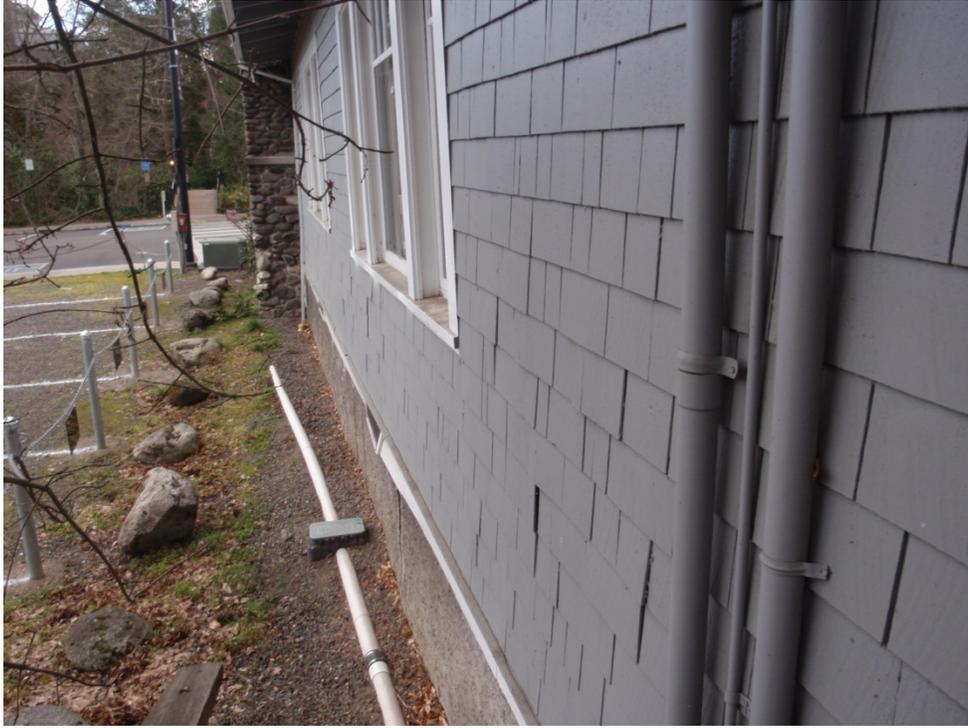
Figure 2: North Exterior Wall of Main Hall Out-of-Plumb

It is also possible that this wall was out-of-plumb in 1985 and was not repaired. It is also possible that the connections in the tie rods have crept and slipped over the years and some extra slack in the tie rod has been taken up by the outward movement at the top of the wall.

The north wall of the Main Hall should be brought into plumb after the roof framing has been removed. The current condition is unacceptable. If more outward deflection occurs at the top of the wall because of a failed member or slipping connections, it could cause a total collapse of the building. Wood structures are very forgiving and give lots of warning, but only to a point. Trying to bring this wall into plumb with the roof framing still in place will not be safe due to the lack of dependable, repetitive members.

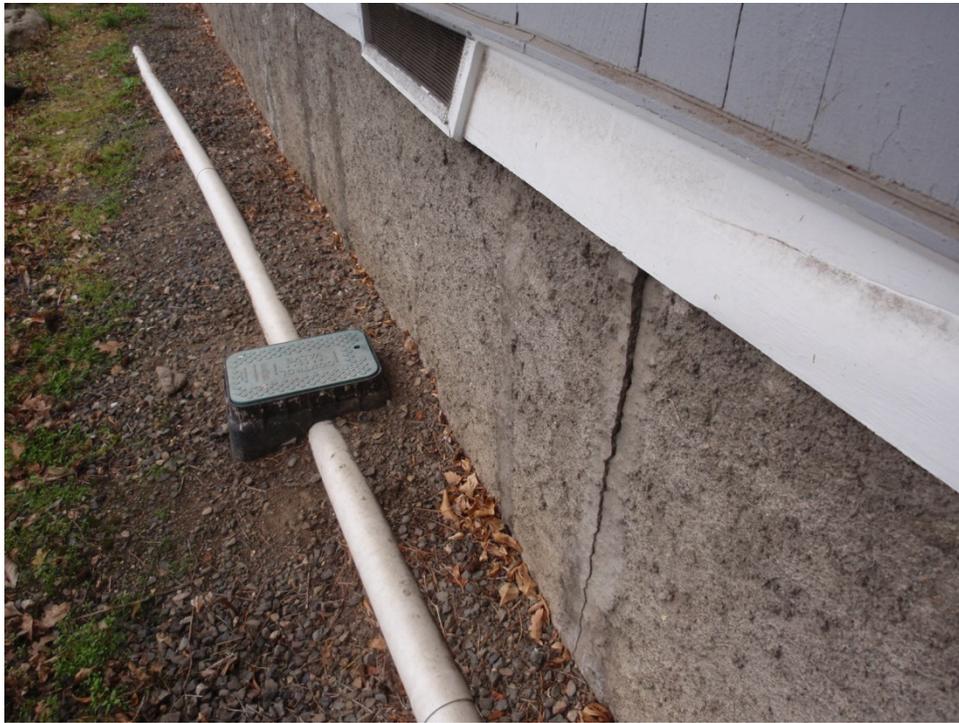
Figure 3: Concrete Veneer at Crawlspace Pushed Outward

The concrete veneer that is bowing outward on the north crawlspace wall is not structural. This should be repaired, however, in order to preserve the water resistance of the building and protect the wood structure in the crawlspace.

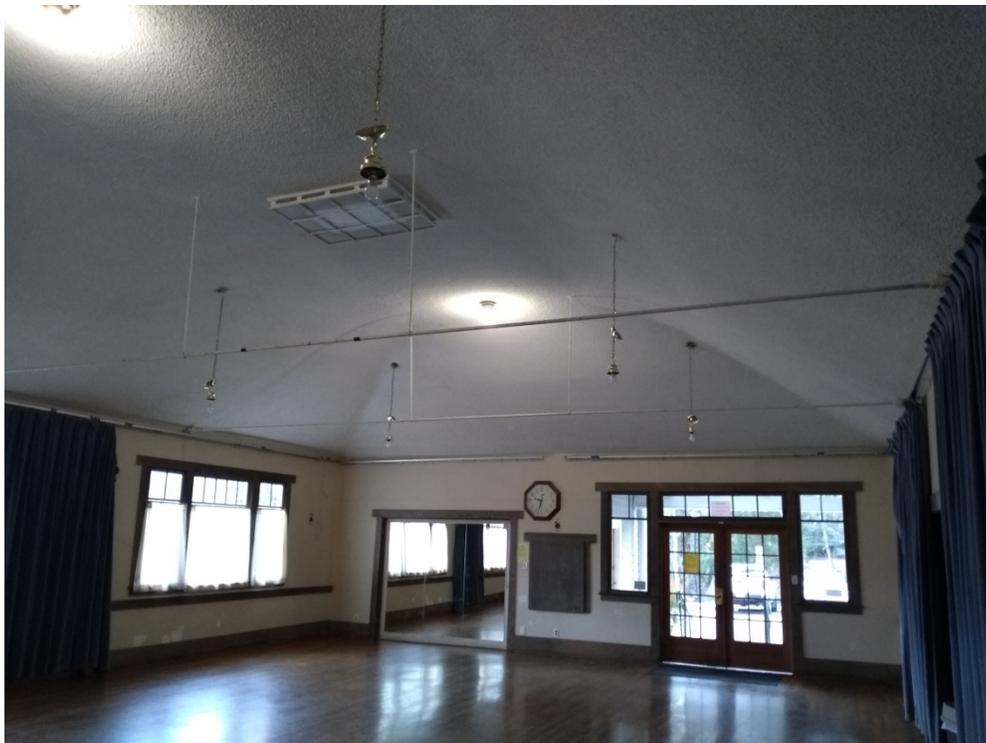
As can be seen in Figure 6 below, the Main Hall has a curve, vaulted ceiling. This area is of most concern, due to observed ceiling deflections, and deformations in the exterior wall. The floor is also not level in the Main Hall.

Figure 6: Main Hall

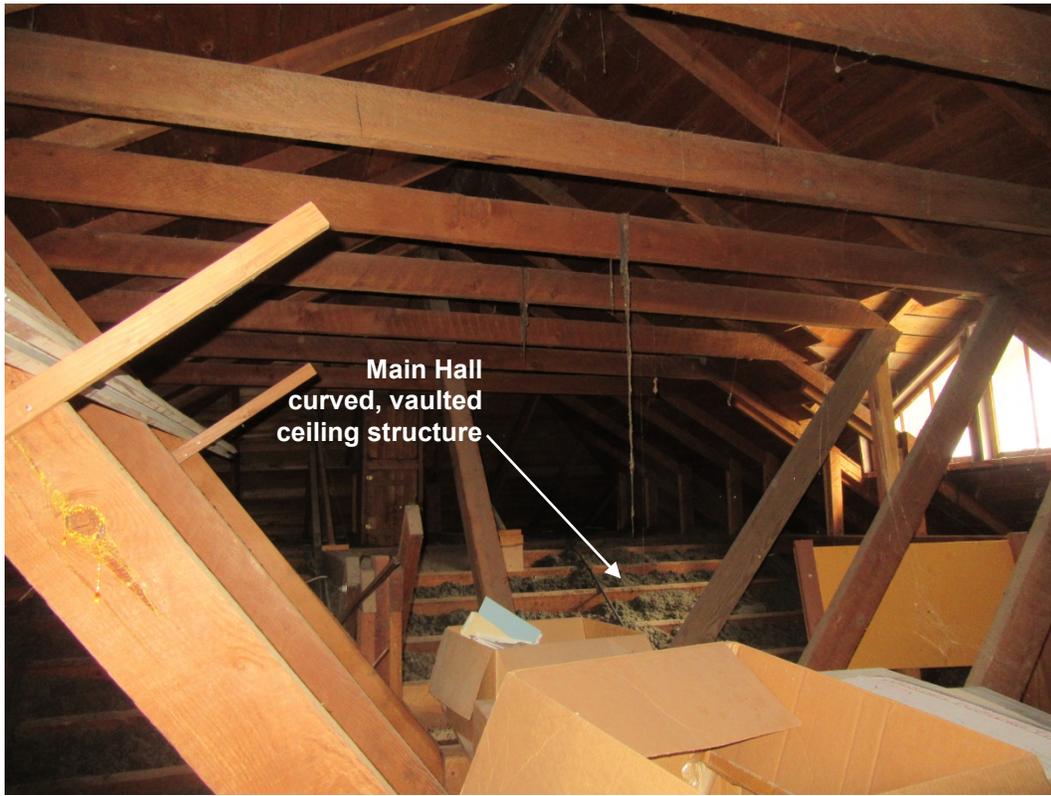
Figure 7: Roof Structure

A visual inspection of the roof framing reveals some issues with the framing arrangement over the Main Hall. Several ceiling joists and hip rafters bear on insignificant structure exactly at the line where downward deflection is occurring in the west end of the Main Hall near the stage. Perhaps at one time there had been a beam or wall here, which is suggested in the 1985 drawings. The roof framing plan shows a line of studs to be put under the rafters, which should bear on new 2x6 ceiling joists, but in the area where the ceiling has deflected down, no ceiling joists were added, because it is a vaulted ceiling. The flat 2x6 joists work in the flat ceiling areas of the building, but there are no 2x6 joists for the studs to bear on in the vaulted area. The photo below shows this condition where ceiling framing and rafters terminate at a point where there is no member on which to bear.

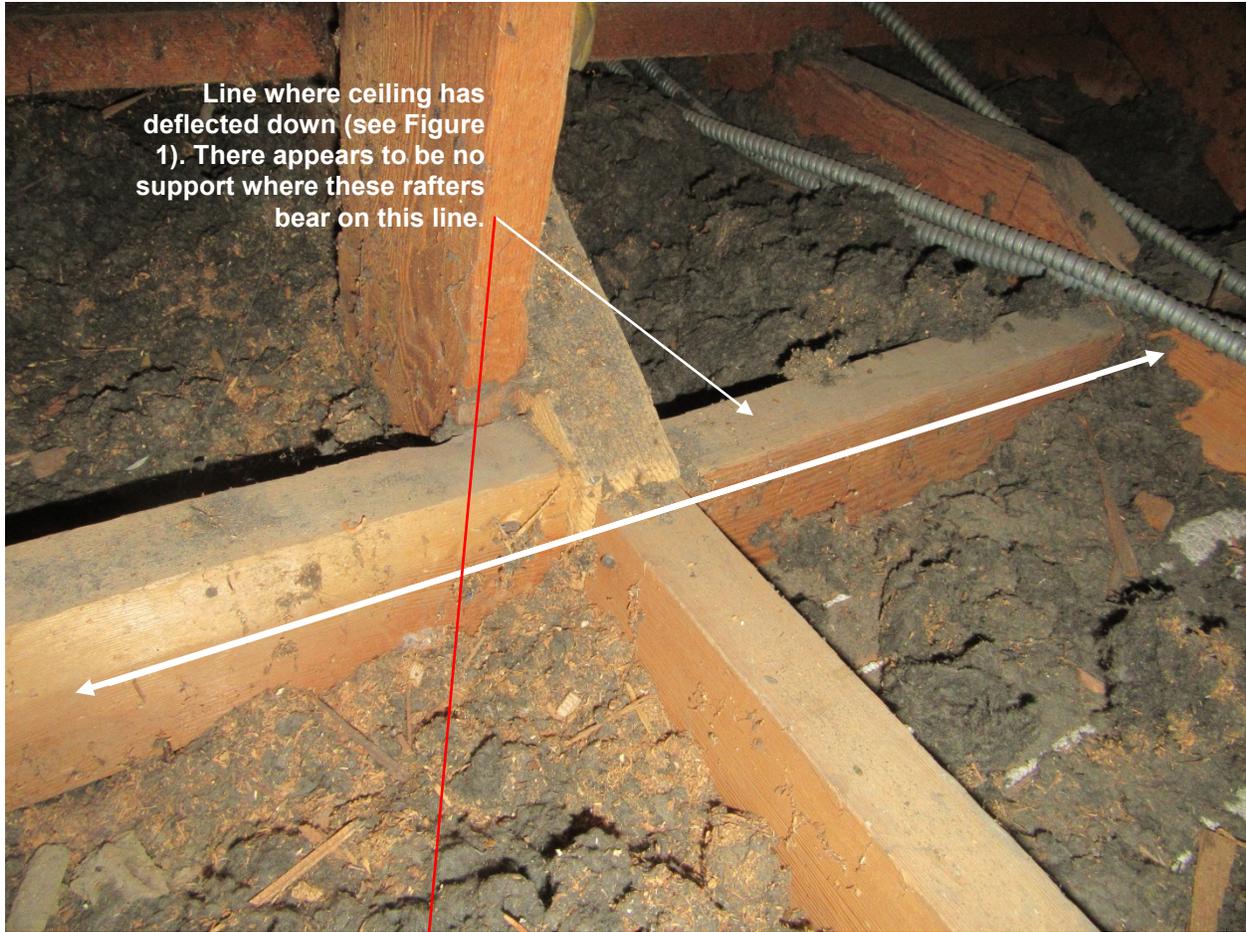
Figure 8: Line of Downward Deflection in Ceiling

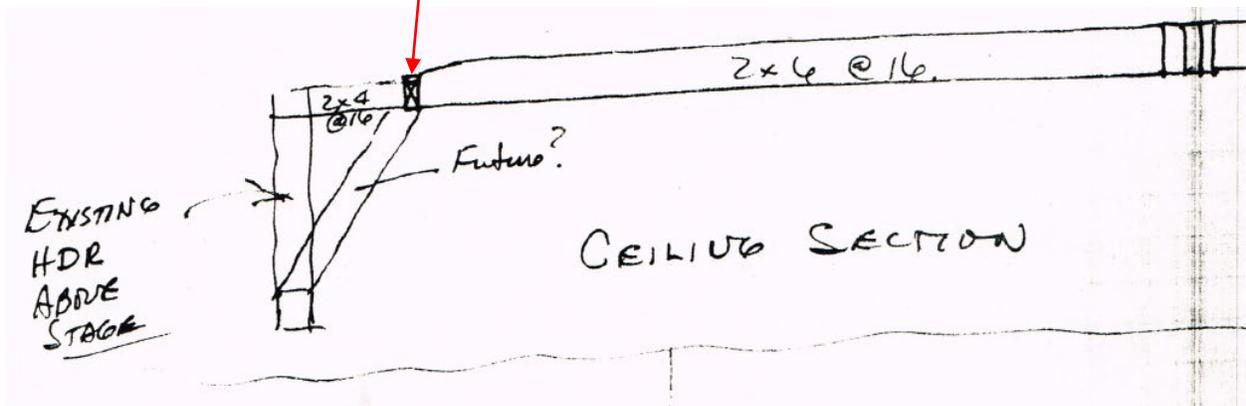
The engineer's notes from 1985 also indicate that some type of support that is not currently existing could or should be installed by a note "Future?". A copy of the sketch is below.

Figure 9: Copy of Sketch from 1985 Engineer's Notes

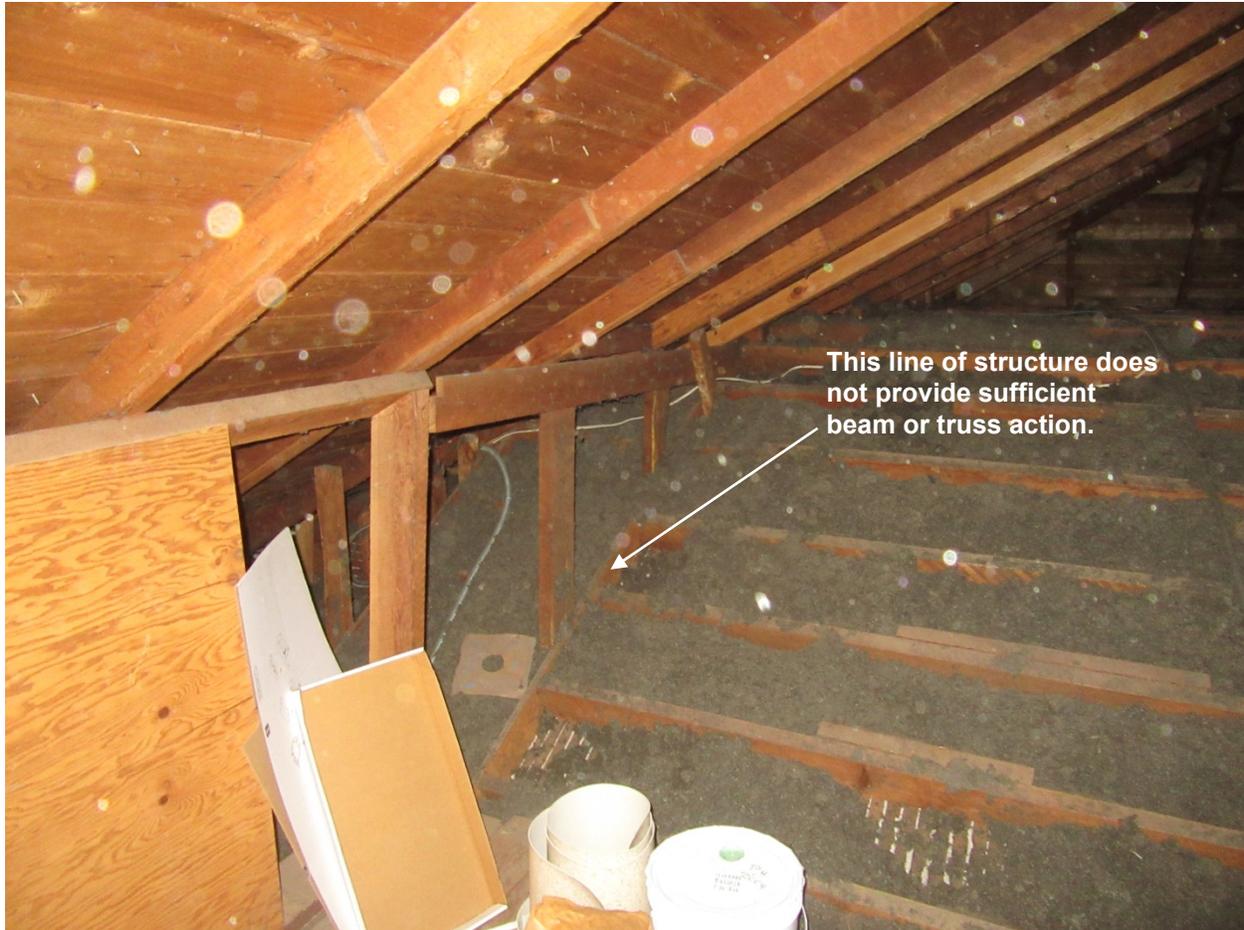
Figure 10: Photo at Line of Downward Deflection in Ceiling

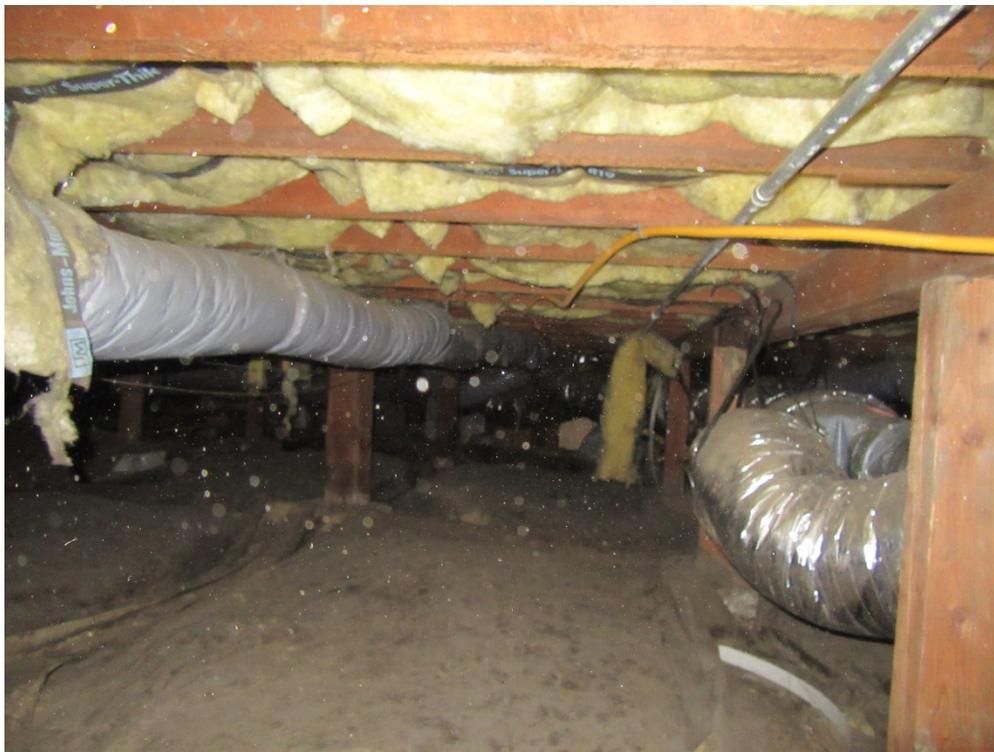
The settlement has not caused any excessive deflection of the main structure, but it has created an undesirable condition at the interior joist bearing line.

Figure 11: Crawlspace Showing Floor Joists and Beams

Another option is to jack up the floor beams and place a filler between the floor beam and the tops of the crawlspace posts.

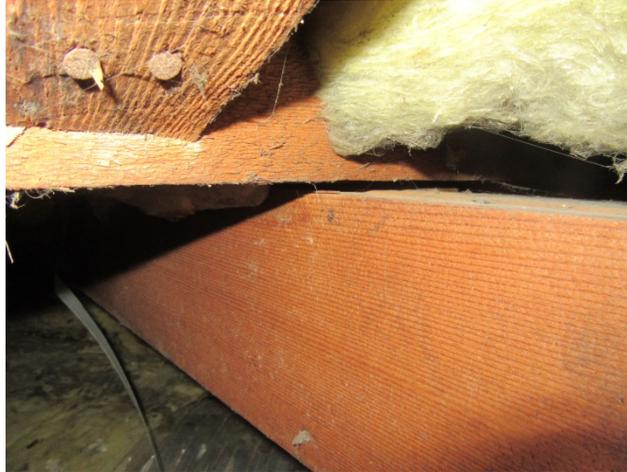
Figure 12: Gap Between Bottom of Floor Joist and Top of Beam

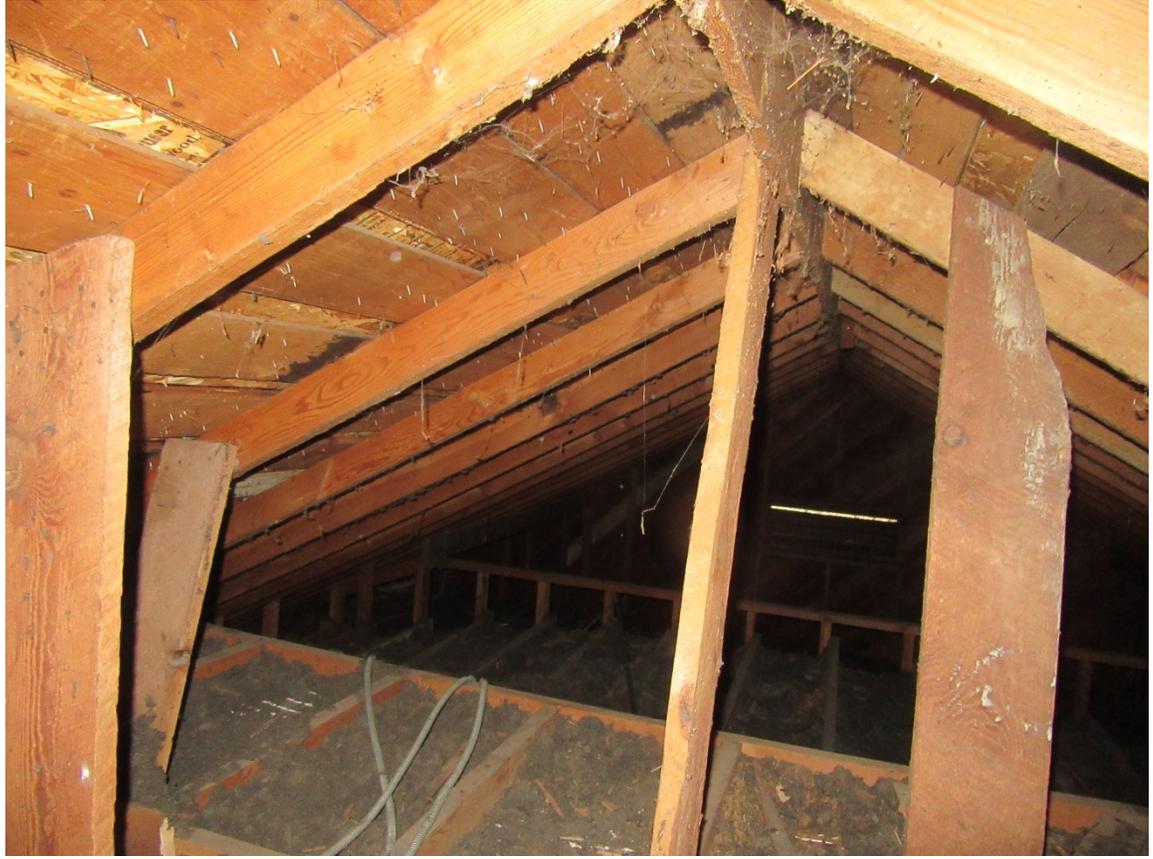
- C. The roof rafters over the Stage, Backstage, and Dressing rooms in the northwest corner of the building are over-spanned. There is also no ridge beam, only a continuous, thin rim. The rafters are sagging due to the large span.

**Figure 13: Overspanned Rafters and Ridge
at Northwest Corner of Building**

Conclusion – A ridge beam with posts could be installed at the apex of the roof. New rafters should be installed that frame into the new ridge beam. Alternatively, the roof could be completely removed, as suggested over the Main Hall and new trusses could be installed.

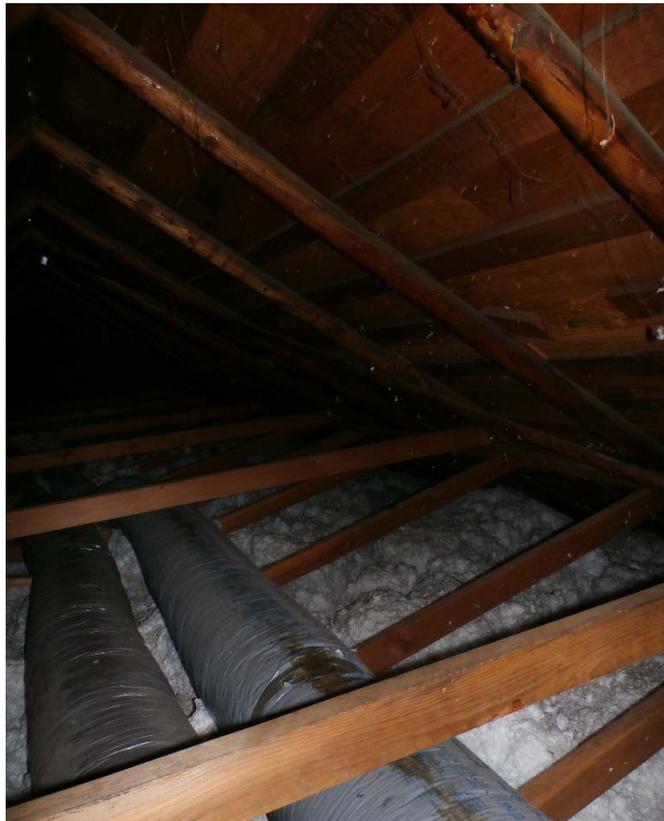
Figure 4: Attic Space

The roof above the meeting hall does sag significantly, but this is most likely due to creep over several years rather than material degradation.

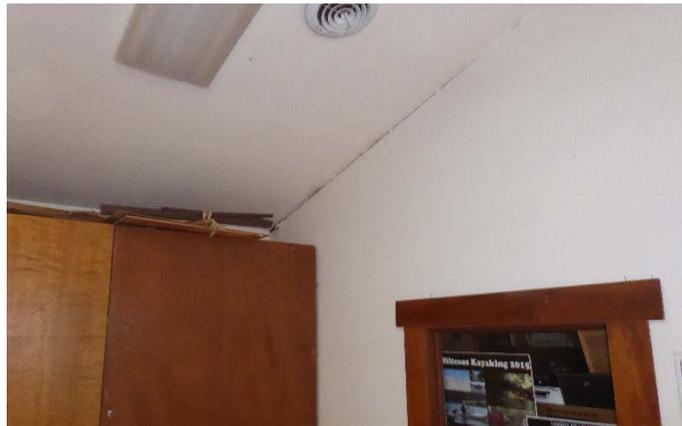
There is a partition at the office that is separating from the ceiling at the top. This wall is located at the exterior wall of the previous addition, so there is a concrete footing below it. If it continues to settle, the issue should be addressed, but because it is at a rigid foundation, there is not a strengthening that could be implemented that will not involve significant foundation work.

Figure 5: Settling Wall

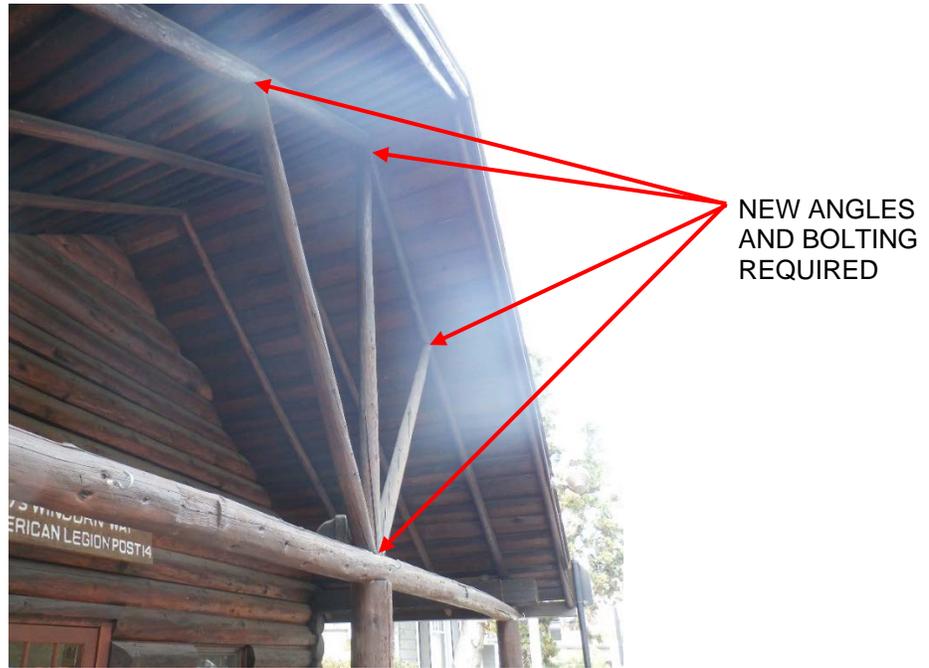
- B. It is unknown if the members of the log truss at the front of the building under the canopy have substantial end connections. It is anticipated that the cantilevered diaphragm at the canopy will deflect a fair amount, which could put a lot of stress into those end connections of the log web members.

Conclusion – Create new positive connections between the canopy log truss web members and the chords with steel angles and bolting.
