# Public Arts Advisory Committee Agenda

PUBLIC ARTS COMMISSION  
REGULAR MEETING  
November 18, 2022  
*DRAFT* Minutes

CONDITION ASSESSMENT AND RECOMMENDATIONS

Ashland Parks Foundation | July 26, 2022, Rev. 01 October 05 2022

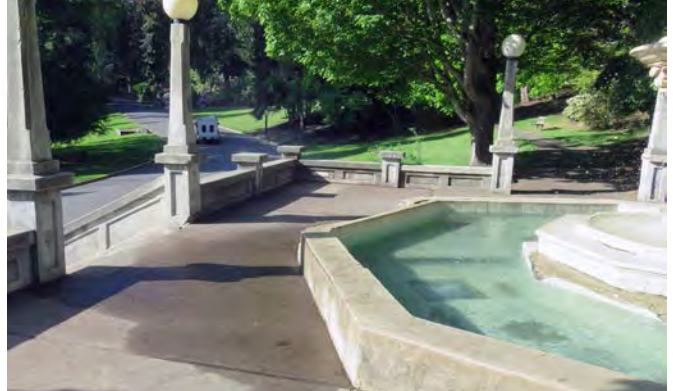
*Water splashes out of the east end of the fountain, at the top of the stairs.*

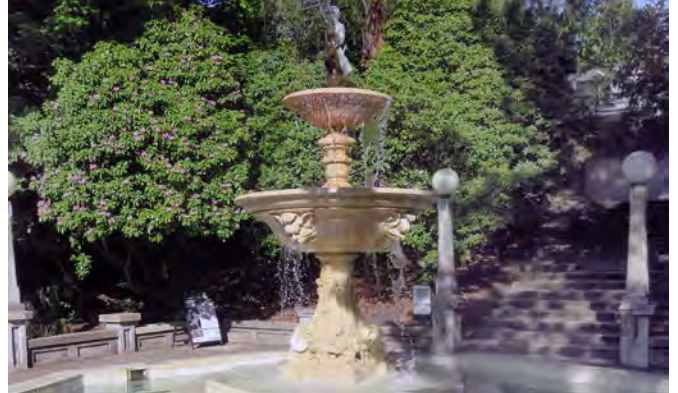
*Water flows unevenly off the north east edges of the bowls. Note that the flow out of the lions is not smooth.*

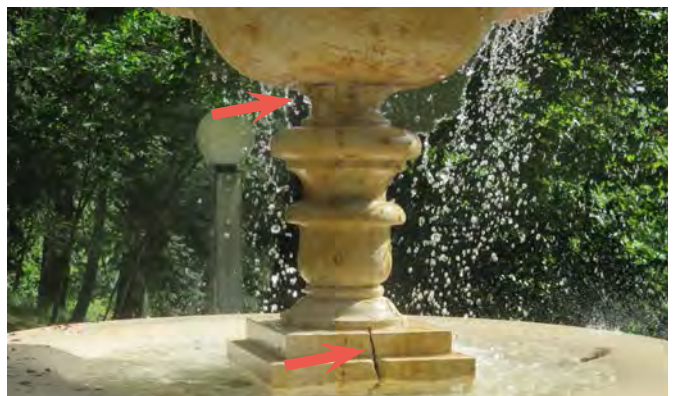
- The pedestal supporting the upper bowl is in poor condition. It has spalls at the upper and lower lips, and a through-unit crack in its base. Although it could not

*Cracks and spalls at the upper pedestal.*

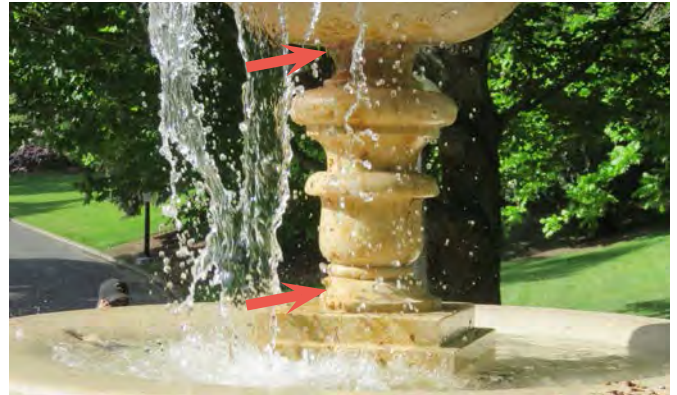
*Spalls at the upper pedestal.*

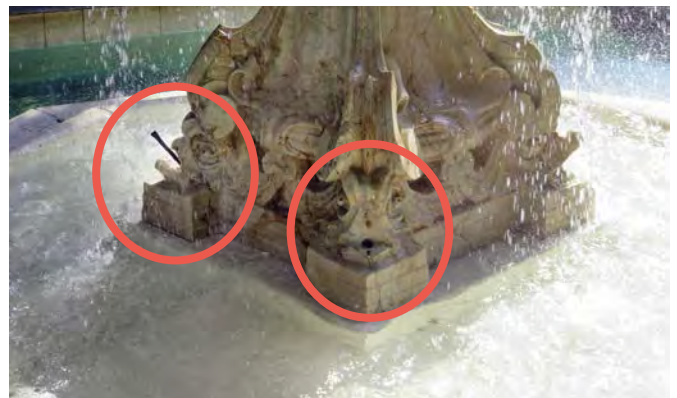
- Two of the gargoyles at the lower pedestal are in poor condition. Two are missing most of their faces. One of these has a piece of piping sticking out of its mouth. This appears to have been a recent attempt at vandalism. It should be noted that water still flows from this spout. The other that is missing its face no longer spits water. These two gargoyles may have been repaired in the 1987 restoration, but these repairs have failed.

*Damaged gargoyles at lower pedestal. Note the pipe sticking out of the element on the left.*

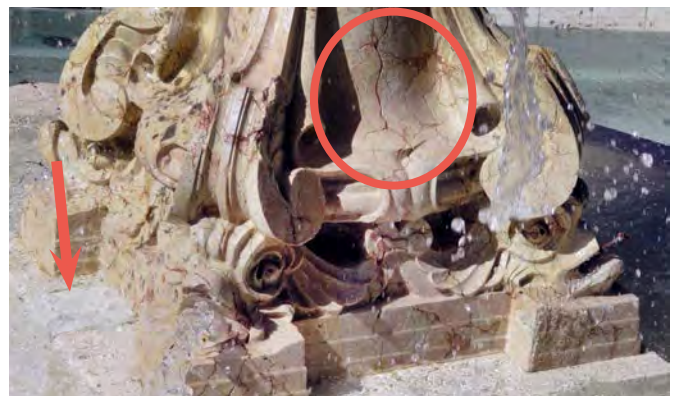
*Weathered veining in lower pedestal. Note the dutchman repair indicated with an arrow.*

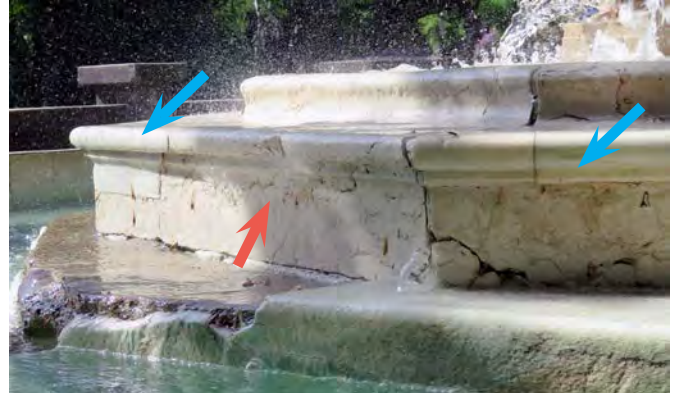
*Crack (red) and dutchman repairs (blue) in lower bowl. Note the open joint between the plaster and the marble.*

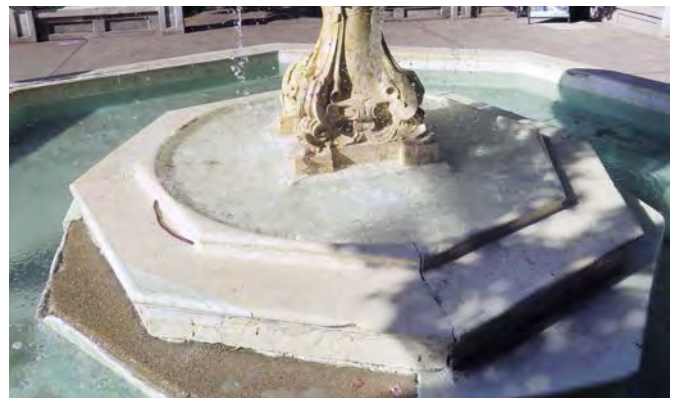
*Previous repairs and open joints at lower bowl. Note the plaster failure and exposed concrete at the bottom right.*

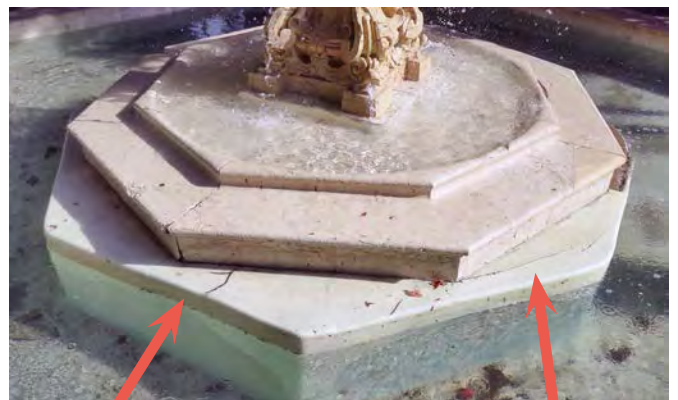
- The pool of the fountain is in poor condition, with large areas of cracked and missing swimming pool plaster. The plaster shows signs of previous patching, and many of the interfaces of these patches have failed and exhibit large cracks. Some of the pool plaster extends above the waterline onto the lower podium and has experienced significant delamination. In general, pool plaster should be continually submerged as it can dry out, check, crack, and fall apart. Hence, if a fountain is to be drained in the wintertime or experiences periods with no water such as shutdowns during extreme drought conditions, swimming pool plaster is a poor choice if lining material.

*Cracks in plaster over concrete base.*

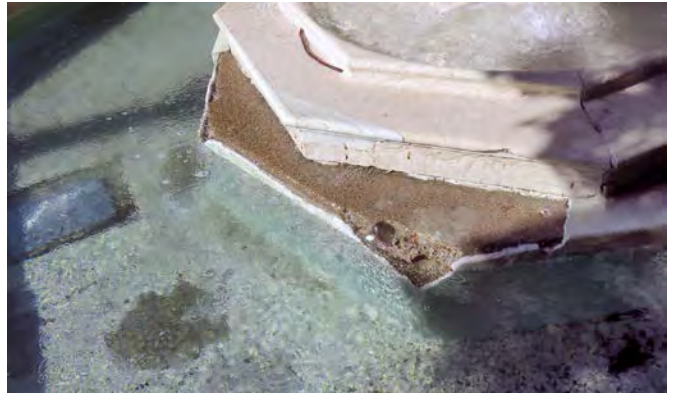
*Plaster loss at concrete base. Note plaster loss below the water, on the floor of the pool.*

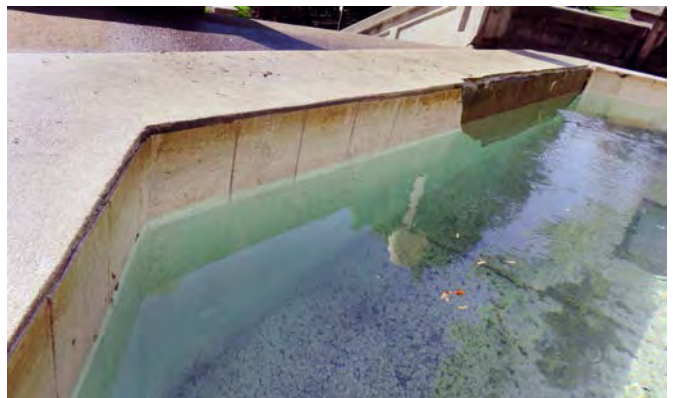
*Missing and soiled perimeter tiles.*

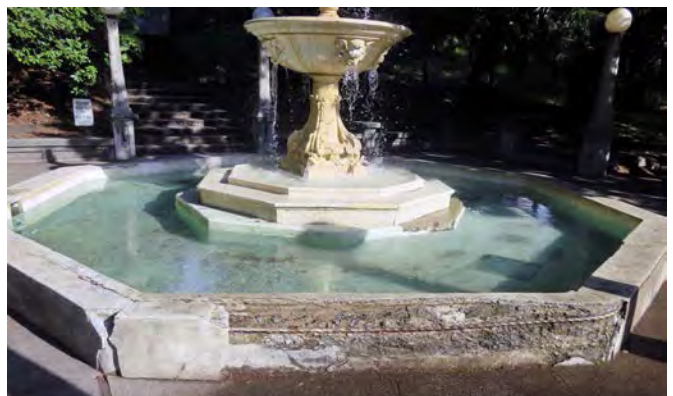
- The outer rim of the pool is in poor condition, with a large area of loss and exposed ferrous reinforcement at the east side of the fountain. This appears to have been a recurring problem area, as there are signs of at least four repair campaigns. Additionally, based on historic photos the outer rim was made thicker and taller in the 1987 restoration, likely in response to water issues at this wall. The delamination issues at this wall suggest that it is another avenue for water to escape the fountain system.

*Concrete loss at outer rim of fountain pool.*

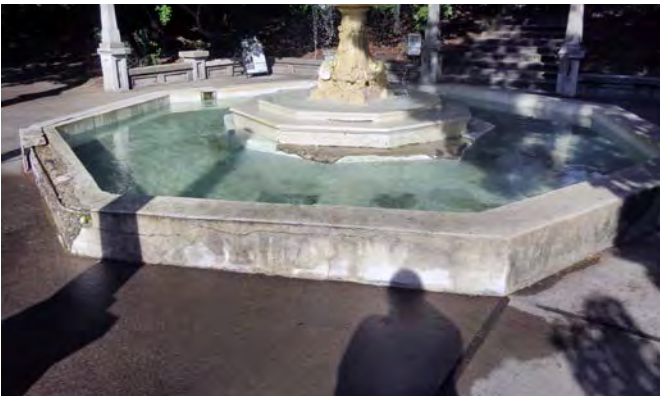
*Concrete cracking, spalls, and soiling at outer rim of fountain pool.*

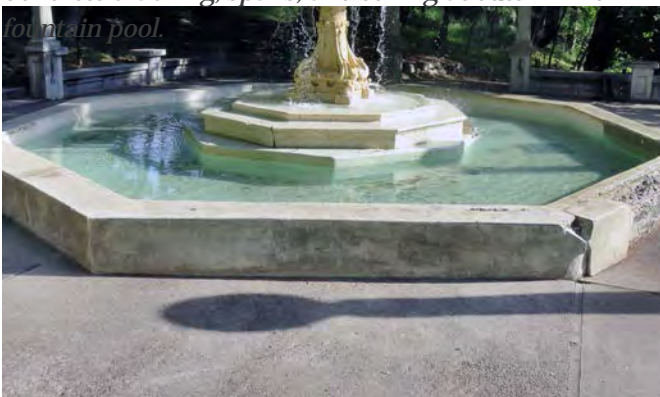
*Concrete cracking, spalls, and soiling at outer rim of fountain pool.*

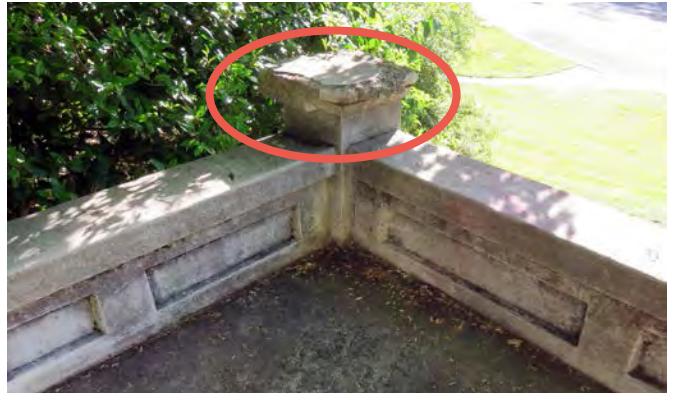
*Concrete cracking, spalls, and soiling at terrace column.*

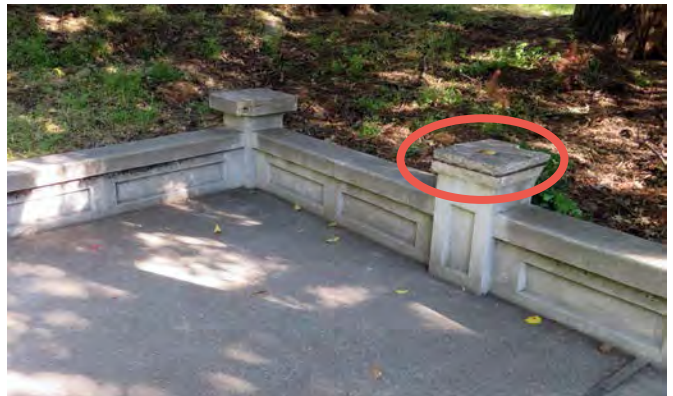
*Concrete cracking, spalls, and soiling at terrace columns.*

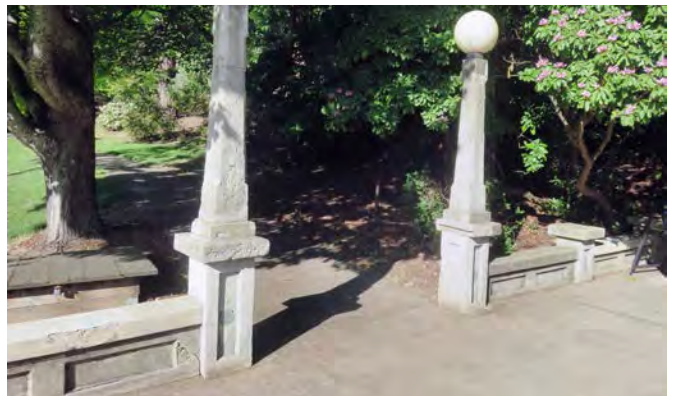
*Concrete cracking, spalls, and soiling at light posts.*

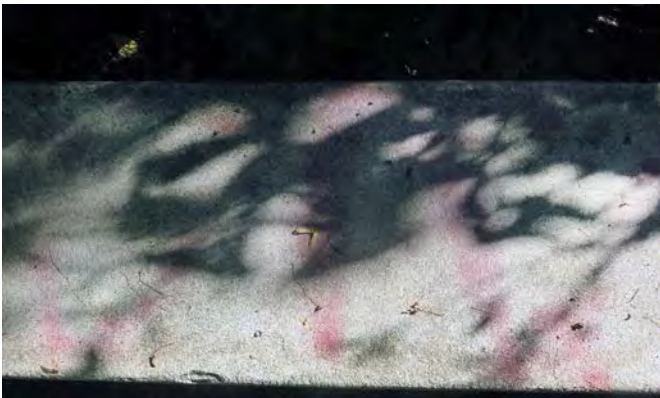
*Graffiti ghosting on terrace wall.*

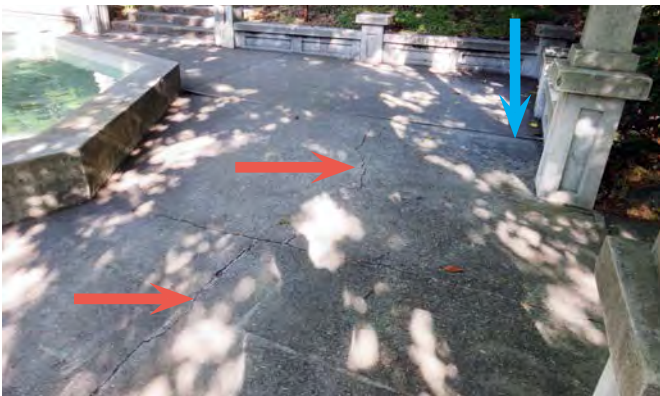
- The flat concrete is in fair condition, with cracking and surface loss on the north end.
- The flat paving has inset wood strips. These strips are beginning to warp in some areas due to moisture in the wood.

*Concrete cracks (red) and warped wood strips in terrace floor (blue).*

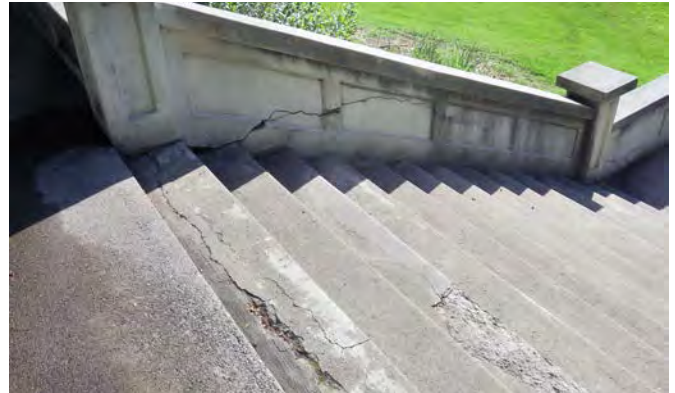
- Overall the stairs are in good condition, with some areas in poor condition. There are spalls and cracks in stairs at the base and top of the staircase. There are previous repairs visible on the top steps, and some of these have failed.
- The stair walls are in fair condition. There are cracks in the cheek walls. Several of these cracks are visible on the inner and outer faces of the walls and may be due to water infiltration at the terrace or movement. Although most of the water that splashes out of the fountain evaporates naturally, it is possible that water is leaking from the fountain pool, particularly around the drain and other embedded items and is migrating beneath the concrete paving and stairway, compromising its integrity.

*Cracks in cheek wall and failed repairs and cracks in the stairs.*

- Spalls and cracks on the stair treads should be repaired. Failed repairs should be removed and replaced.

- Cracks in the cheek walls should be routed and repaired. Care should be taken to match the existing color and texture.
- The concrete should be cleaned using a biodegradable, non-acidic cleaner and low-pressure power washer. In order to prevent streaking and wand marks, a distance of at least 6 inches should be maintained between the surface and the tip of the power wash wand equipped with a fan tip 60 degrees or greater.
- While not included in the scope of this project, as it is not a signed or publicized pathway, the staircase from Granite Street should be studied for accessibility, and a handrail should be added if needed.

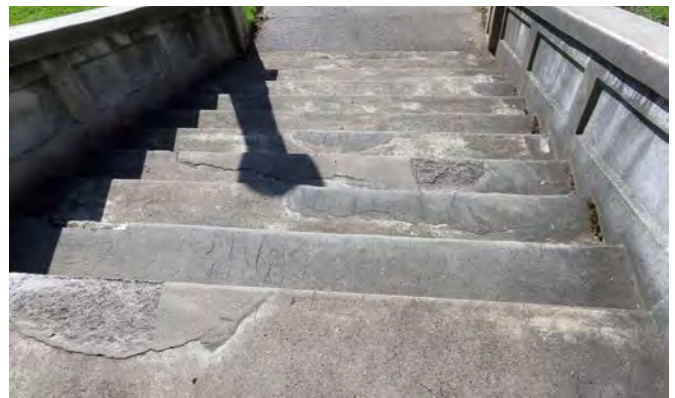
*Uneven and failed repairs at the lower stairs.*

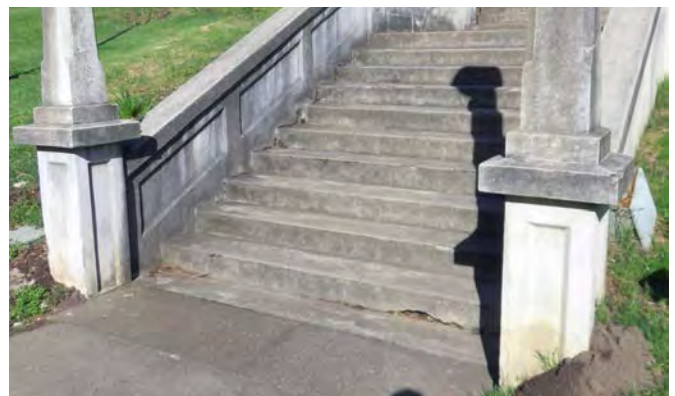
*Failed repairs and small spalls at lower stairs.*

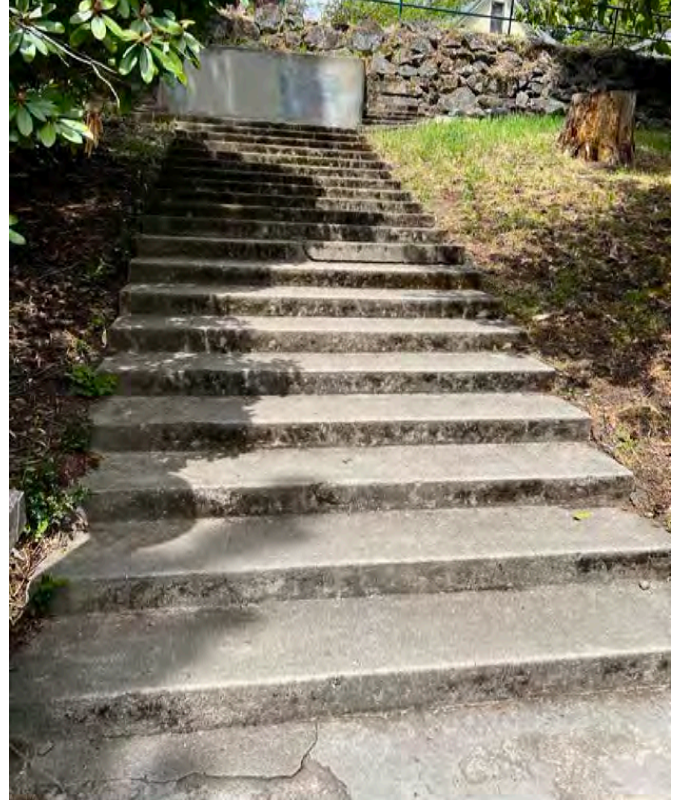
*Staircase to Granite Street, to the west of the terrace.  
Note that this is not a signed or publicized pathway.*
