# Public Arts Advisory Committee Agenda

# Butler-Perozzi Fountain: Request for recommendation

**Butler Perozzi Fountain Assessment and Recommendations**

#### CONDITION ASSESSMENT AND RECOMMENDATIONS

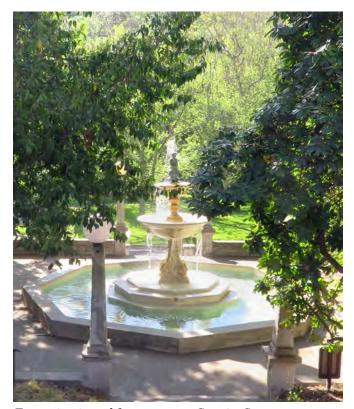
Fountain viewed from steps to Granite Street.

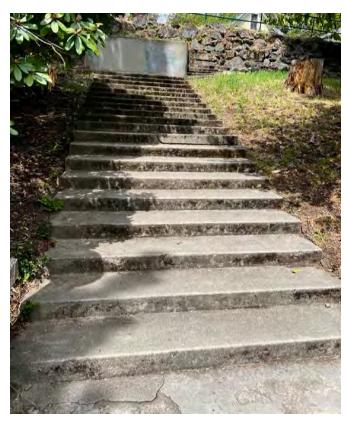
Staircase to Granite Street, to the west of the terrace. Note that this is not a signed or publicized pathway.
