**ASHLAND CANAL PIPING PROJECT
PROJECT PHASE 1A
ASHLAND, OREGON**

For: Paula Brown, Director
Public Works Department
City of Ashland
51 Winburn Way
Ashland, OR 97520

By: THE GALLI GROUP
612 NW Third Street
Grants Pass, OR 97526
(541) 955-1611

02-5407-01
August 30, 2018

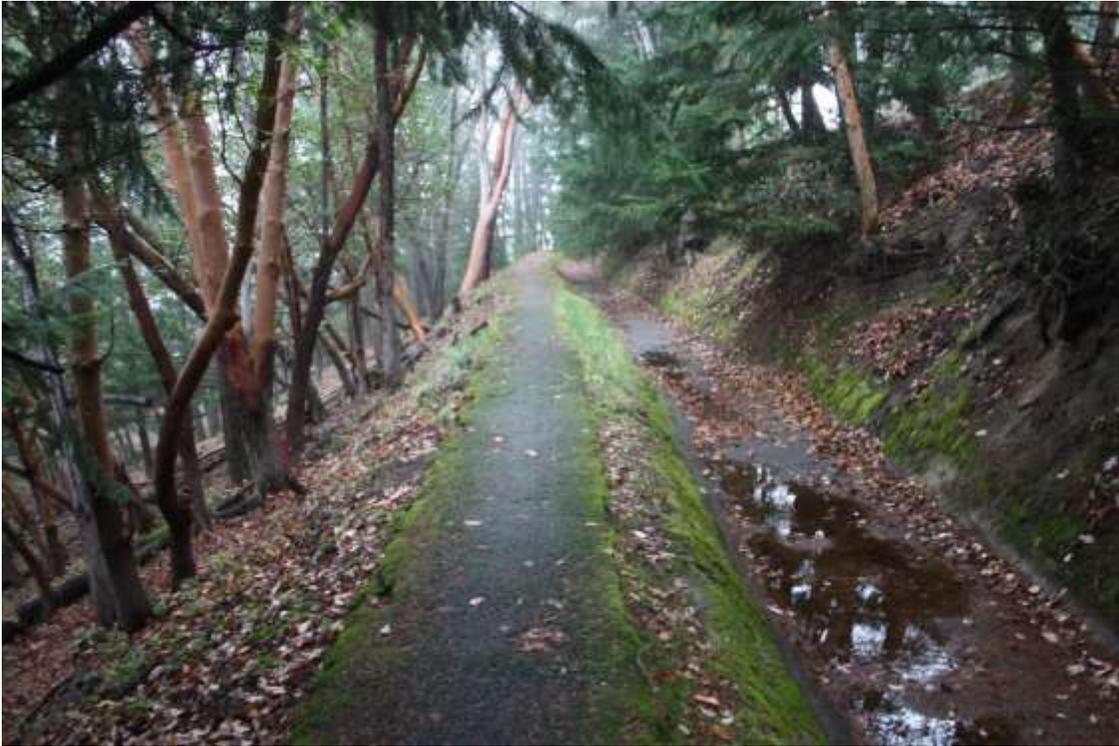
PHOTO 1: East End of Canal on Steep Slopes

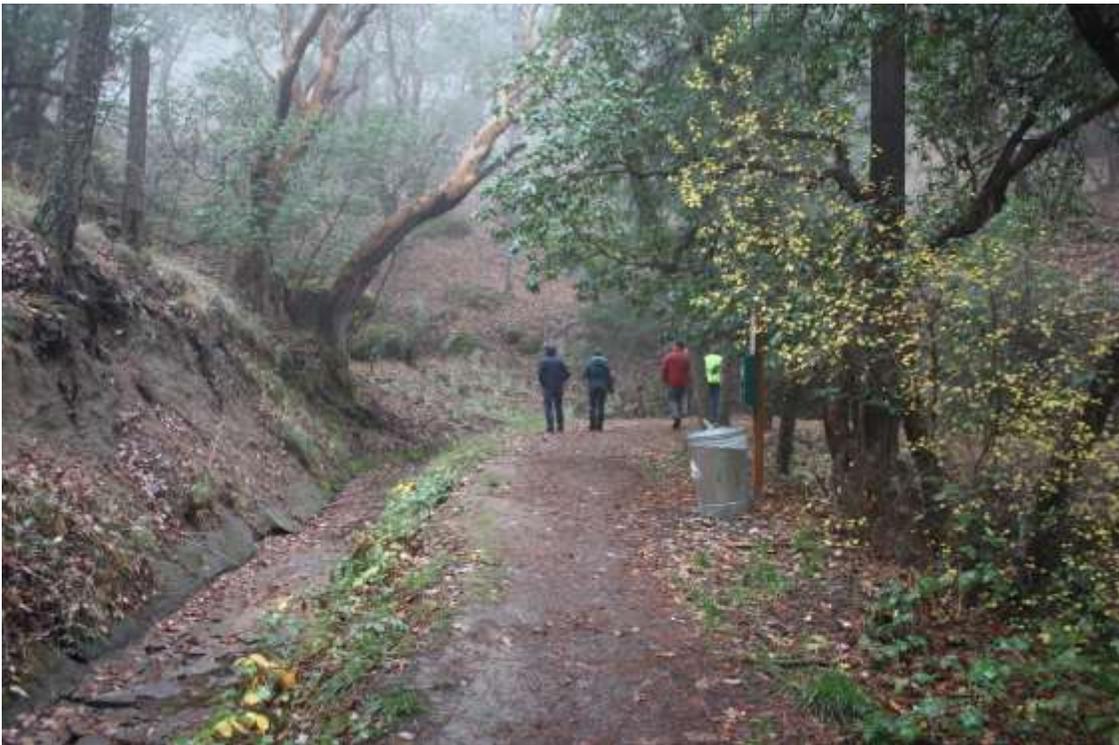
PHOTO 2: Steep Slopes Near Ashland Loop Road

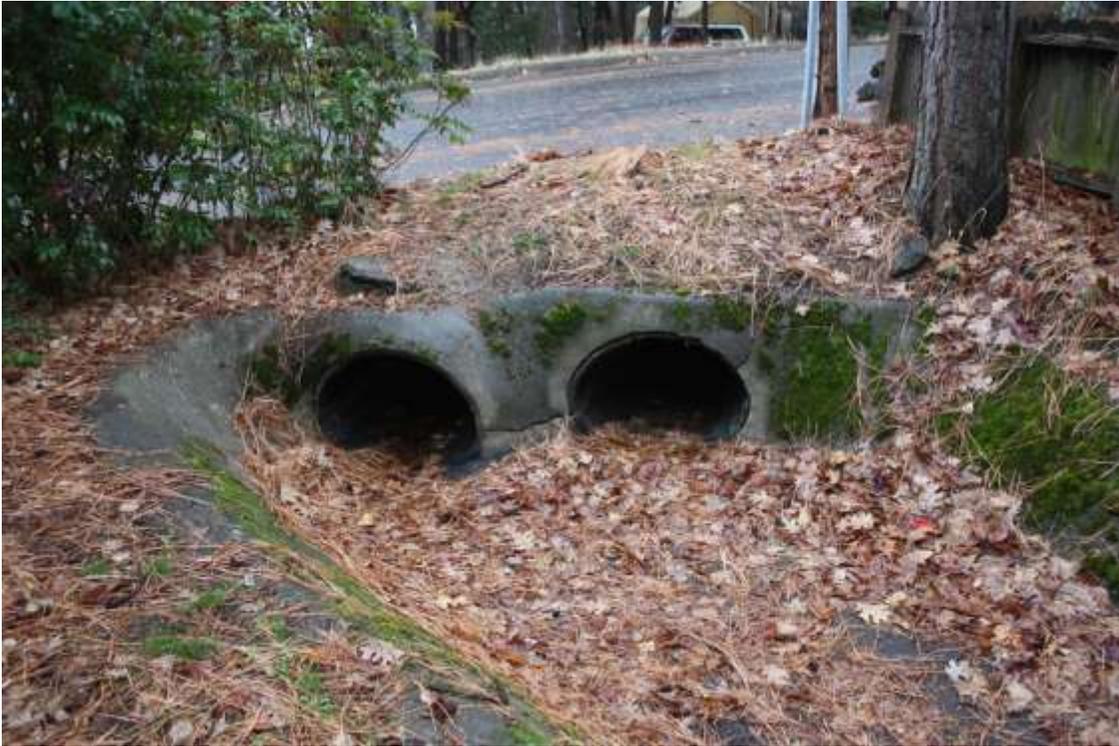
PHOTO 3: Dual Culvert Beneath Roadway

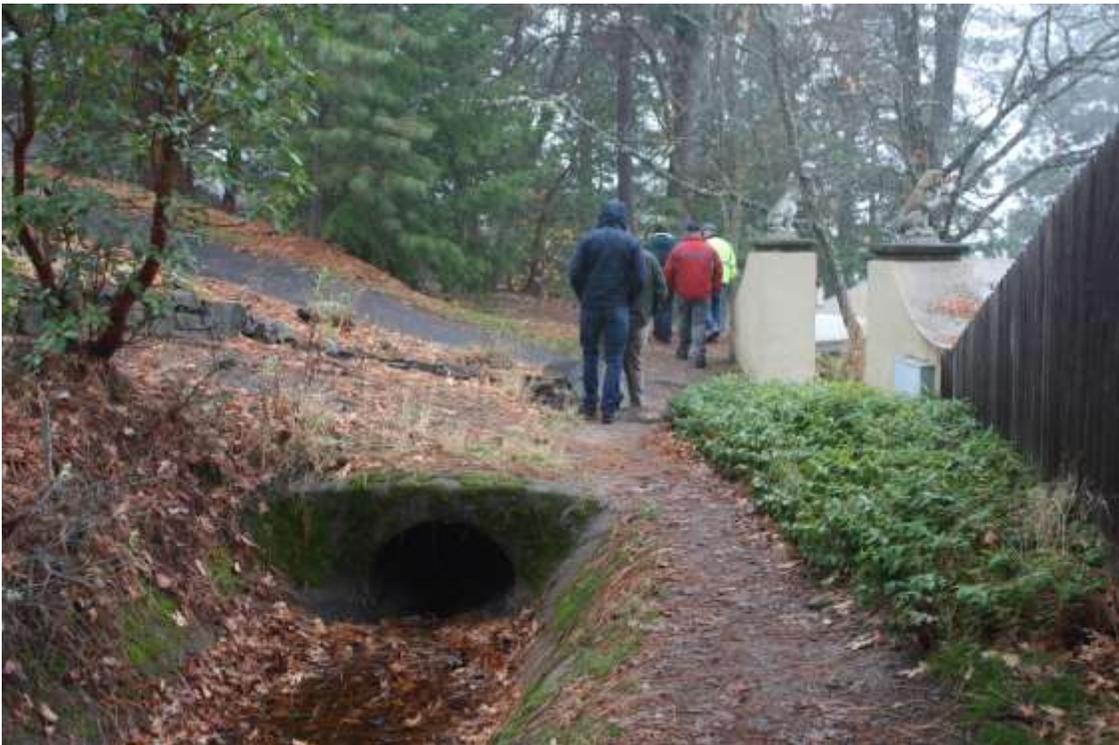
PHOTO 4: Culvert Beneath Driveway

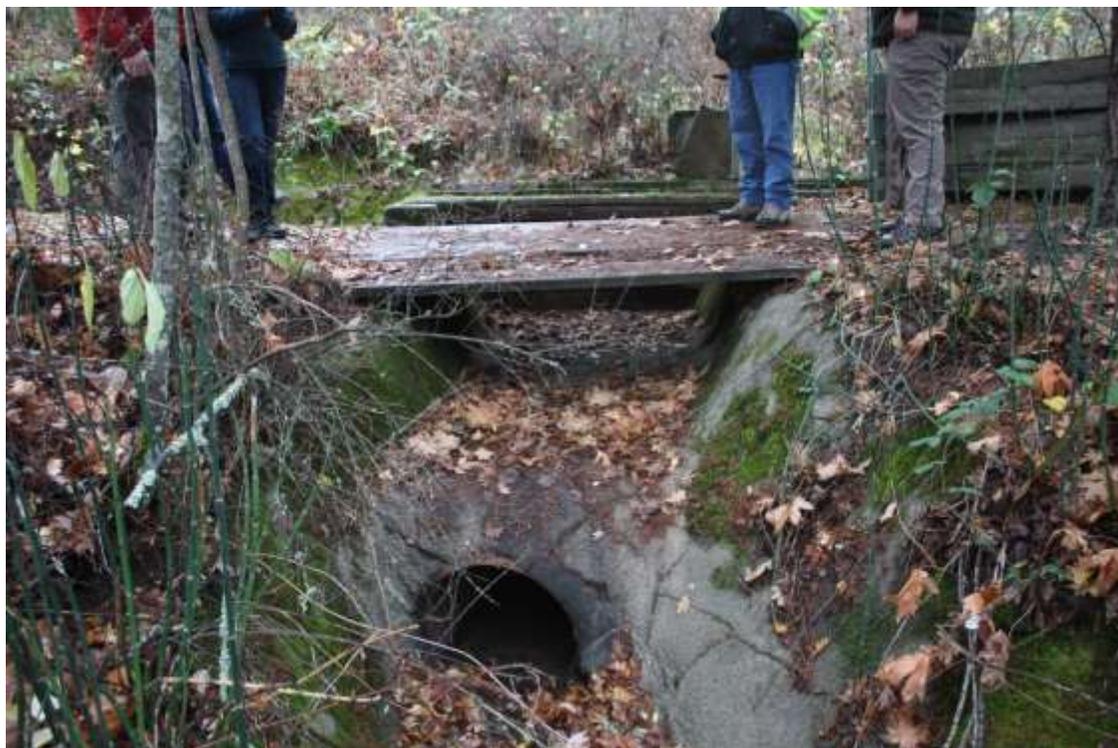
PHOTO 5: Canal Goes Over Ravine Culvert

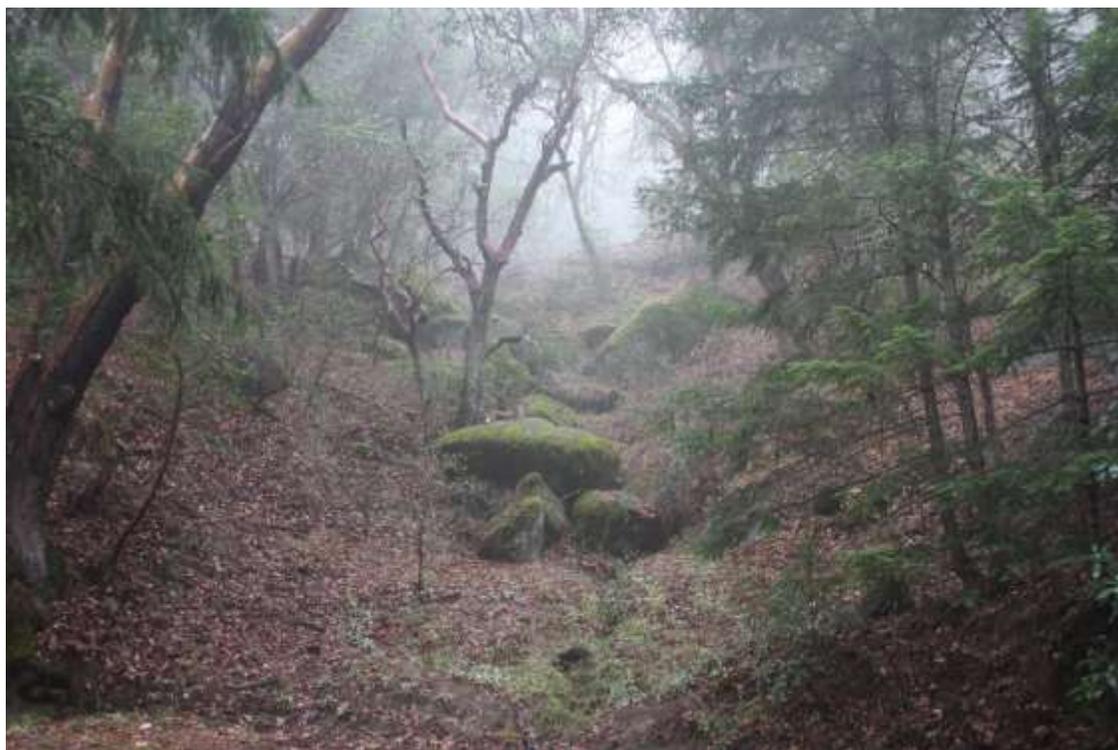
PHOTO 6: Ravine Comes into and Below Canal Near Ashland Loop Road

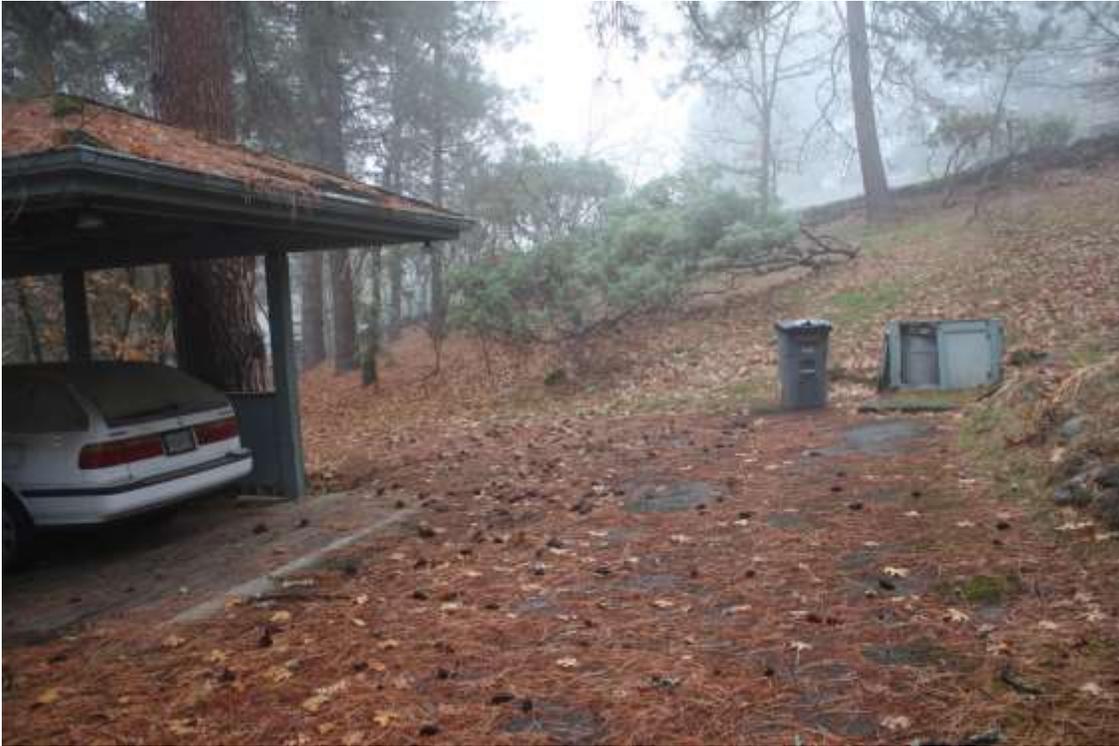
PHOTO 7: Car Shelter Built Right Next to Buried Portion of Canal

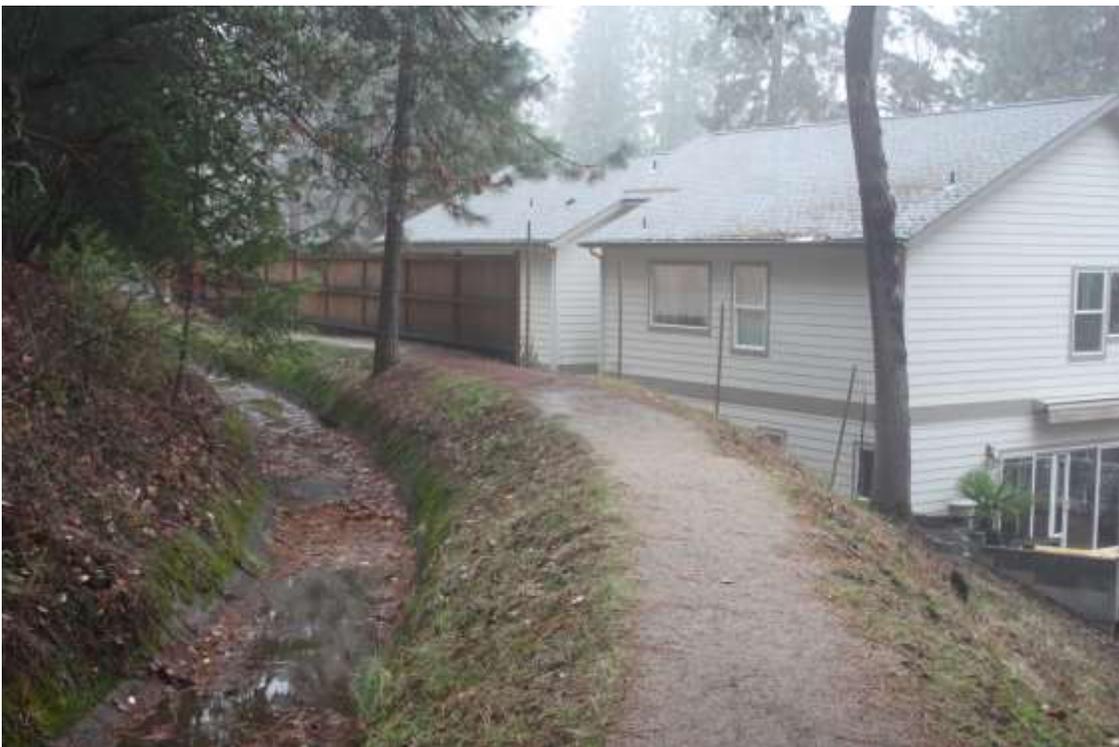
PHOTO 8: House and Fence Next to Canal

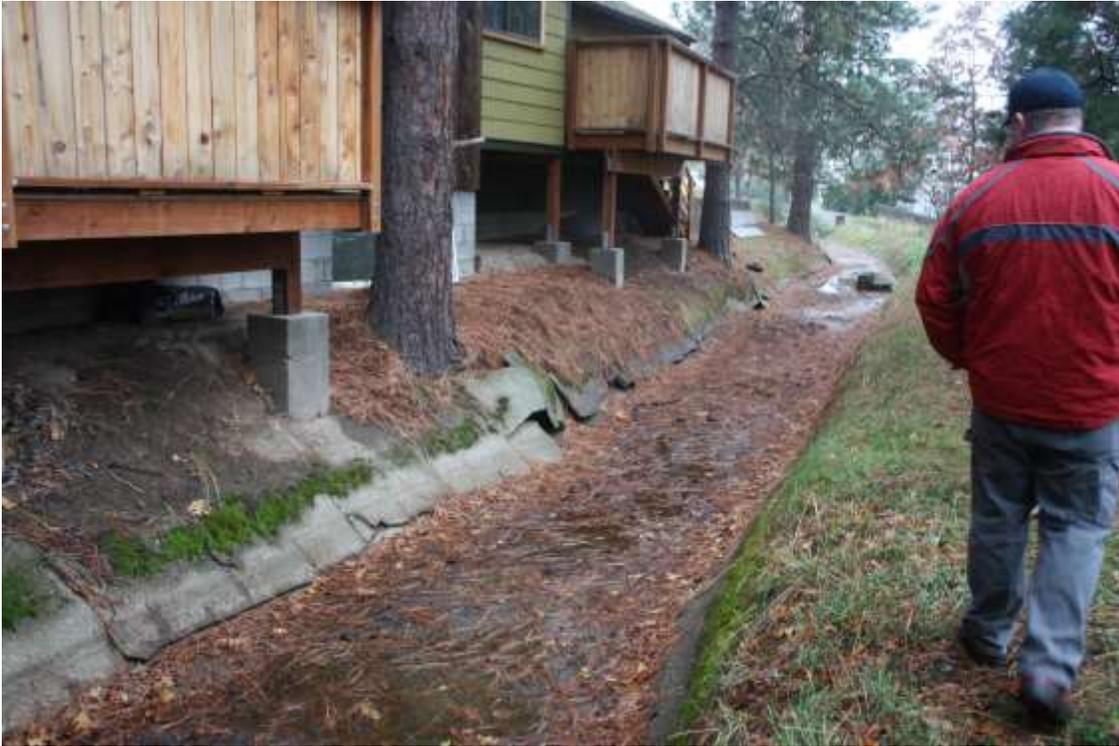
PHOTO 9: Deck Supports on Bank of Canal

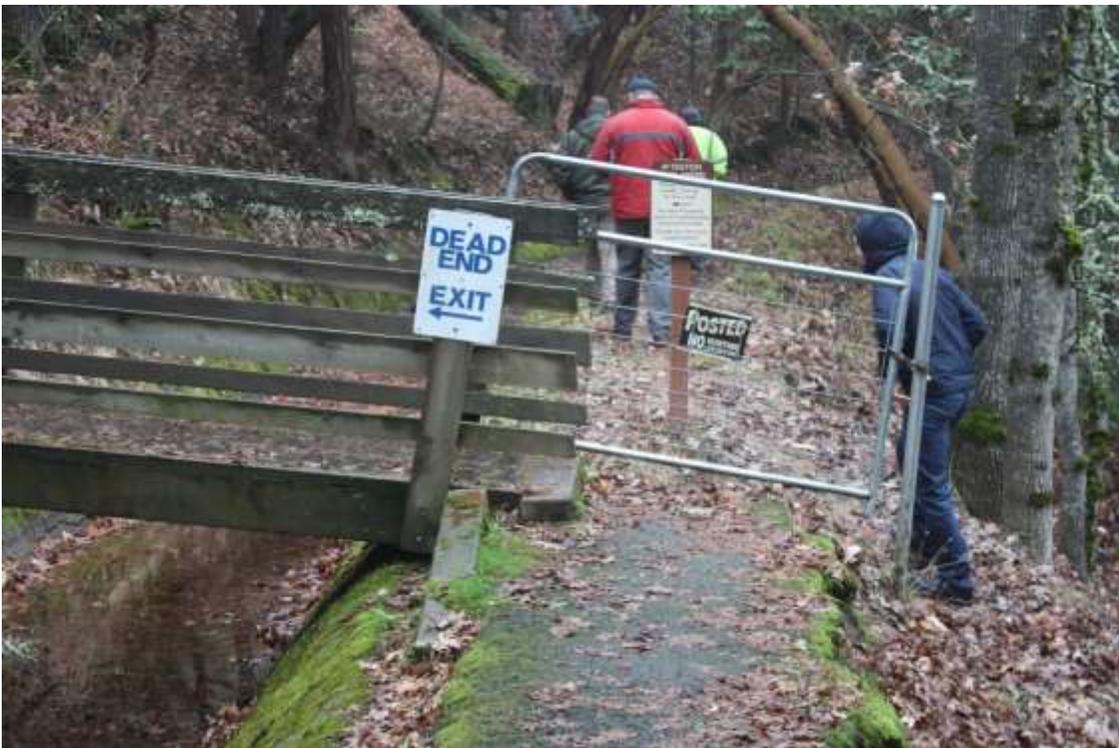
PHOTO 10: Footbridge Over Canal Near East End

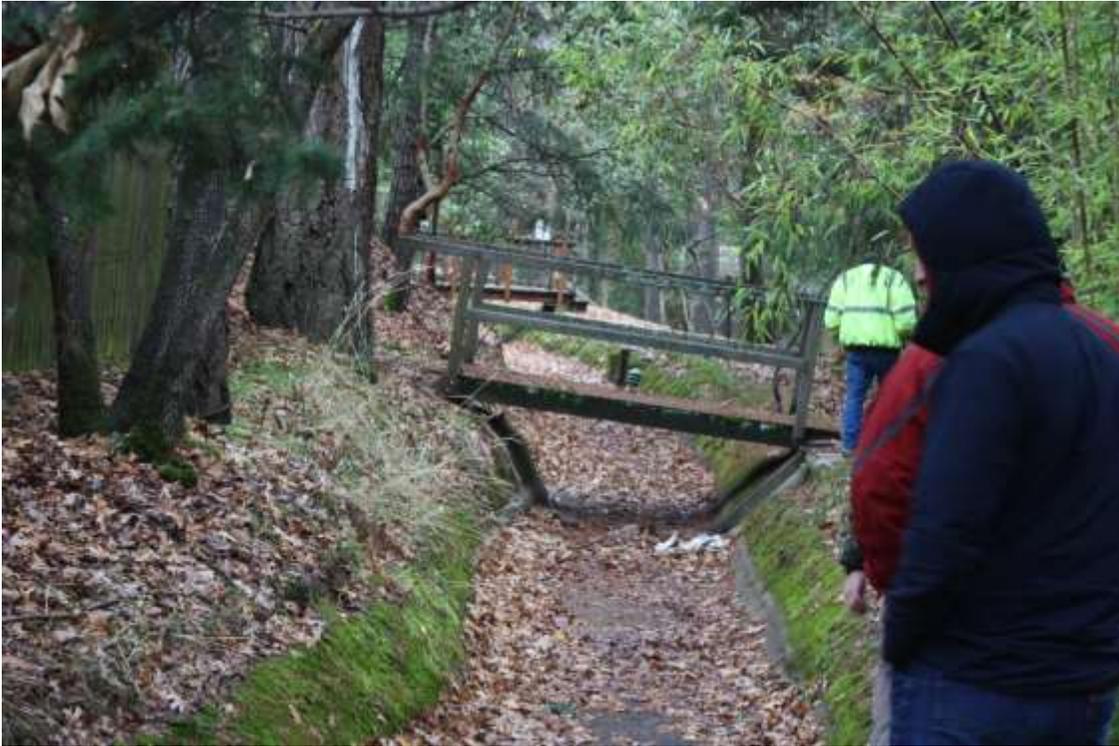
PHOTO 11: Footbridge Over Canal

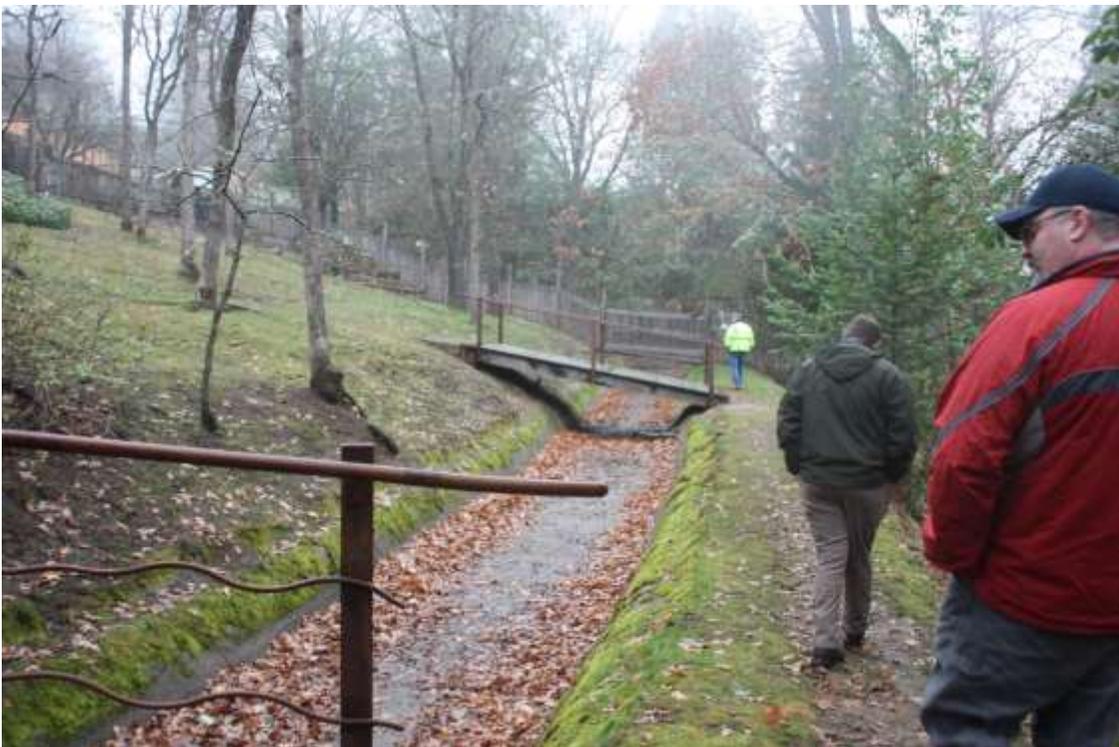
PHOTO 12: Footbridge Over Canal

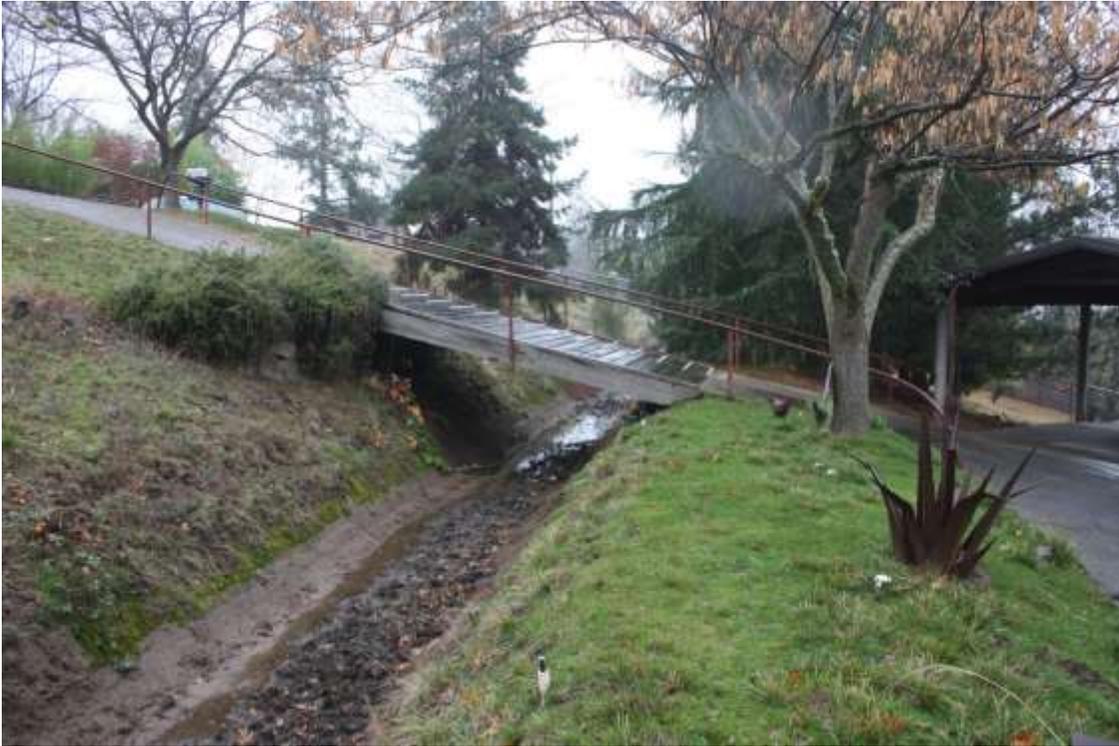
PHOTO 13: Driveway Bridge Over Canal Near West End

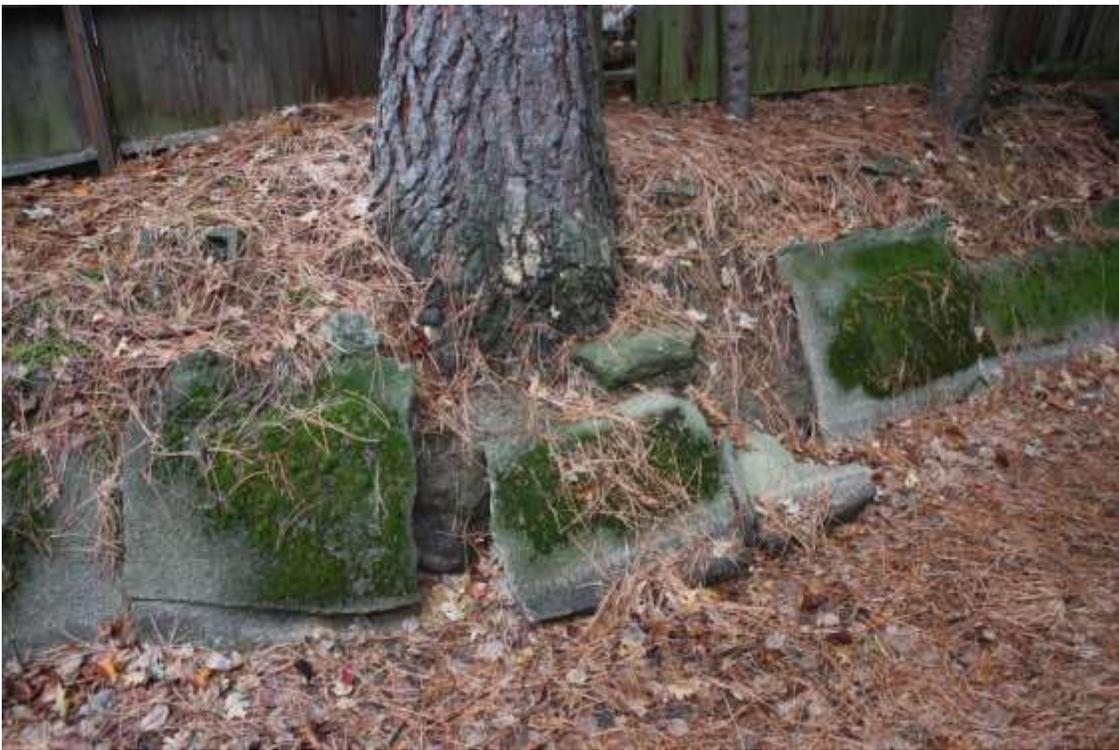
PHOTO 14: Tree Buckled Side of Canal

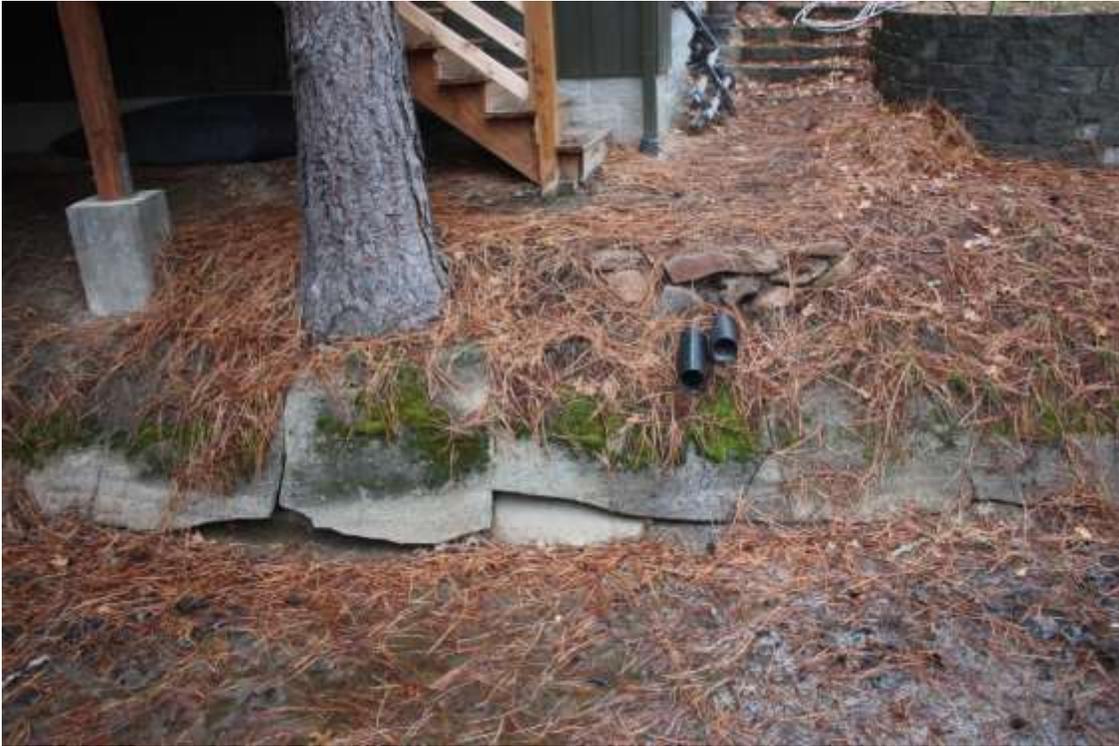
PHOTO 15: Tree Buckled Side of Canal

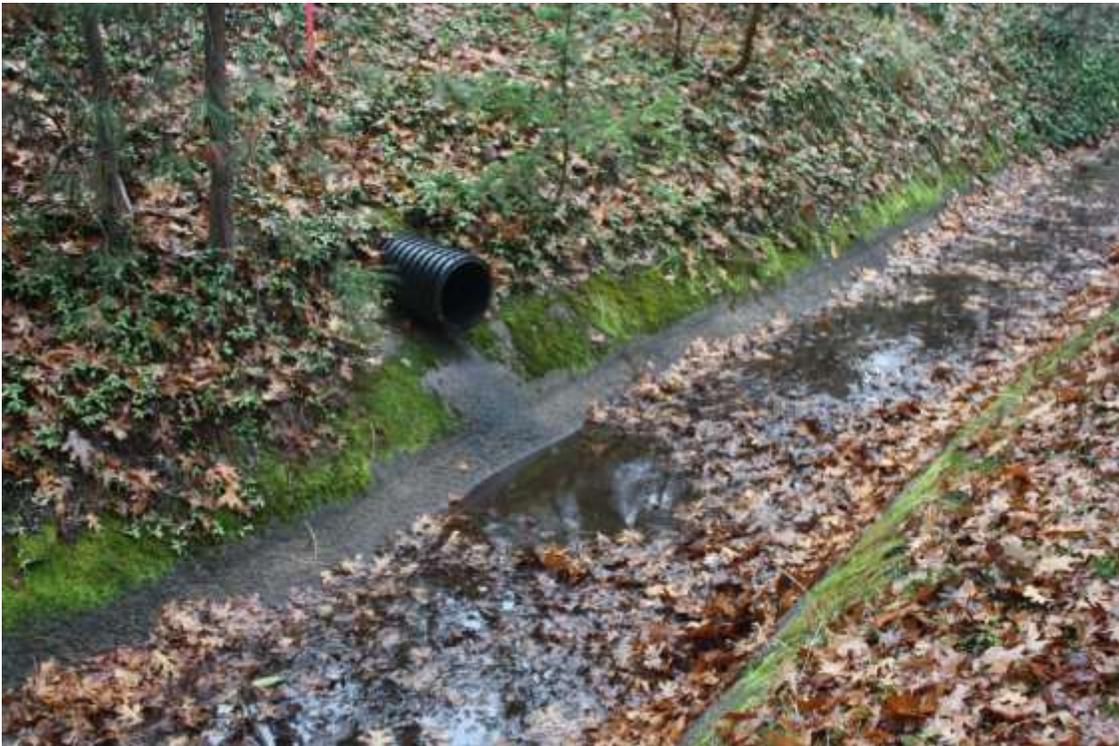
PHOTO 16: Conjugated Pipe Discharging into Canal

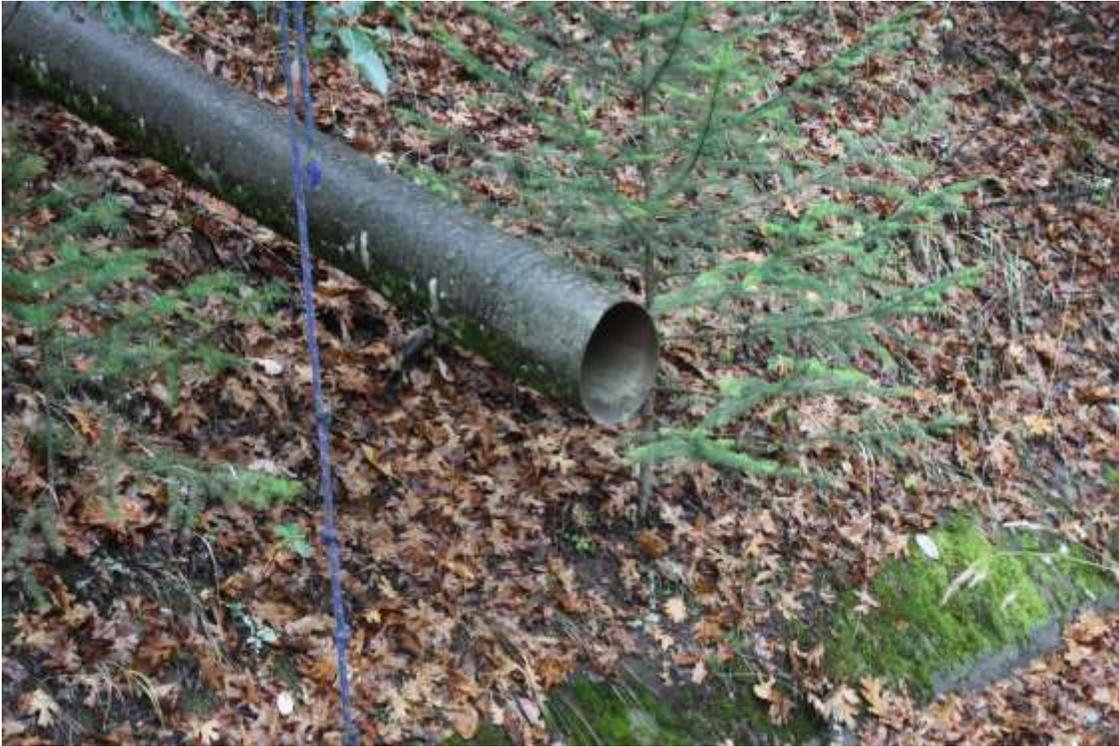
PHOTO 17: Steel Pipe Discharging into Canal

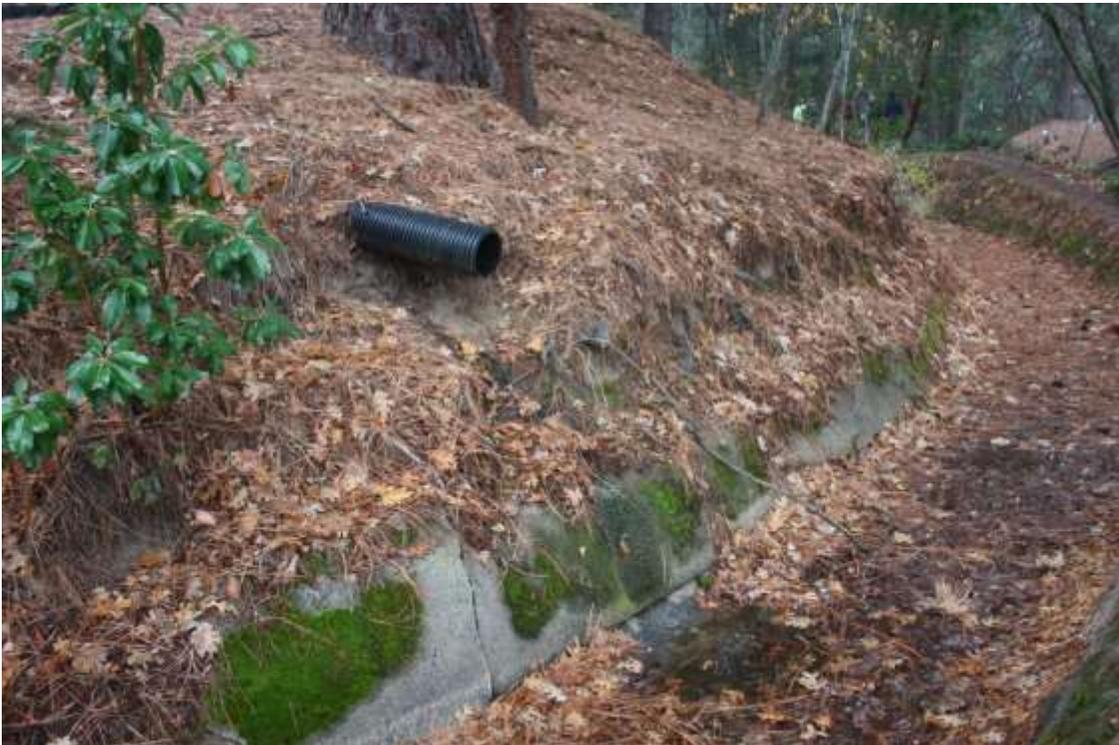
PHOTO 18: Conjugated Pipe form House Discharges into Canal

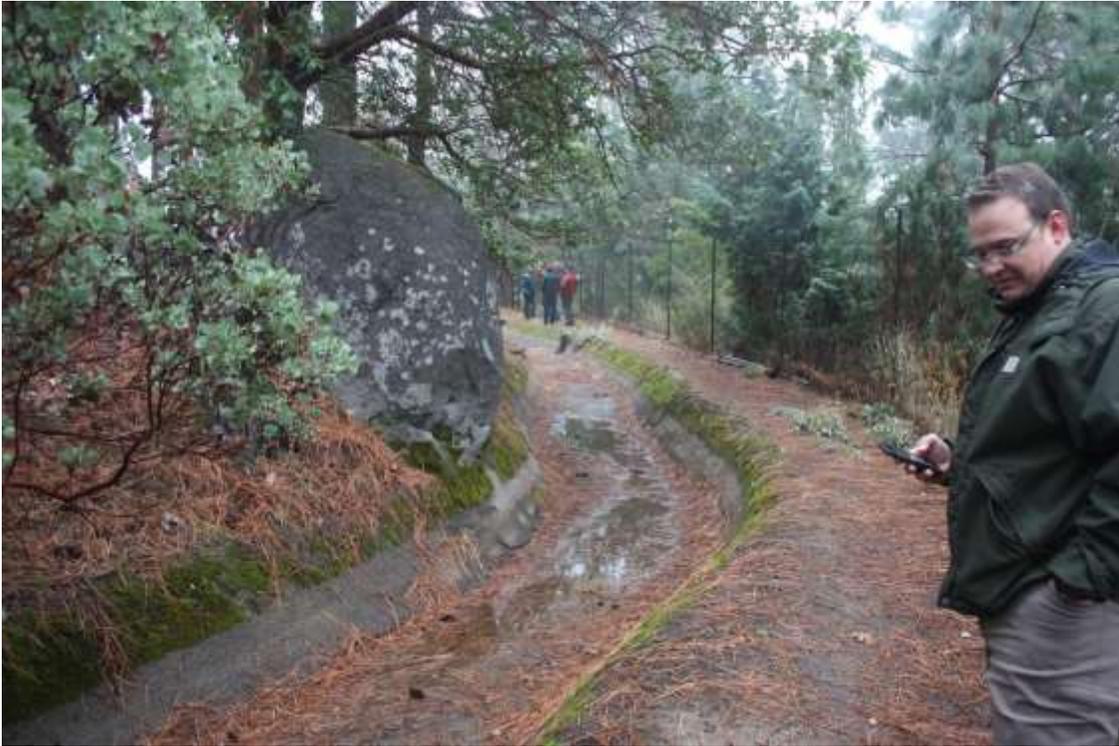
PHOTO 19: Large Boulder Encroaching into Canal Area

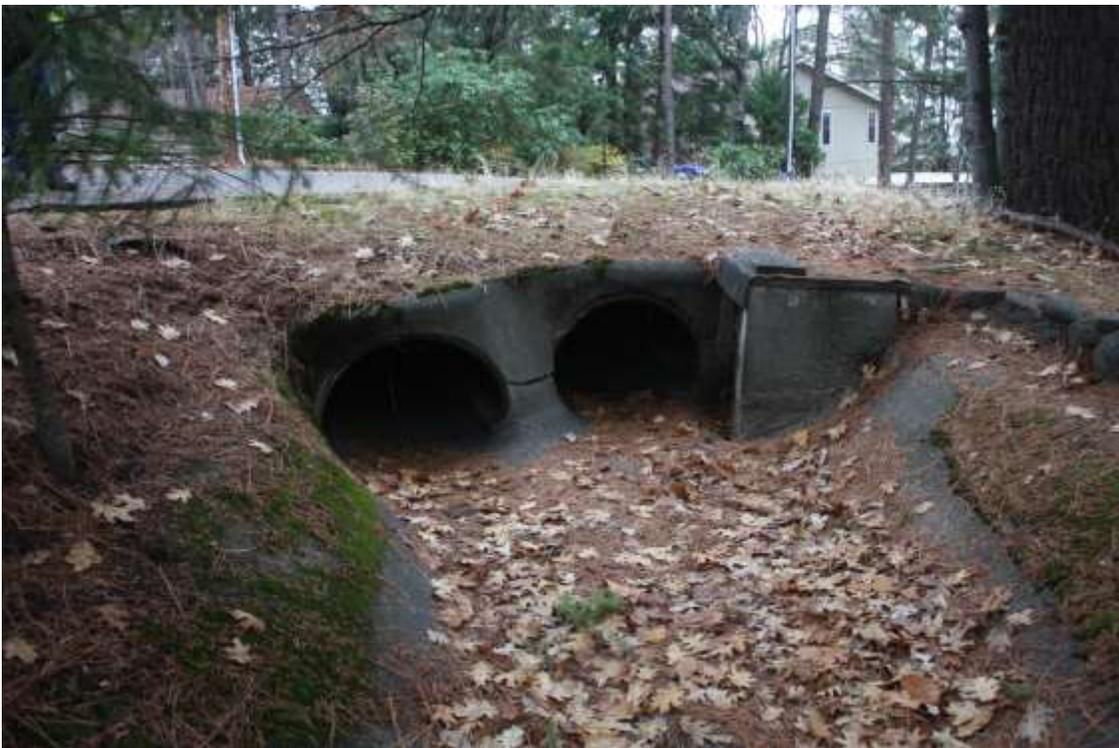
PHOTO 20: Canal in Double Culvert Under the Road

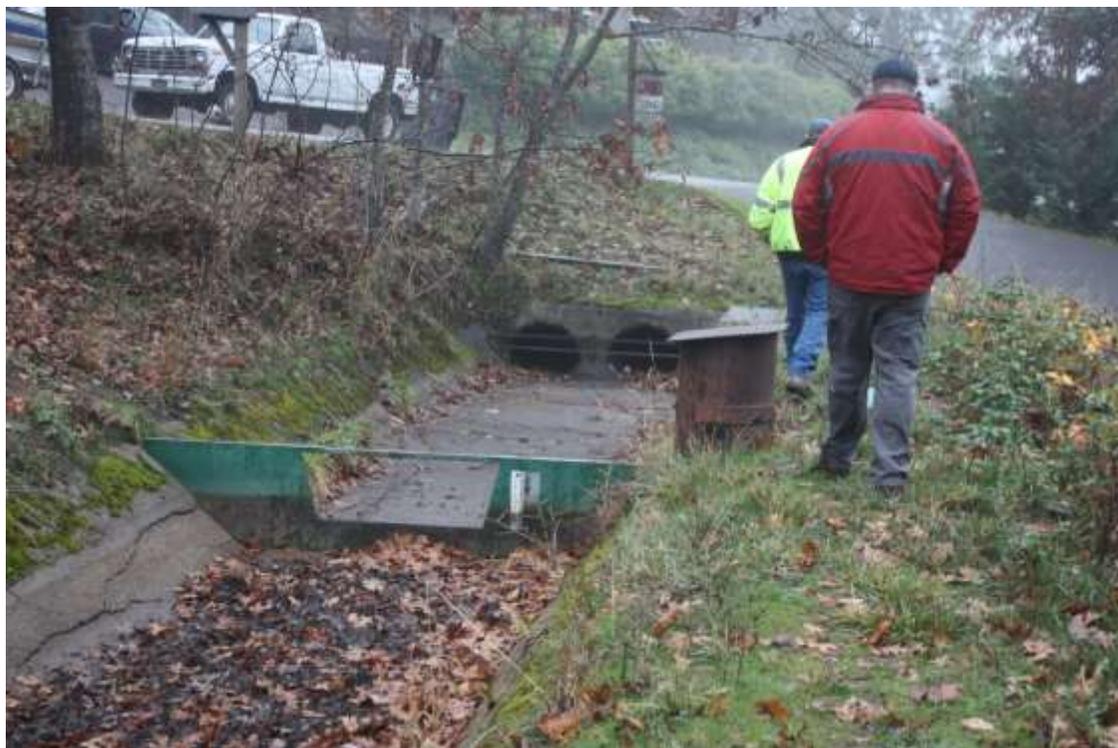
PHOTO 21: Double Culvert Under Roadway

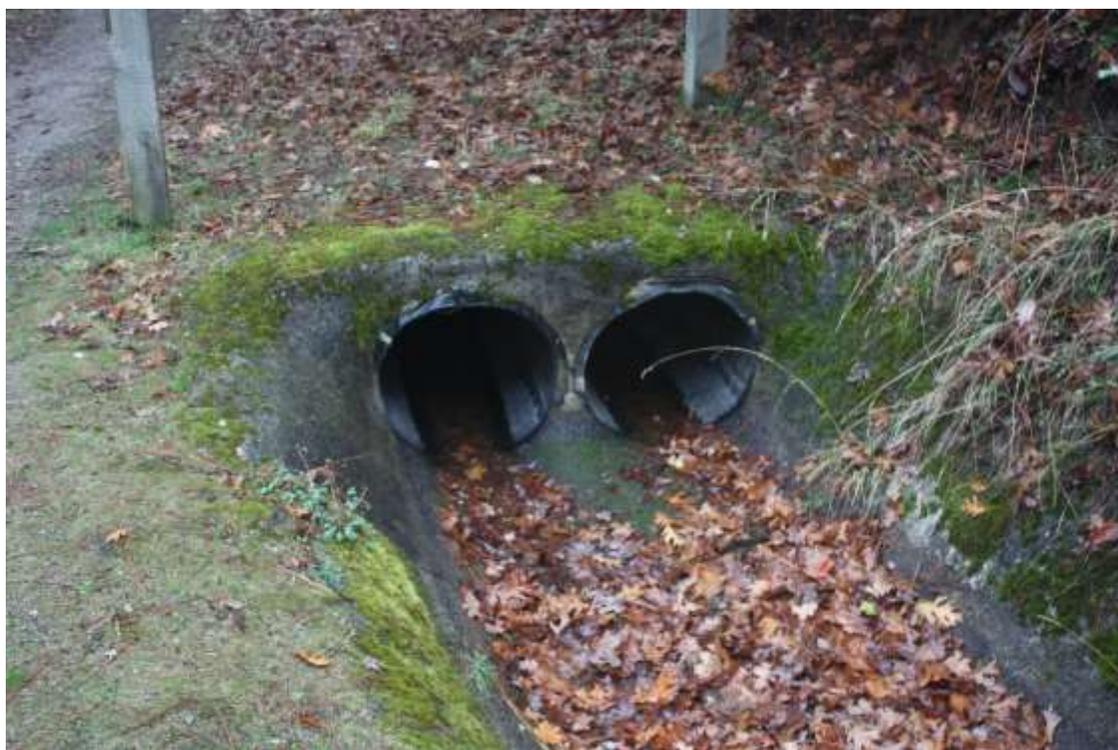
PHOTO 22: Double Culvert Under Property

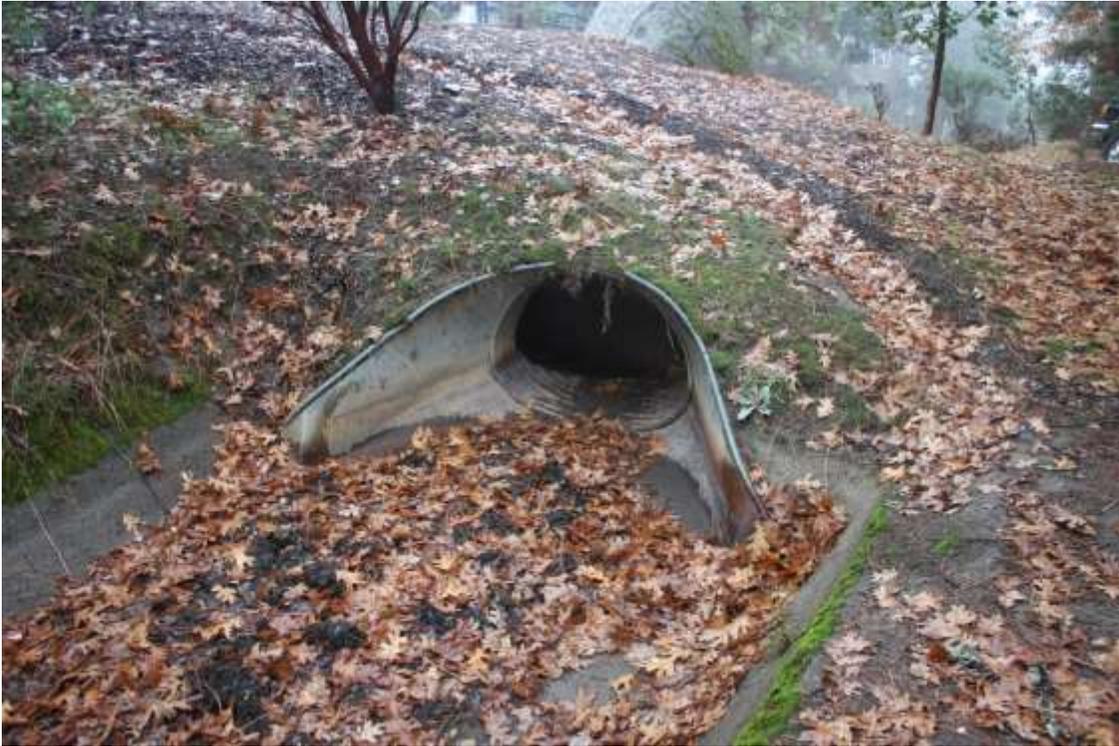
PHOTO 23: Culvert Under Driveway then Roadway and Several Lots

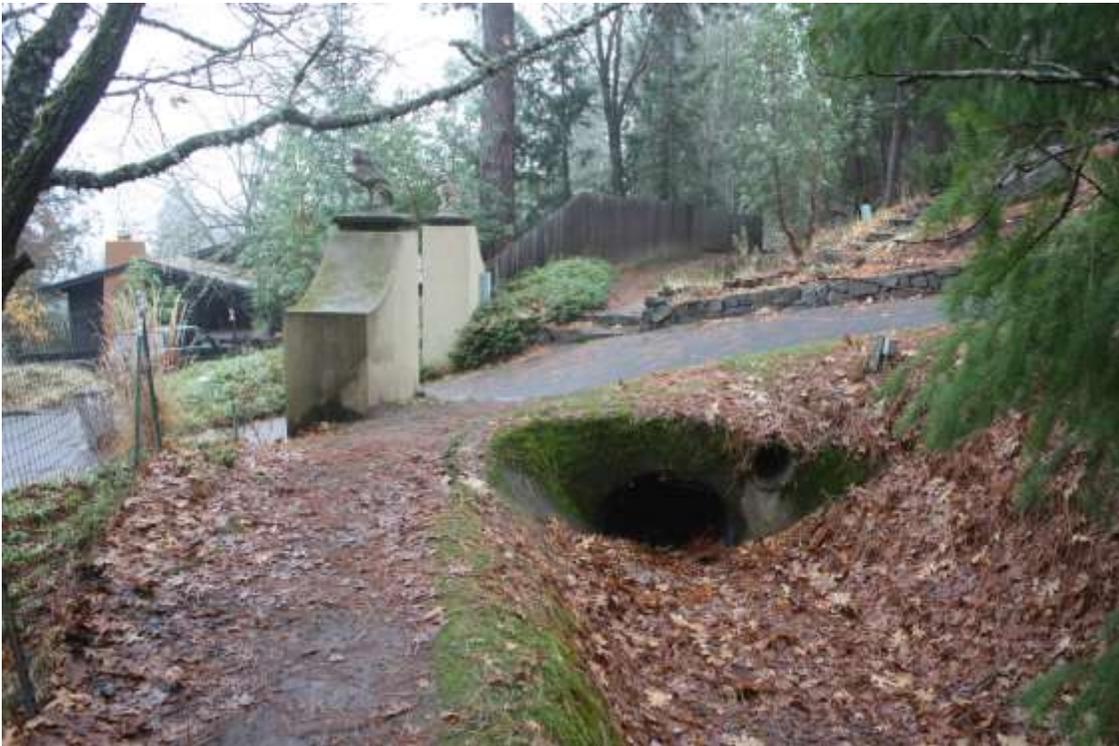
PHOTO 24: Culvert Under Driveway with Lions

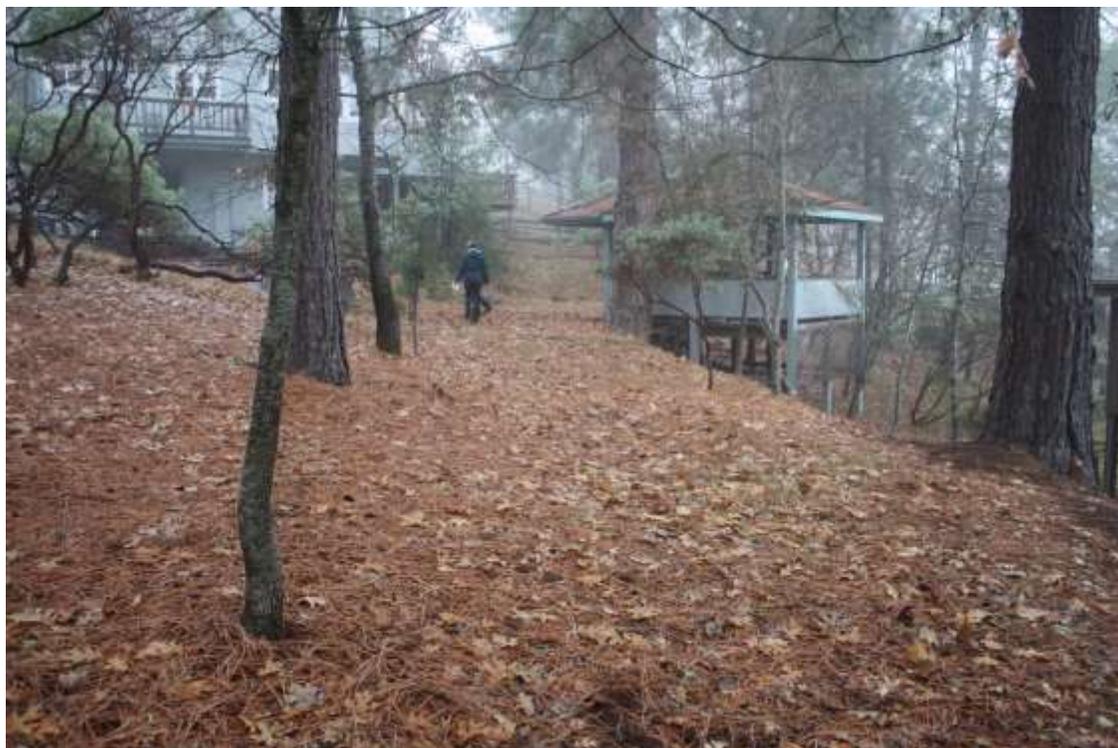
PHOTO 25: Culvert Under Access Pathway

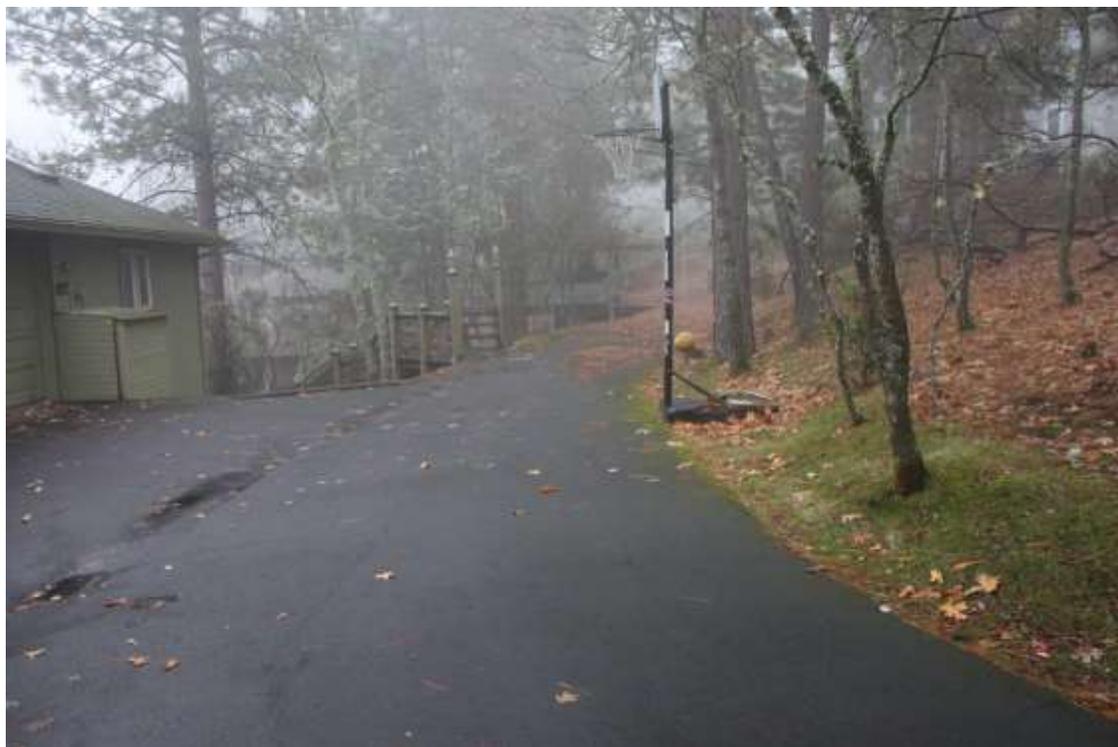
PHOTO 26: Culvert Under the Driveway

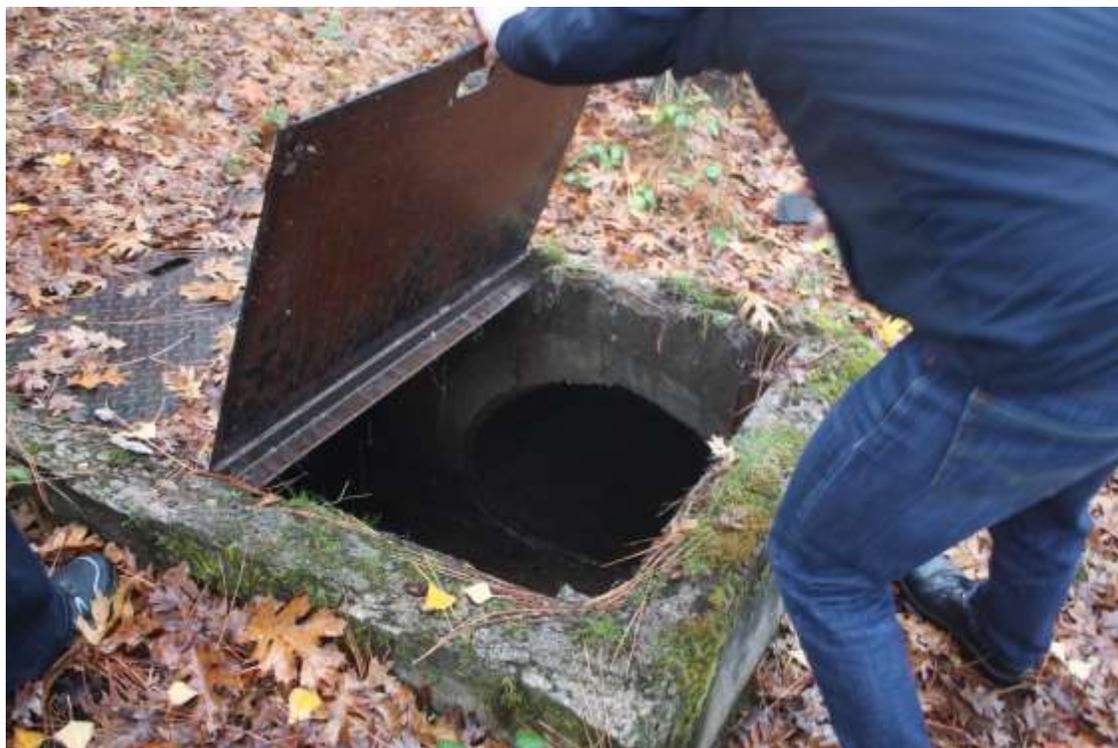
PHOTO 27: Hatch to Buried Canal Culvert
