**ASHLAND CANAL PIPING PROJECT
PROJECT PHASE 1A
ASHLAND, OREGON**

For: Paula Brown, Director
Public Works Department
City of Ashland
51 Winburn Way
Ashland, OR 97520

By: THE GALLI GROUP
612 NW Third Street
Grants Pass, OR 97526
(541) 955-1611

02-5407-01
August 30, 2018

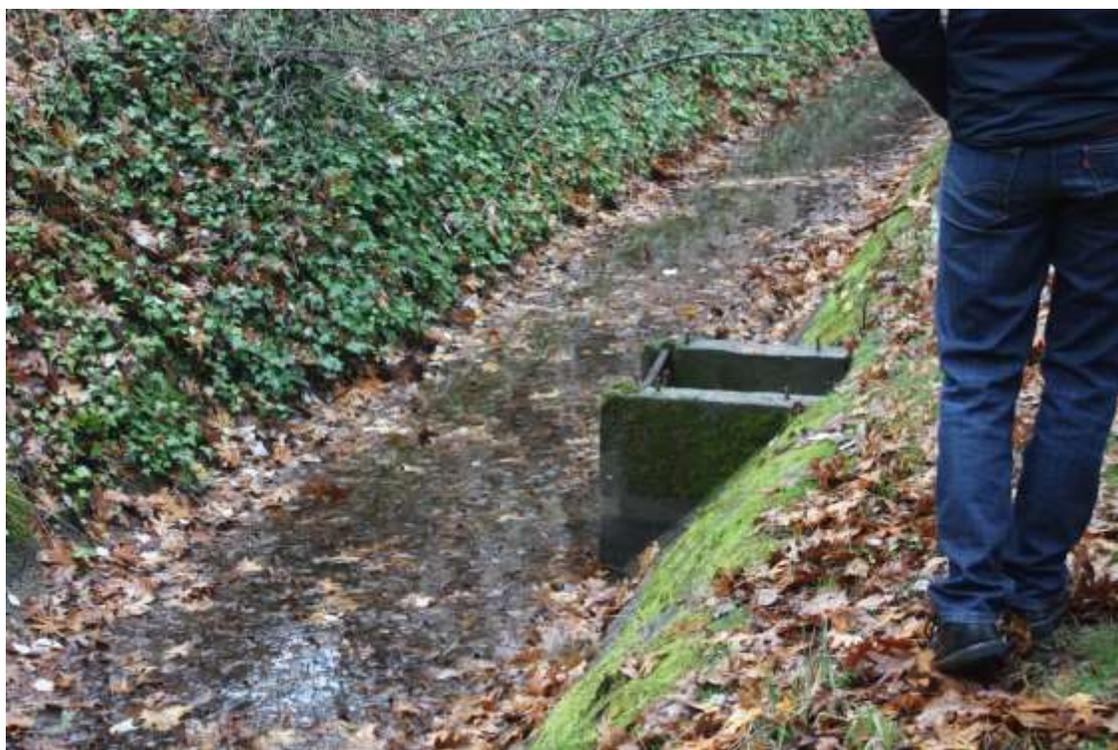
PHOTO 28: Legal Spill from Canal

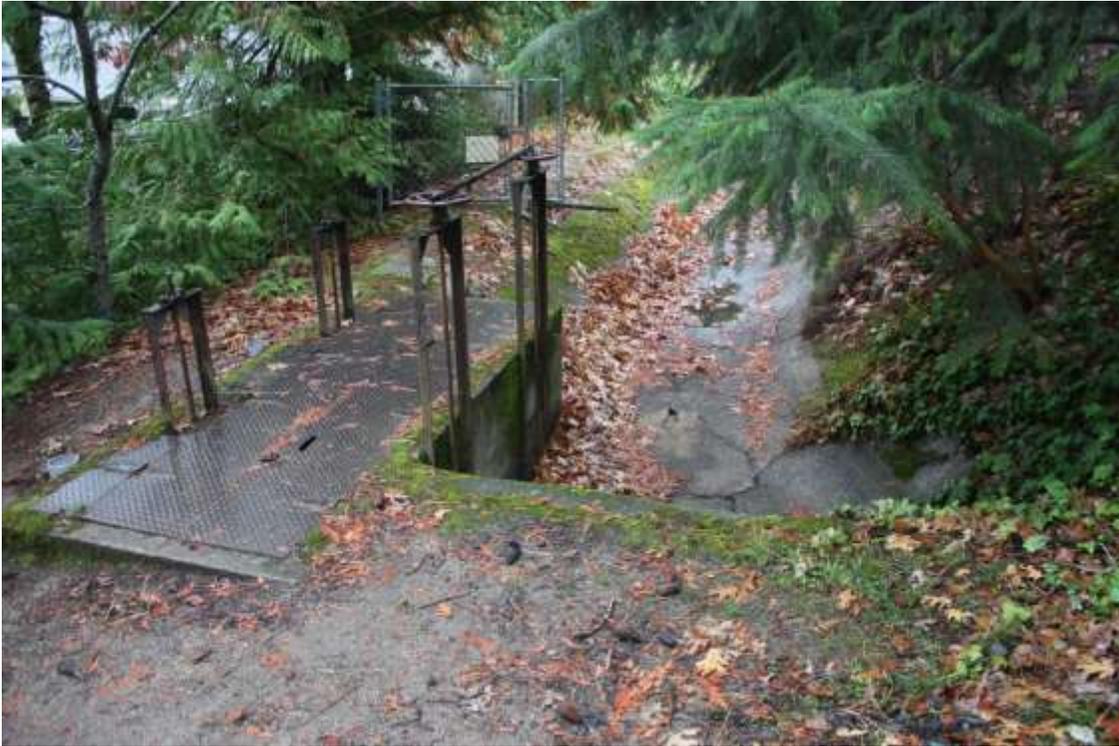
We also observed several areas where water was leaving the canal. Some were legal diversions to paying customers. See Photo 29. Some were due to fractures in the canal's concrete/gunite lining. See Photos 30 and 31.

PHOTO 29: Legal Spill from Canal

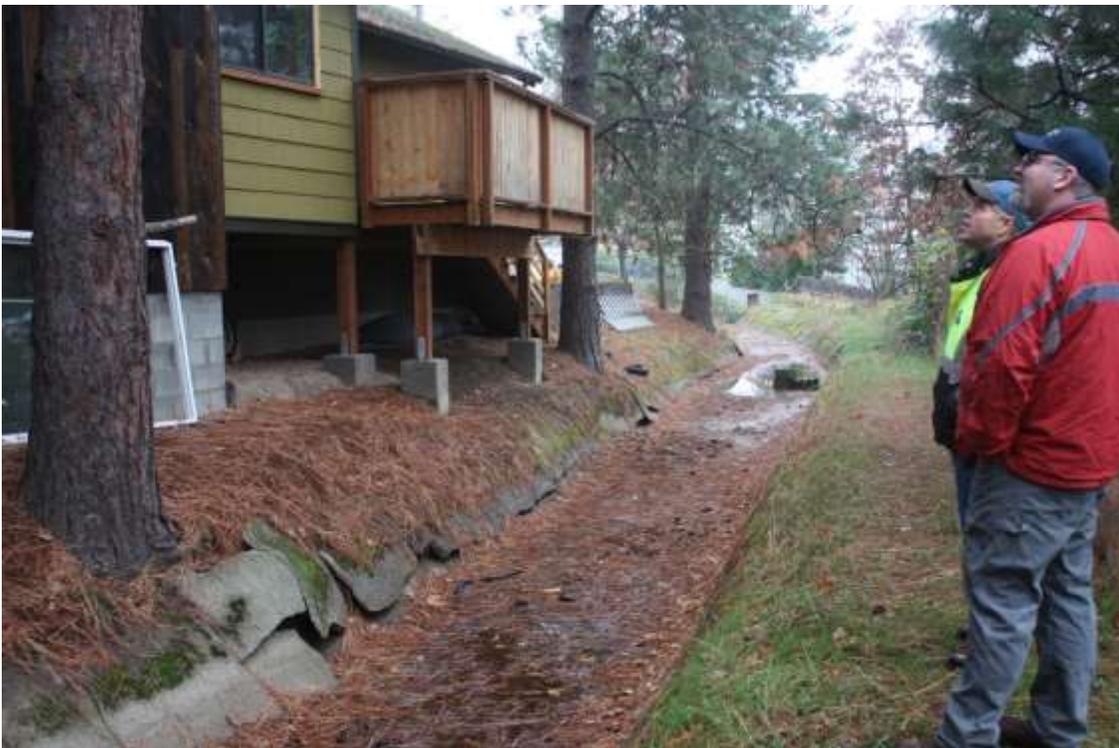
PHOTO 30: Large Cracks that Create Significant Leakage

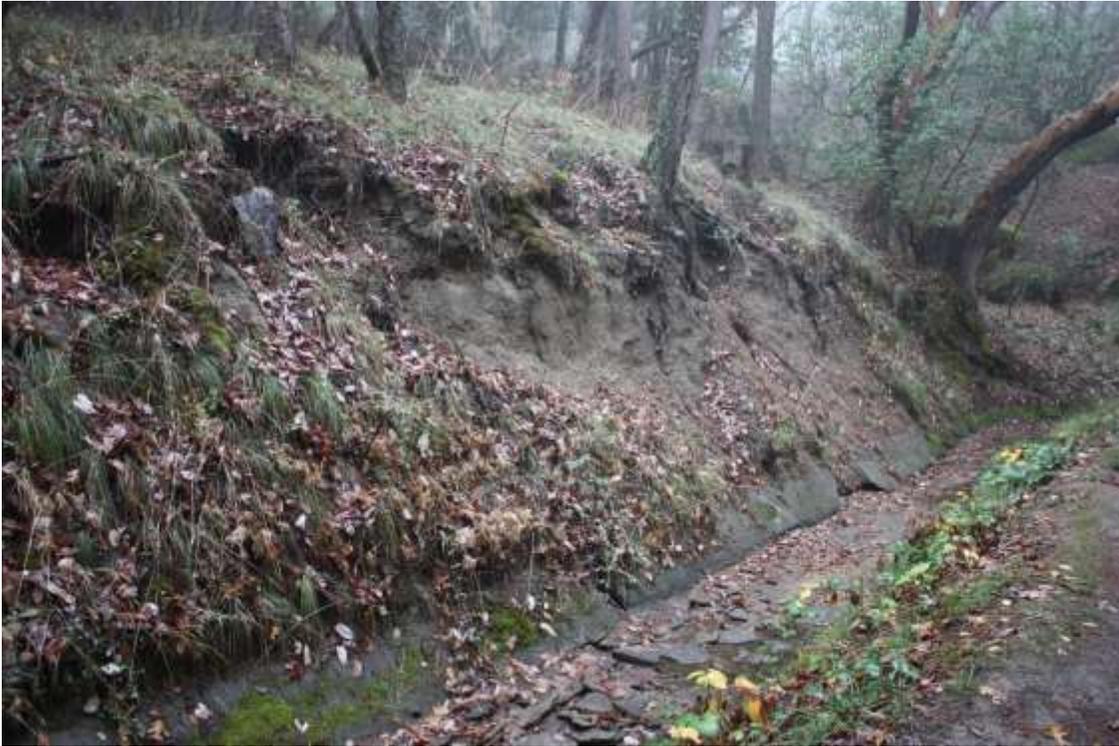
PHOTO 31: Fractures in Bottom and Sides of Canal

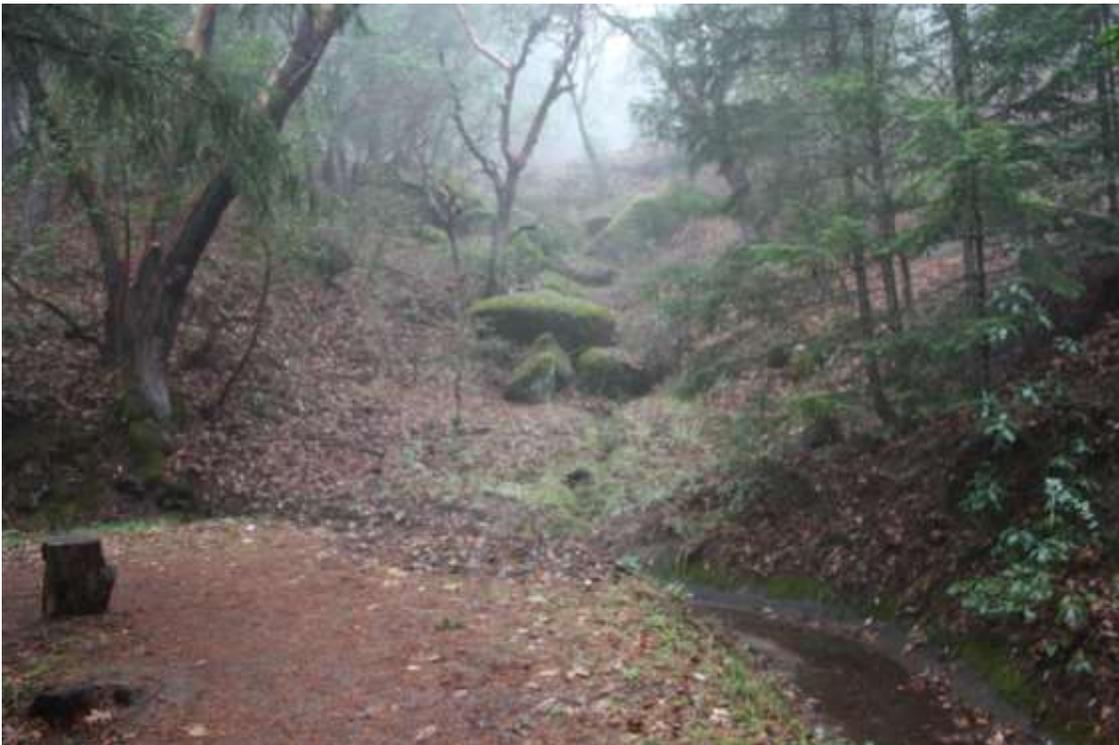
The canal weaves its way through terrain that can be compromised by debris flows, slope instability and larger scale failures unless the area has been stabilized by engineered structures. See Photos 32 to 35. All of these items listed above present challenges and engineering opportunities for the construction of a new fully enclosed canal culvert along this 9,000-foot length of existing canal. Much of this will be addressed in general terms in this report. Specific designs for problematic sections or locations will be addressed in the next phase of the work.

PHOTO 32: Area Subject to Debris/Mud Flows

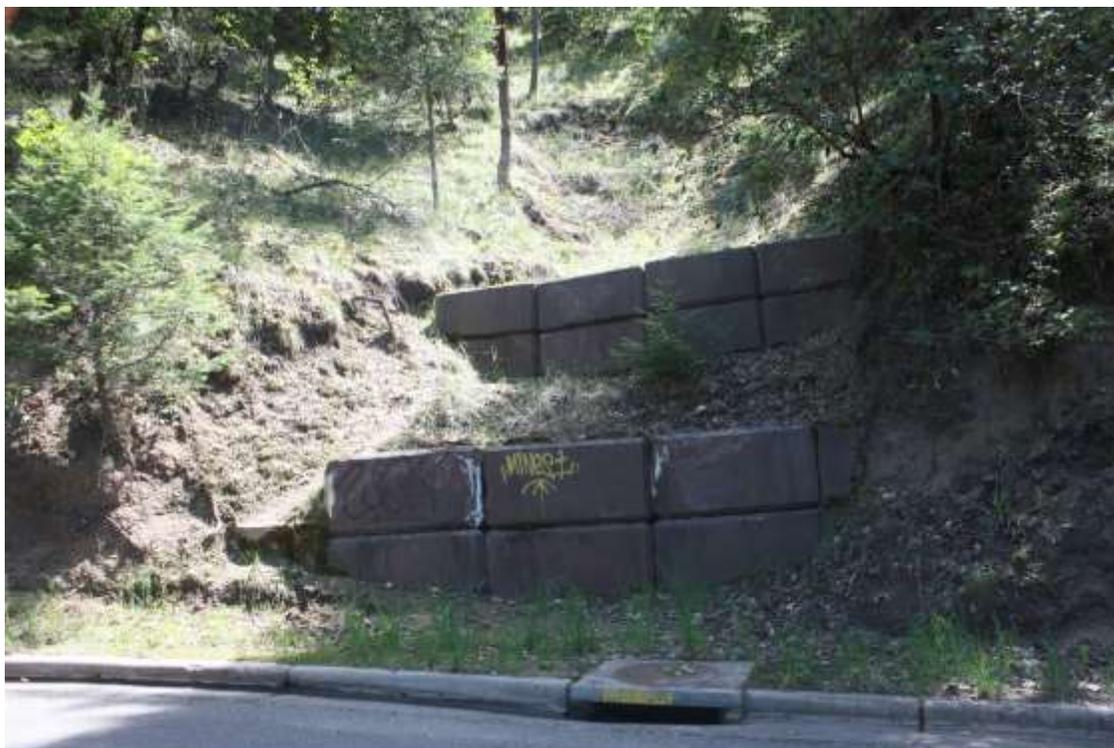
PHOTO 33: Area Subject to Mud Flows by the Roadway

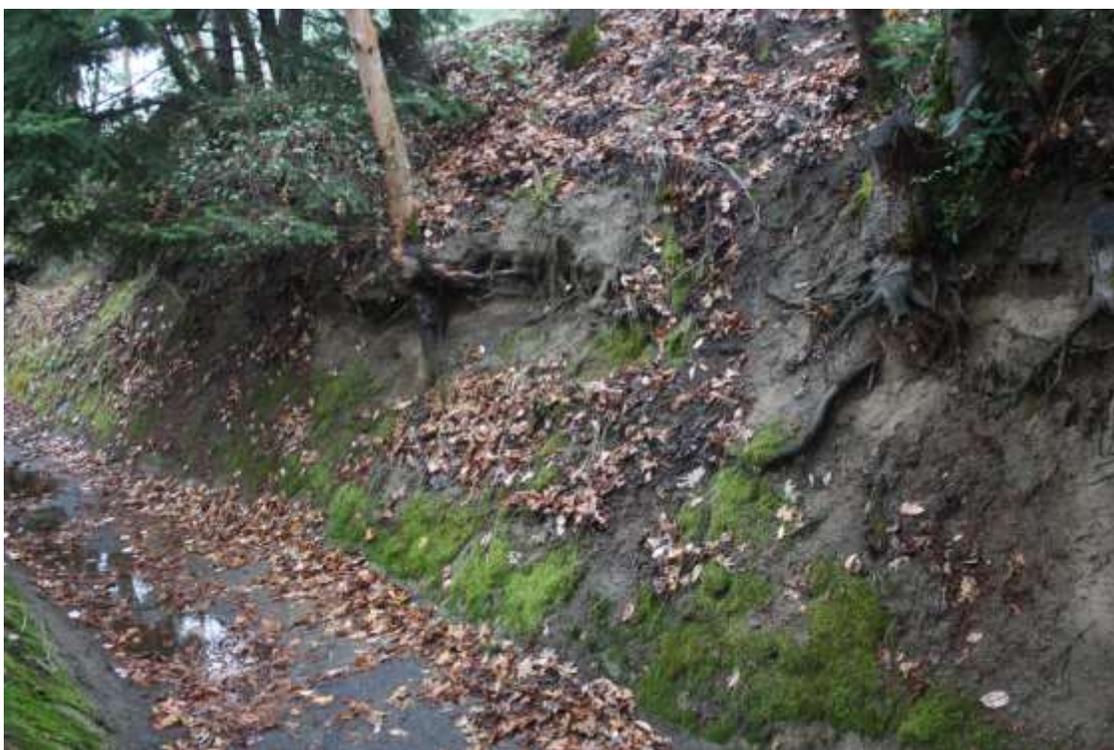
PHOTO 34: Cut Slope Instability

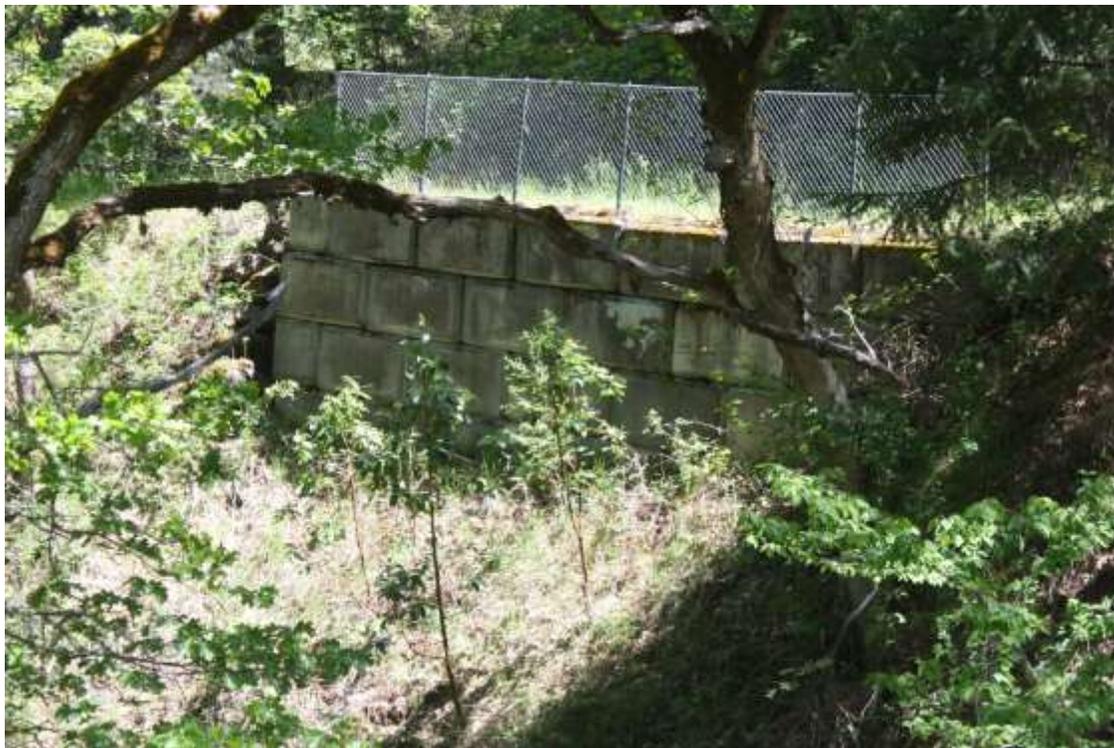
PHOTO 35: Ecology Block Support of Existing Canal Culvert
