APPENDICES

Appendix A: Ashland Canal Tenth Mile Segment Profile Summaries

Ashland Canal Piping Project Segment #1 Summary

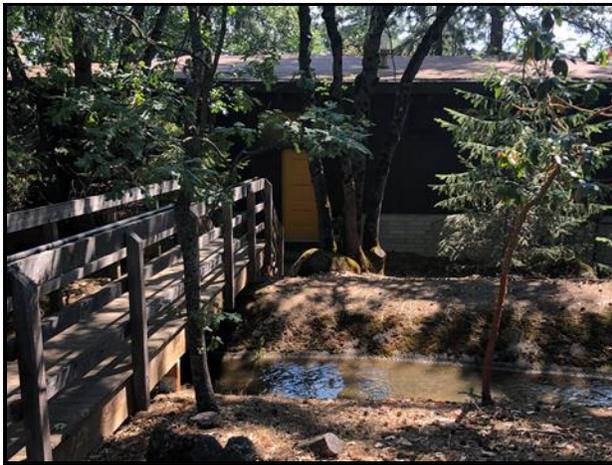
Segment 4: Bridge Over Canal to Front Door (1333 Leonard St.), Looking East

Recommendations. AOC 4.1, 4.2, and 4.3: Construction steward and Rep should consult on probable outcomes and appropriate actions. Also meet with private landowners on respective issues. Where feasible, avoid damage, disturbance and/or removal of large conifers during construction. **2.** Monitor health of conifers following construction and prepare for mitigation techniques such as mulching where advised. Potentially supplement deep watering 2 or more times as necessary each month over the summer to help important trees transition from their water dependency to a more natural drought tolerant state. This process could easily require 10 years of supplemental watering for very large trees gradually reducing the frequency of watering. Thin young understory Douglas-fir trees near specimen trees for long-term vegetation health and resiliency. **Noxious Weeds Treatments.** Remove holly and hawthorn trees, and English Ivy prior to excavation to reduce infestation risks.

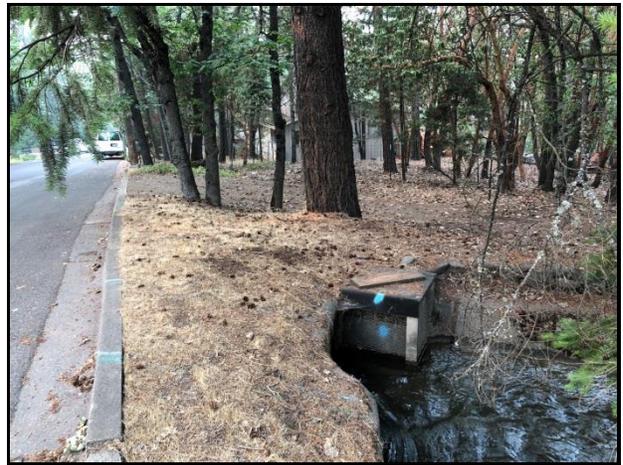
Segment 4: Large Pine Near Construction Footprint, Looking North

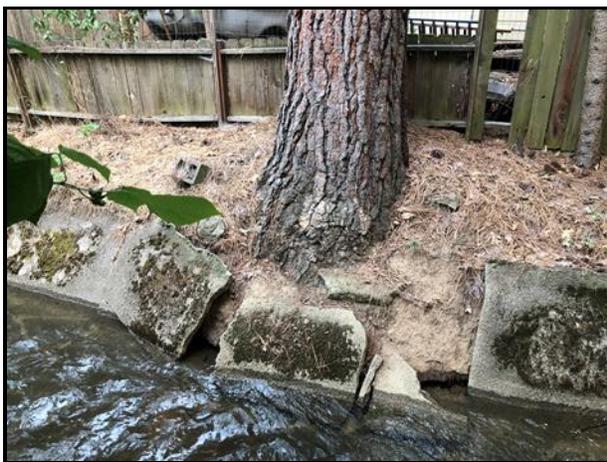
Segment 4: Broken Canal at Large Pine, Looking South

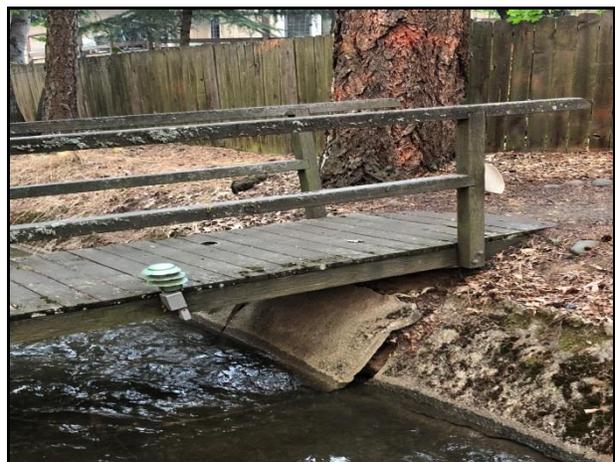
Segment 4: Broken Canal at 2nd Large Pine, Looking NE

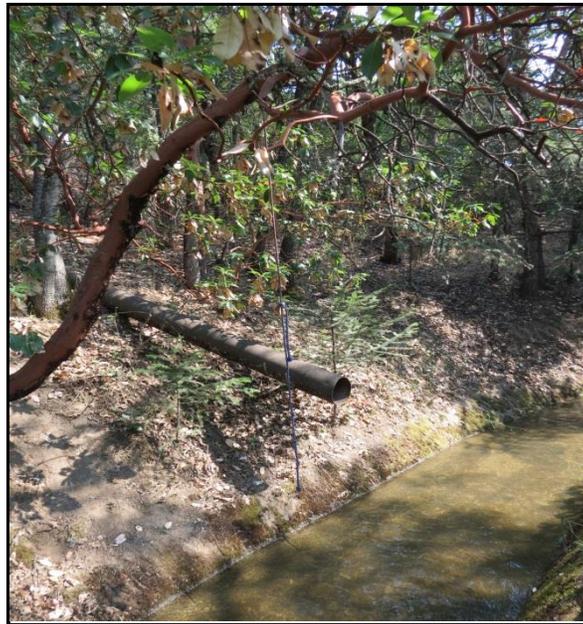
Segment 6: Metal culvert (and rope swing) upslope from Pinecrest Terrace Road, looking SE

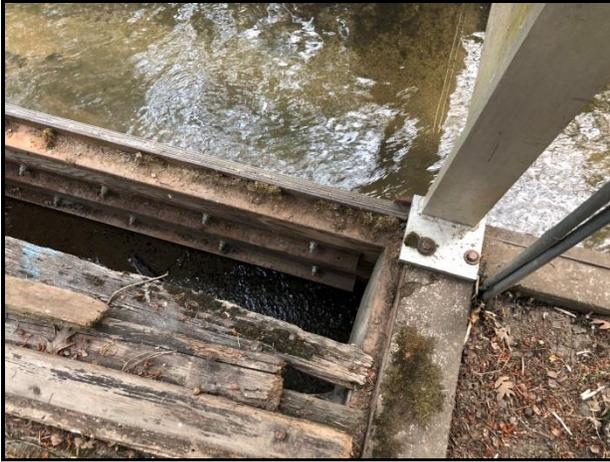
Areas of Concern (AOC) 7.1. When the augmentation of canal water to Roca Creek is stopped, riparian vegetation is likely to be

negatively impacted. Young and larger Douglas-fir are unlikely to survive this transition longterm. The moist site trees and shrubs (poplar, maple, dogwood, mock orange) and the wet creekside vegetation will likely die back, especially in drought years.

Segment 7: Site of Leakage/flow Out of Canal, to Roca Creek, looking Down at Canal

Recommendations. AOC 7.1. 1. End canal flow to Roca Creek by building a culvert at the Roca Creek crossing. **2.** Thin the young Douglas-fir downslope and adjacent to trail to favor pines and oaks and increase forest health and resiliency. **3.** Selectively thin multi-trunk oaks upslope to increase long-term

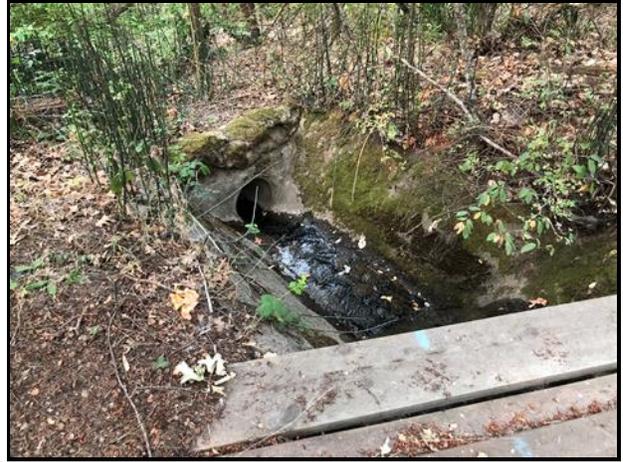
Segment 7: Flow of Water out of Canal to Roca Creek, looking NE

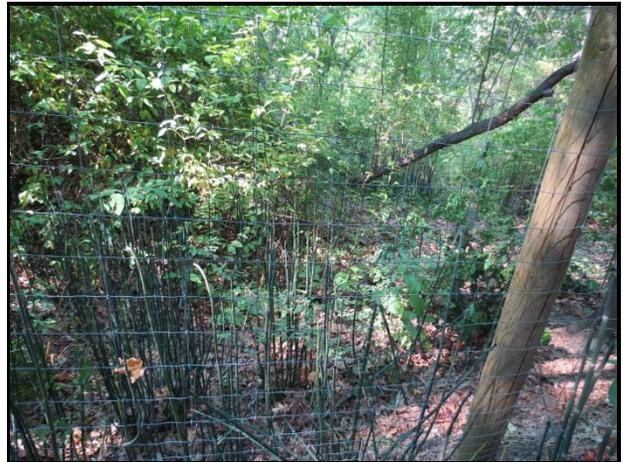
Segment 7: Moist Site Vegetation near Canal Augmentation to Roca Creek, looking East

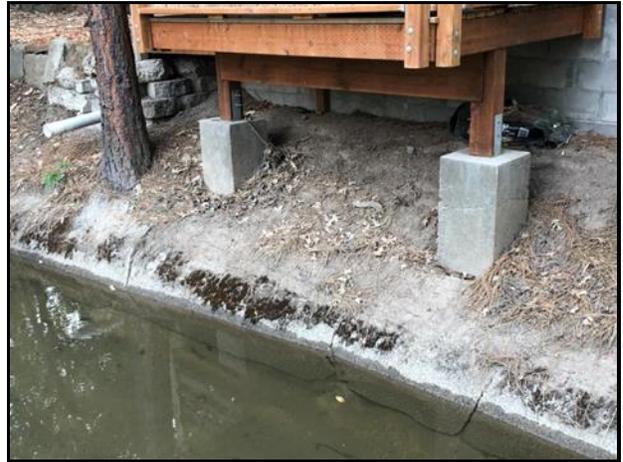
Segment 8: Pine On Canal Upper Slope Edge, Looking West

Recommendations. AOC 8.1. Where feasible, avoid damage, disturbance and/or removal of large pines during construction. Consult (construction steward and rep) on appropriate action. Monitor and mitigate as necessary if any are selected to protect. **Noxious Weed Treatment.** Remove the blackberry prior to excavation to avoid increased infestation.

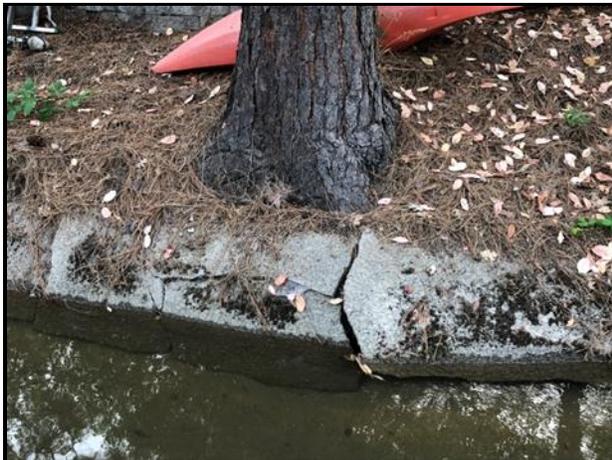
Segment 8: Large Pine At Broken Canal Edge, Looking West

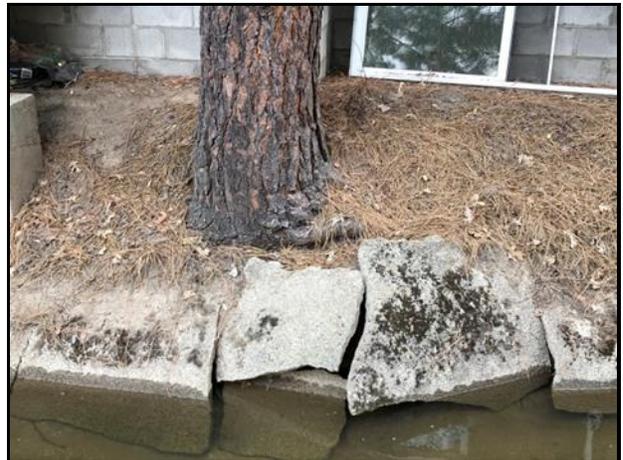
Segment 8: 2nd Large Pine At Broken Canal Edge, Looking West

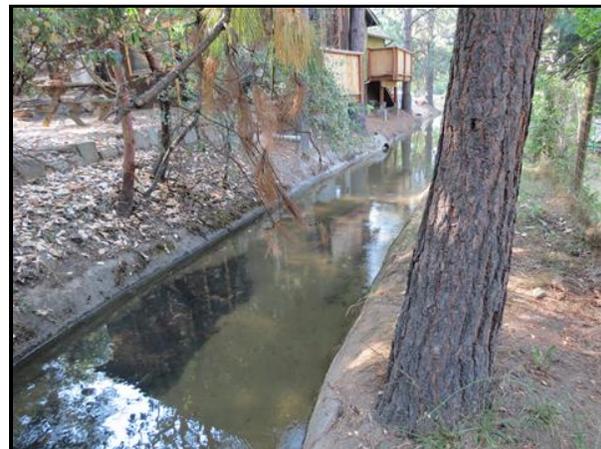
Segment 8: Large Pine On Trail Edge, Looking North

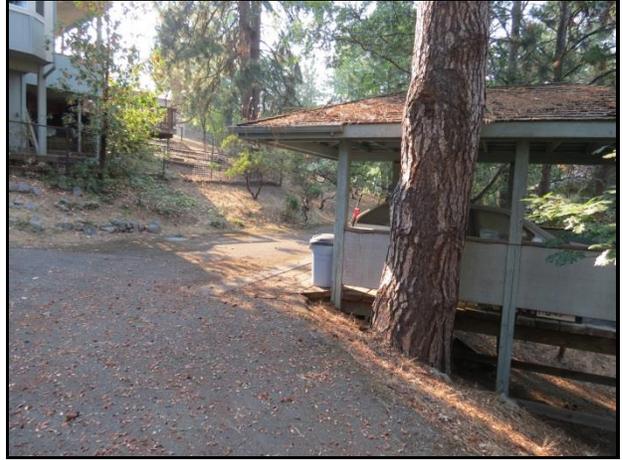
Segment 9: Large Pine along Construction Footprint, at Carport Structure, Looking NW

Recommendations. AOC 9.1. Consult among experts to refine the pipe replacement methods to ensure least impacts to selected portions of existing mature landscape, including large pines, oaks, madrones and manzanita along project corridor.

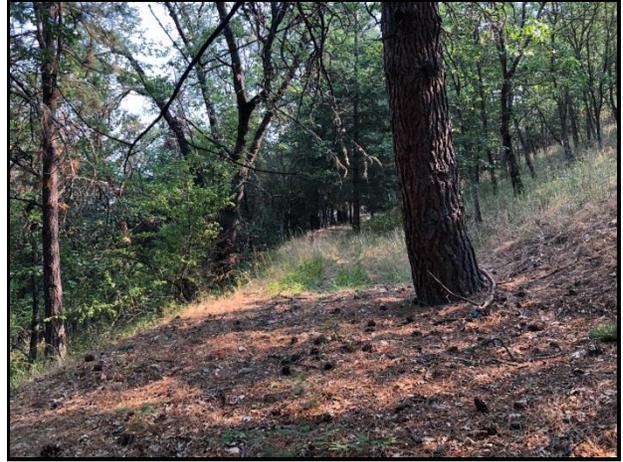
Areas of Concern (AOC). 10.1. Large specimen pines, a large Douglas-fir, mature oaks and a Deodar cedar occur in or near the construction/excavation zone and will likely risk root damage or removal. A large pine growing near Wildwood Way is at risk of damage or removal and is a shade/privacy tree.

**Segment 10: Large Pine along Construction Corridor,
Looking NE**

Recommendations. AOC 10.1. Refine the pipe replacement methods to ensure least impacts to selected portions of existing mature landscape, including large pines, oaks, madrones and manzanita along project corridor. **2.** Monitor health of conifers, maple and deodar cedar in post-construction years; consider augmented watering. **3.** Thin young understory Douglas-fir trees and selectively thin oaks for long-term health and resiliency. **Noxious Weed Treatment.** Remove Himalayan blackberry and vinca, prior to excavation to avoid spread of infestation.

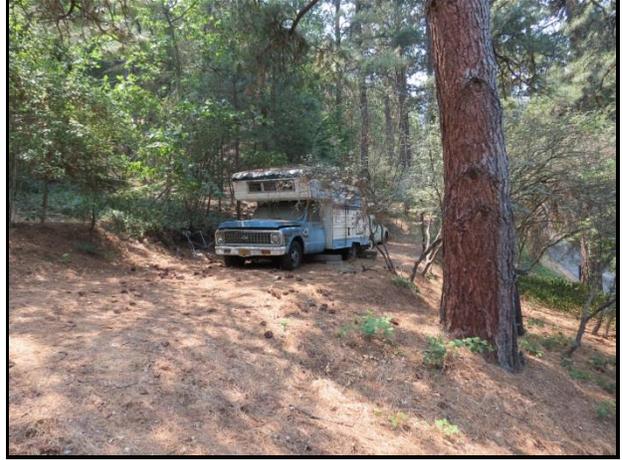
Segment 12: Large Pine along Canal Construction Corridor, Looking West

Recommendations. AOC 12.1. Monitor health of trees in the riparian area after project completion. Consider adjusting to species appropriate to moistness of site following construction by removing those species not well suited including thinning of young understory Douglas-fir trees for long-term vegetation health and resiliency. **Noxious Weeds:** Remove Himalayan blackberry, Scotch broom and English Ivy prior to excavation to avoid spread of infestation.

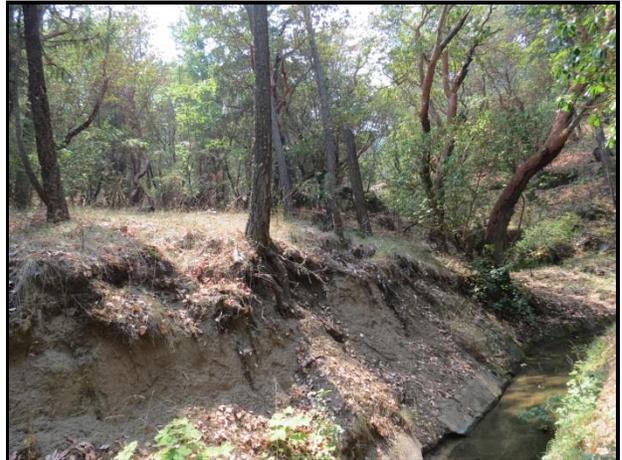
Segment 15: Upslope Conifers & Broken Canal Liner, Looking North

Recommendations. AOC 15.1. Consult (construction steward and rep) on appropriate actions which trees to remove or preserve; follow up with monitoring and prepare for mitigation measures. **AOC 15.2.** Monitor health of conifers downslope of canal within private yards, and upslope/near the canal- especially larger Douglas-fir-in post-construction years; consider augmenting irrigation to Douglas-fir. Thin young Douglas-fir understory and selectively thin multi-trunk madrone for long-term vegetation health and resiliency. **Noxious Weed Treatment.** Remove Himalayan blackberry prior to construction to avoid spreading infestation.

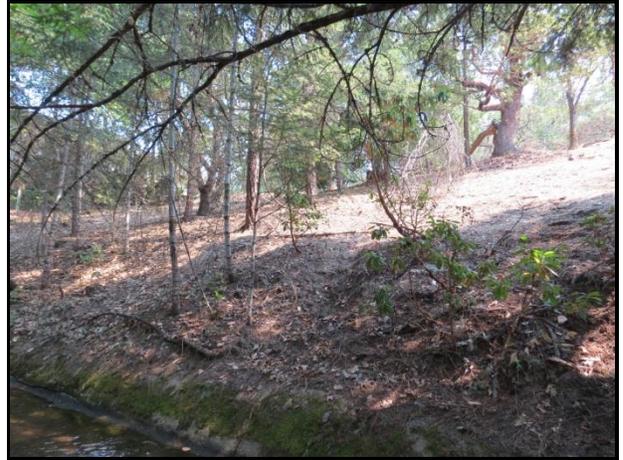
AOC #1: Segment 17: W End looking upslope above canal into the more open stand that will still benefit from thinning to leave larger canopy gaps, providing additional wildfire resiliency.

Recommendations. AOC 17.1. This stand would benefit from thinning, to reduce competition in favor of the larger, older hardwoods, and to create a more fire safe wildland/ urban interface. Generally, thinning should generate larger canopy gaps above the canal as this zone is already predisposed to gaps. The lower slope shouldn't be as radically altered in one treatment. Thin around the bigleaf maples to provide them room from branch entanglement and competition for water and resources. **Noxious Weed Treatments.** Remove blackberry prior to thinning and construction as both forms of disturbance will encourage rapid growth and expansion of this patchy population. Follow up treatments should happen on a regiment with the other weed treatments across this project.

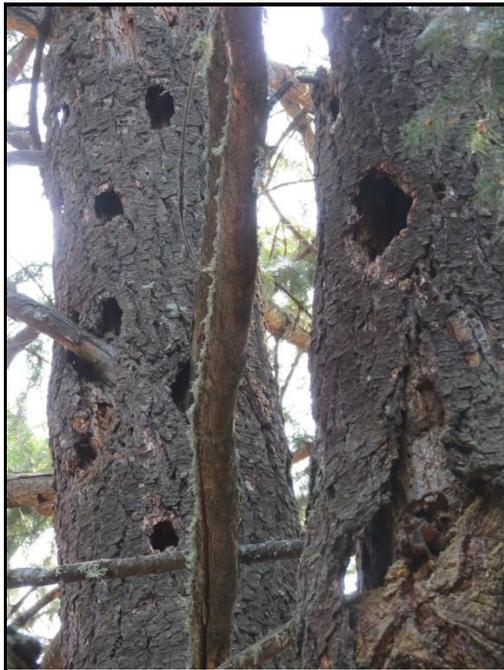
Segment #17: just above ditch

Wildlife tree description: This large Douglas fir has multiple dead tops that have been hollowed out by wildlife. The tree is perched just above and in close proximity to the ditch and is very much alive with several viable trunks. It does pose a construction challenge due to its proximity to the canal. We recommend a full evaluation of this tree with a bias towards protecting it through the construction process because it provides multiple dwelling opportunities for various cavity nesters. We searched below the tree for owl pellets and other signs of nesting but made no discoveries. An ornithologist may have better luck.

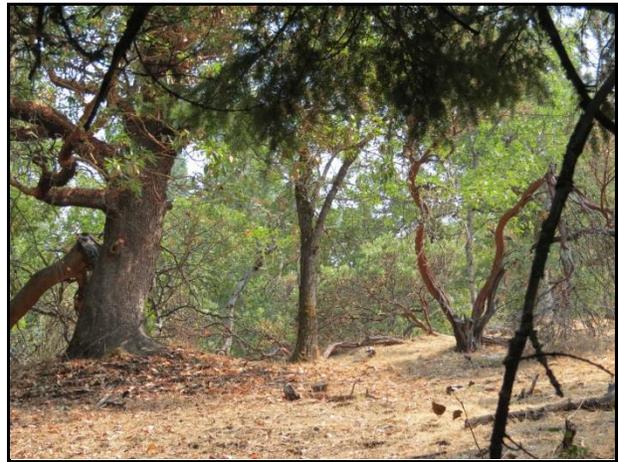
Segment 18: East end above ditch. Photo illustrates specimen madrone that could benefit from some thinning in its vicinity.

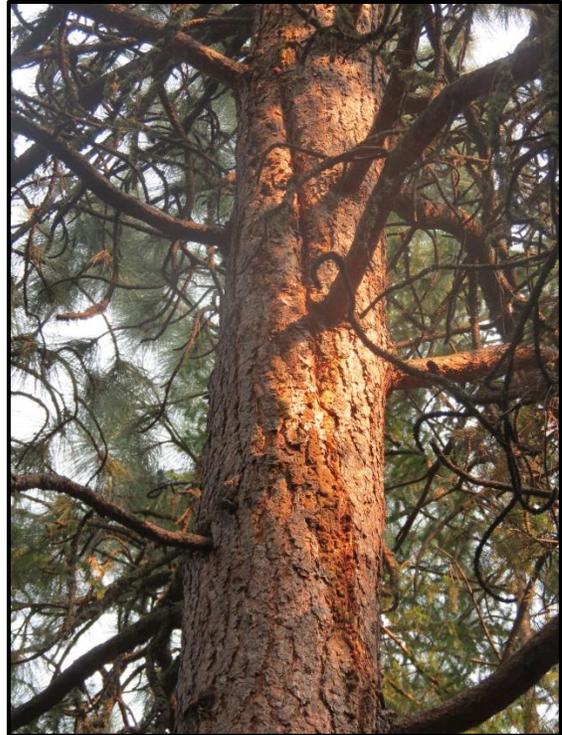
Segment 19: On Private Residence, below ditch- This tree has a lightning strike scar that is slowly sealing over through callus tissue. The tree looks healthy and illustrates the fire prone nature of this project area within the greater fire evolved landscapes of Southern Oregon

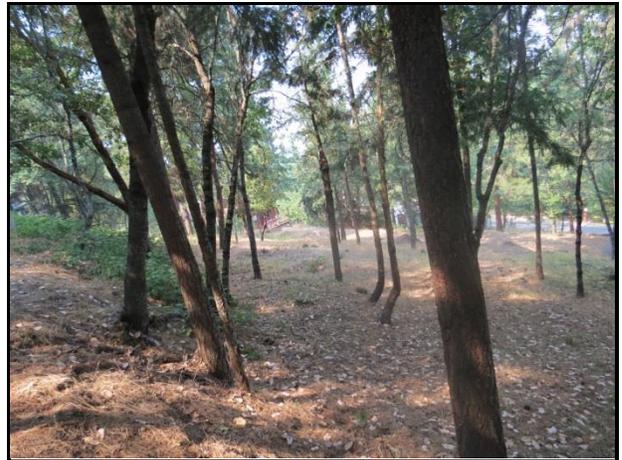
Segment 20: Wildland portion below the ditch-showing blackberry thicket on left edge of photo that will need to be treated to prevent spread during construction disturbances.

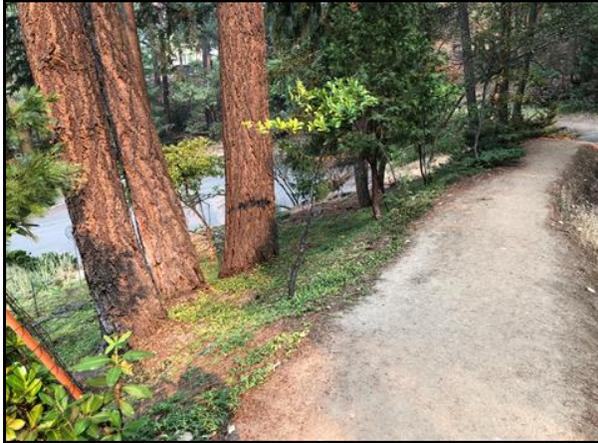
Segment 21: Large Douglas-fir downslope, Risk of Moisture Stress, Looking East

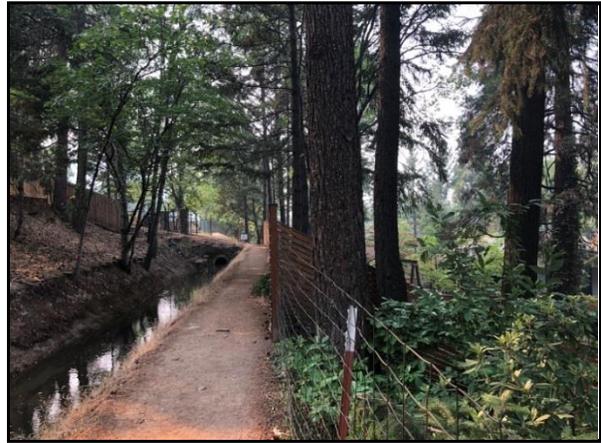
Segment 21: Large Conifers Near Trail, Risk of Construction Disturbance, Looking West

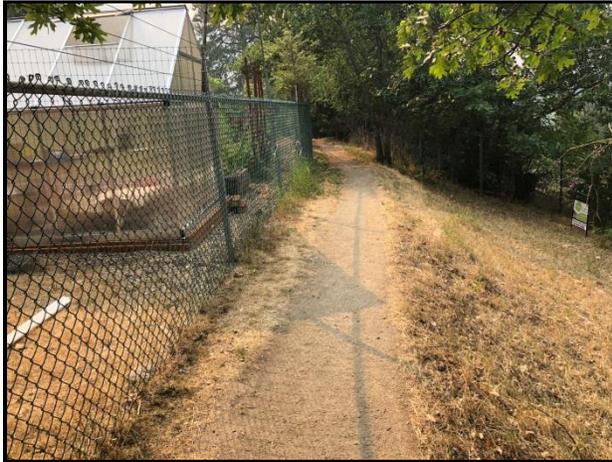
Segment 22: Narrow Corridor between Private Greenhouse & Downhill Slope, Looking West

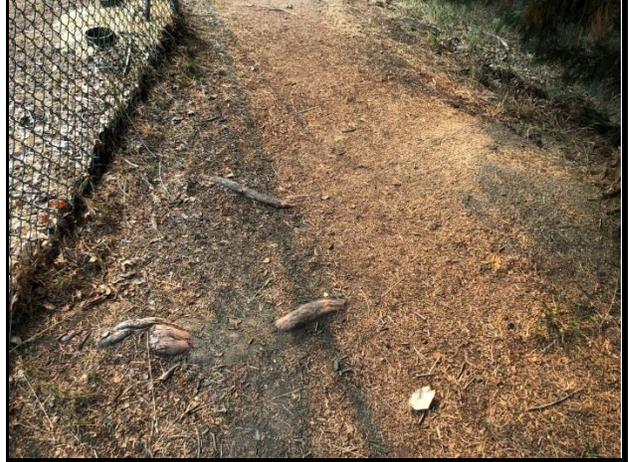
Segment 22: Incense Cedar Roots in Trail, Construction Disturbance Risk, Looking Down

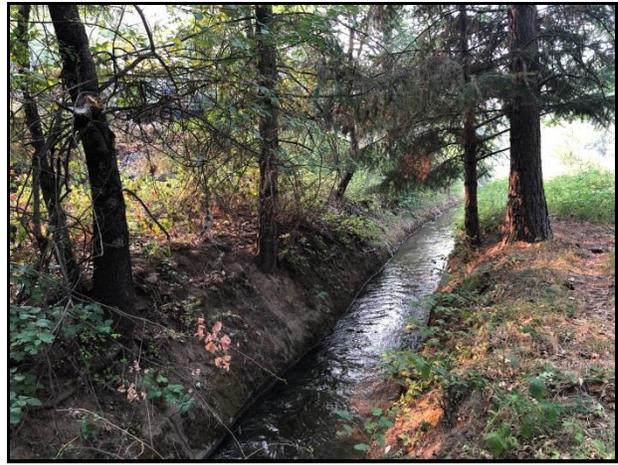
Segment 23: Oaks and Pines on Trail Edge, Risk Construction Disturbance, Looking West

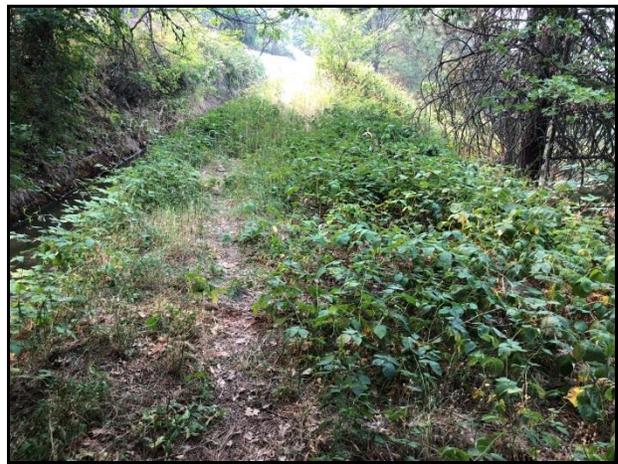
Segment 23: Dense Blackberry Infestation Along Canal, Looking West

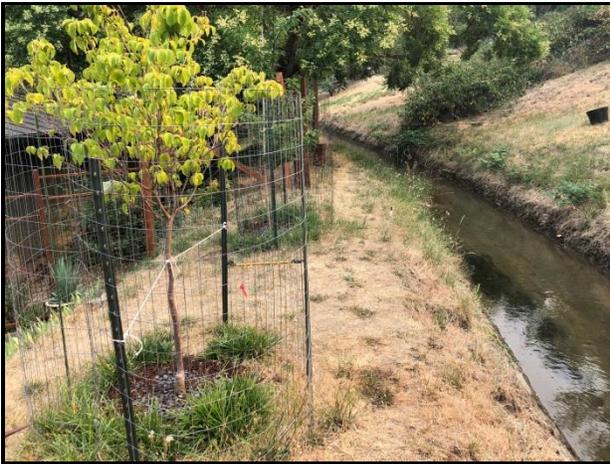
Segment 24: Fruit Trees on Canal Trail, Risk of Construction Disturbance, Looking South

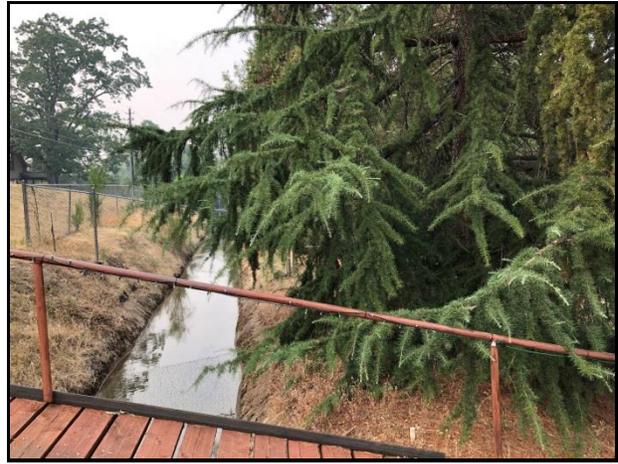
Segment 24: Deodar/Incense Cedars on Canal Trail, Risk of Construction Disturbance, Looking North
