CONDITION ASSESSMENT AND RECOMMENDATIONS

Butler-Perozzi Fountain Lithia Park

Ashland Parks Foundation / July 26, 2022, Rev. 01 October 05 2022

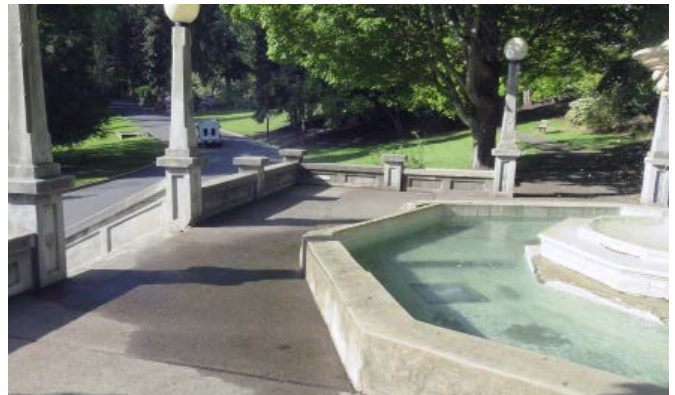
Water splashes out of the east end of the fountain, at the top of the stairs.

- As the main point of entry for water into the system is the swan's mouth in the bronze sculpture, this results in over-spray and heavier flow on that side of the fountain. This condition has impacted other conditions listed in this section.

- Water flow issues should be addressed. Blockages should be cleared so that water flows evenly out of the lion's heads on the middle bowl rather than over the rim of the middle bowl. This will prevent uneven wear and erosion on the rim. Openings could be re-drilled, and brass escutcheons installed to direct the flow downward to minimize the erosive effects of splashing on the lower pedestal.

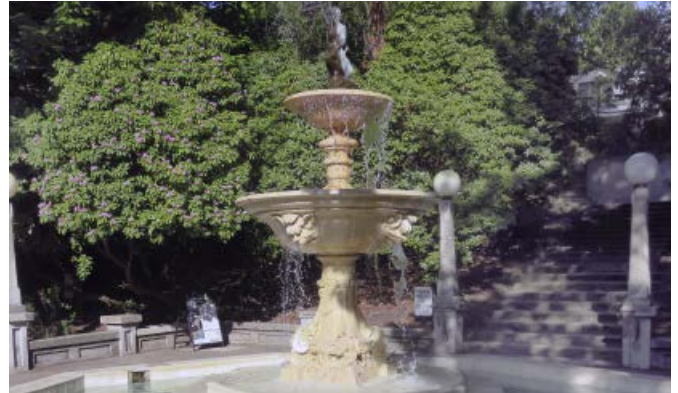
Water flows unevenly off the north east edges of the bowls. Note that the flow out of the lions is not smooth.

- The middle bowl is in fair condition. It appears to be original and shows some uneven wear on the east edge of the bowl, likely related to the flow issues in the fountain. Water was likely meant to flow to the lower bowl through the open mouths of the lion's heads on the underside of the bowl. Currently, the flow out these areas is uneven and may be related to water pressure/flow issues, or blockages in the openings.

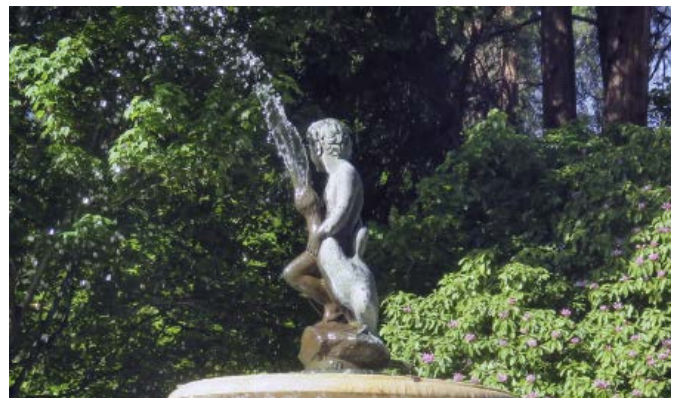
- The bronze statue at the top of the fountain is a replica of the original marble statue and was installed in the 1987 restoration. The bronze is in fair condition and is showing signs of cupric oxidation; it is turning green in some areas whereas the rest of the statue has a typical brown patina. The bronze should be cleaned and given a waterproof protective coating to prevent oxidation.

Bronze discoloration at the fountain's statue.

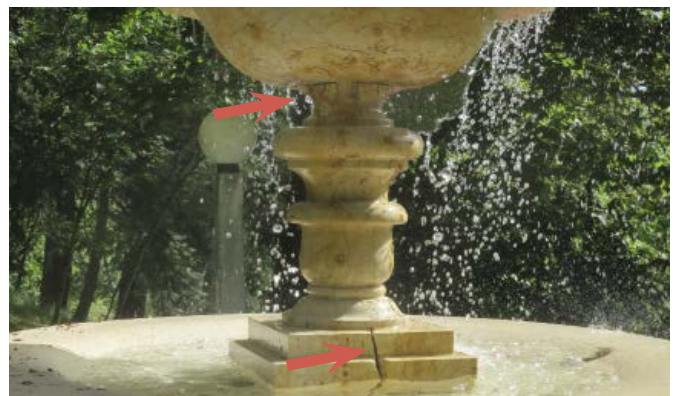
- The pedestal supporting the upper bowl is in poor condition. It has spalls at the upper and lower lips, and a through-unit crack in its base. Although it could not

Cracks and spalls at the upper pedestal.

- The pedestal supporting the upper bowl is in poor condition and should be replaced. The noted conditions affect the structural stability of this unit, and the upper bowl has been known to rock. Should it fall, this poses a significant risk to the upper bowl itself and to the lower elements of the fountain as would impact them when toppled. As these elements are replacements, they should be replaced in kind. Historic photos may be used to achieve a level of detail more consistent with the original pedestal.

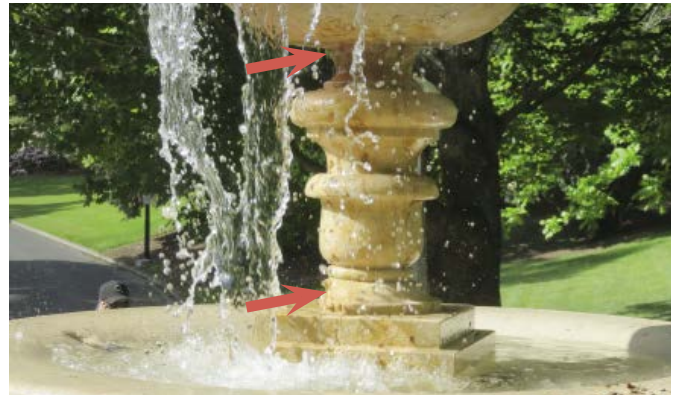
Spalls at the upper pedestal.

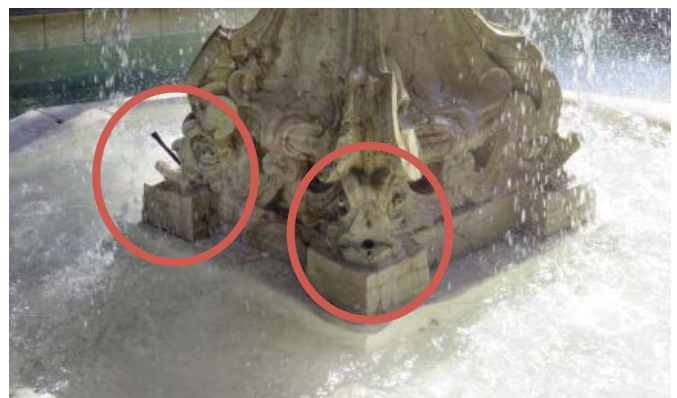
- Two of the gargoyles at the lower pedestal are in poor condition. Two are missing most of their faces. One of these has a piece of piping sticking out of its mouth. This appears to have been a recent attempt at vandalism. It should be noted that water still flows from this spout. The other that is missing its face no longer spits water. These two gargoyles may have been repaired in the 1987 restoration, but these repairs have failed.

Damaged gargoyles at lower pedestal. Note the pipe sticking out of the element on the left.

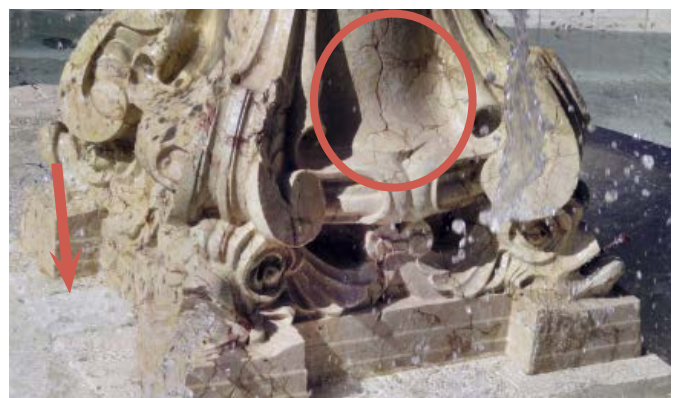
- The lower pedestal is in fair to poor condition, with spalls, uneven weathering, and flow issues. While most spalls are superficial and occur around the scrolls around the spitting gargoyles, two gargoyles show significant loss of their facial features. The valves or other mechanisms that control flow to the gargoyles was not detected. It is possible that these connections are broken and contributing to water flow that emanates from various joints and cracks in the lower pedestal.

Weathered veining in lower pedestal. Note the dutchman repair indicated with an arrow.

- New concrete should tuck under the marble at the lower bowl but should not be in direct contact. A separate joint between the concrete and marble should be maintained.
- The lower pedestal should be repaired. Spalls should be patched with a compatible material, with large areas of loss repaired using dutchman and cracks filled with appropriate crack repair materials matching the existing material. If water flow cannot be restored without significant intervention into the plumbing at the lower pedestal, sealing off of the affected gargoyles should be considered. Should the fountain be de-constructed in the future, these

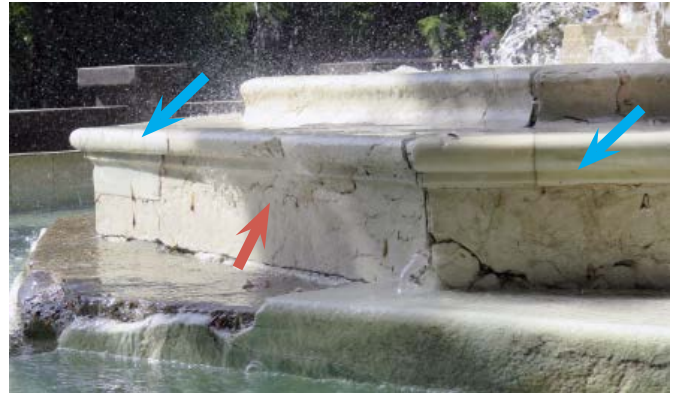
- There are several rounds of repair on the lower bowl, including epoxy repairs and dutchman repairs. The epoxy repairs are in poor condition, as the marble around the repairs has continued to weather, resulting in slightly raised patches. The condition of the dutchman repairs varies. While most are still in good condition there are isolated areas of failed joints that should be repaired. Water flows from various joints and gaps in the lower bowl. Its origin could include gaps between the upper structure or via water conveyance through a cylindrical chase that typically contains the piping that delivers water to the upper portions of the assembly.

Crack (red) and dutchman repairs (blue) in lower bowl. Note the open joint between the plaster and the marble.

- The joints, especially those in the lower bowl, should be repaired. A tile grout appropriate for marble and partially submerged conditions should be used.

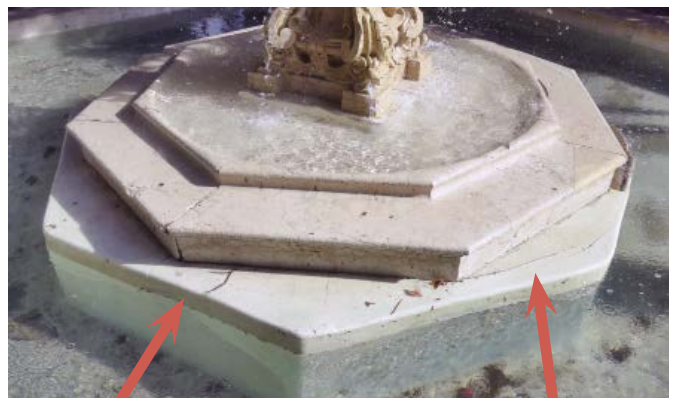
- The pool of the fountain is in poor condition, with large areas of cracked and missing swimming pool plaster. The plaster shows signs of previous patching, and many of the interfaces of these patches have failed and exhibit large cracks. Some of the pool plaster extends above the waterline onto the lower podium and has experienced significant delamination. In general, pool plaster should be continually submerged as it can dry out, check, crack, and fall apart. Hence, if a fountain is to be drained in the wintertime or experiences periods with no water such as shutdowns during extreme drought conditions, swimming pool plaster is a poor choice if lining material.

Cracks in plaster over concrete base.

- The lower pool and outer rim of the fountain pool should be demolished and replaced. Historic photographs indicate that this wall has long had water issues and the plaster and tile installation is both prone to failure and is non-historic. There are multiple failed repairs and corroding reinforcement. Furthermore, the installation of new piping and reliable

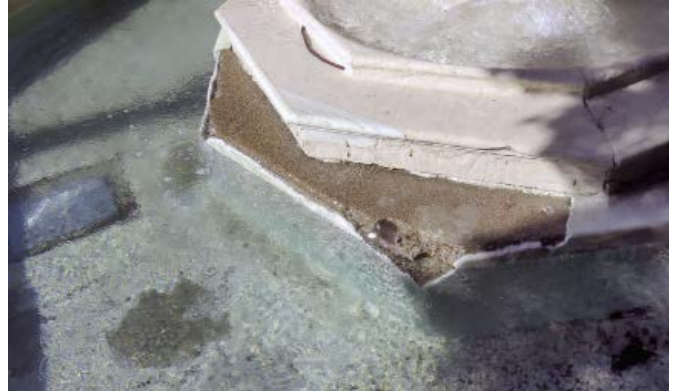
Plaster loss at concrete base. Note plaster loss below the water, on the floor of the pool.

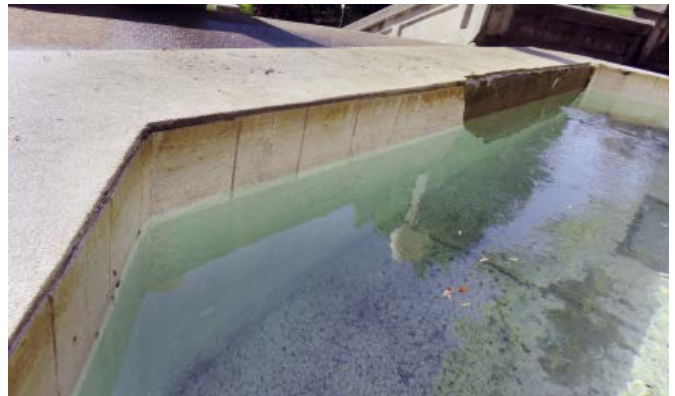
- The tile line at the outer edge of the pool is in fair to poor condition. There is a large area of missing tiles at the east side of the fountain, and the tiles are weathered and stained. A tile band is a necessary feature to maintain a submerged condition for the pool plaster and to provide a smooth surface for cleaning scum that tends to accumulate at the waterline.. Based on historic photos, this tile line was added in the 1987 restoration.

Missing and soiled perimeter tiles.

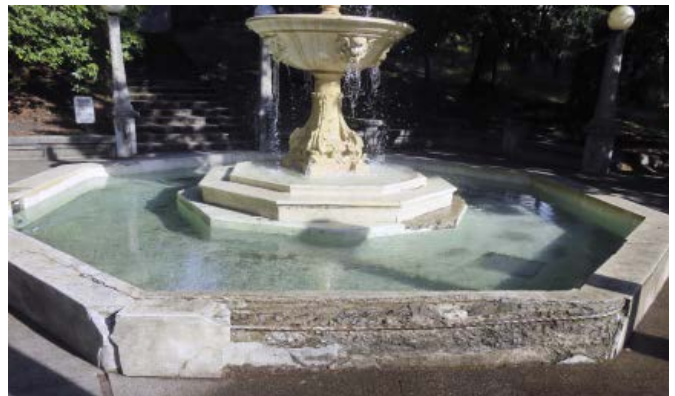
- The outer rim of the pool is in poor condition, with a large area of loss and exposed ferrous reinforcement at the east side of the fountain. This appears to have been a recurring problem area, as there are signs of at least four repair campaigns. Additionally, based on historic photos the outer rim was made thicker and taller in the 1987 restoration, likely in response to water issues at this wall. The delamination issues at this wall suggest that it is another avenue for water to escape the fountain system.

Concrete loss at outer rim of fountain pool.

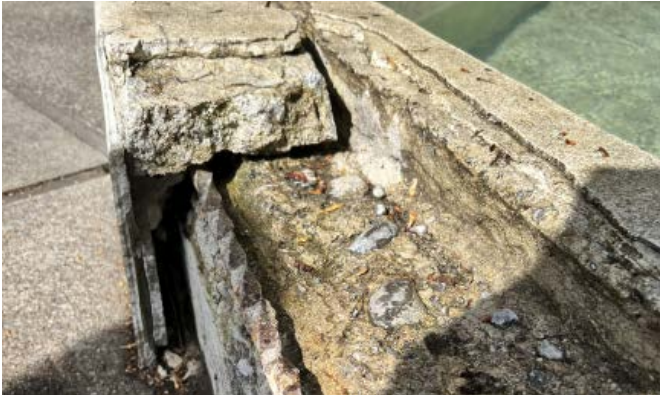
Concrete cracking, spalls, and soiling at outer rim of fountain pool.

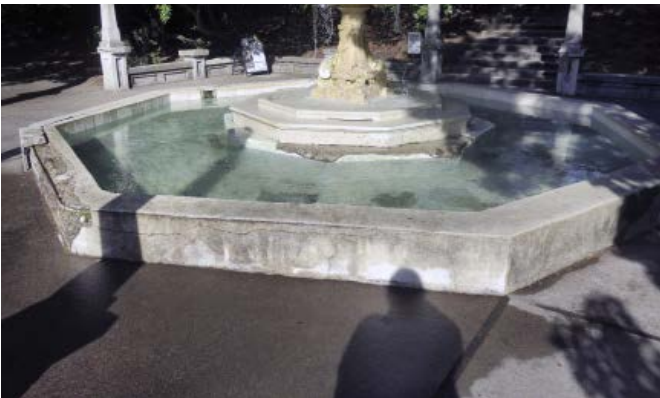
Concrete cracking, spalls, and soiling at outer rim of fountain pool.

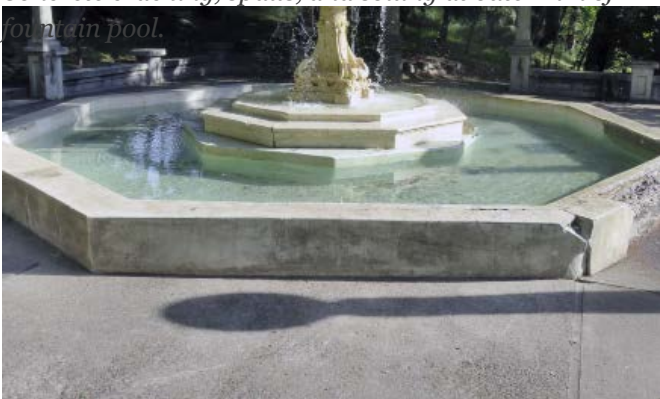
Concrete cracking, spalls, and soiling at outer rim of fountain pool.

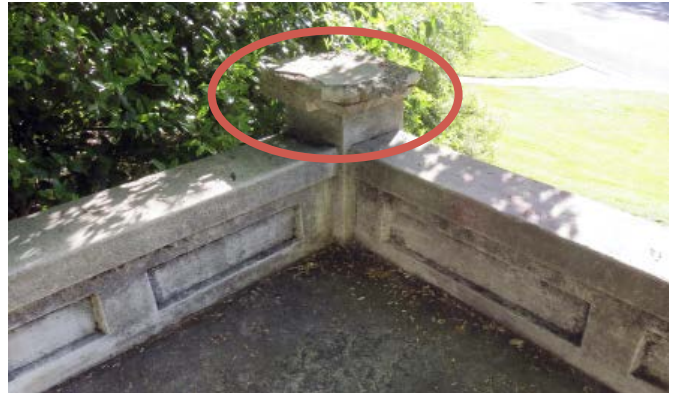
- Several of the column capitals are in poor condition, with corrosion of the embedded ferrous reinforcement. This has caused delamination of the surface finish, cracking, and spalling. In some locations the ferrous reinforcement has been exposed. Many of these areas show signs of previous repair.

Concrete cracking, spalls, and soiling at terrace column.

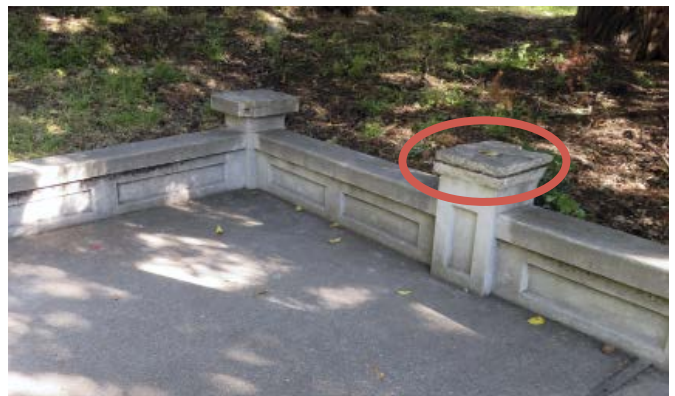
Concrete cracking, spalls, and soiling at terrace columns.

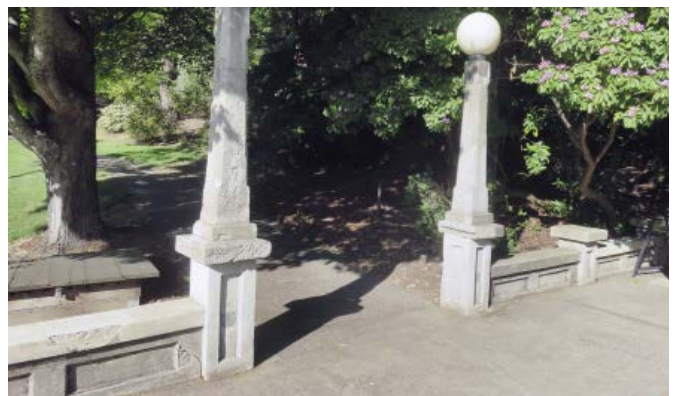
- The light posts are in good to poor condition. They exhibit similar signs of deterioration to the column capitals with delamination of the surface finish, cracking, and spalling. There are also areas of exposed ferrous reinforcement, and signs of previous repair.

Concrete cracking, spalls, and soiling at light posts.

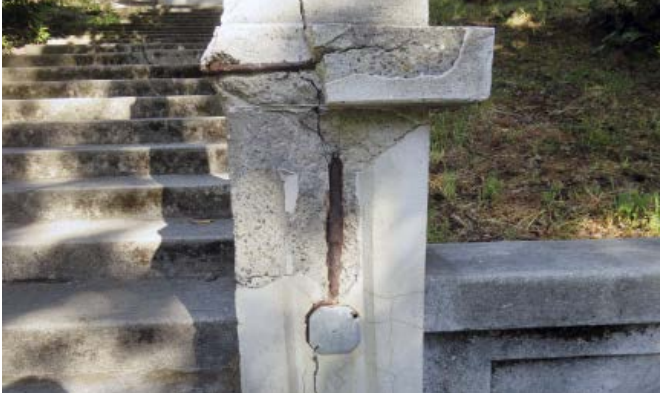
Concrete cracking and spalls at light post.

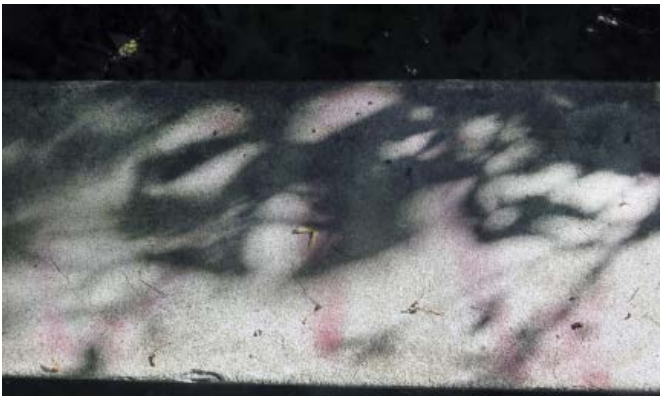
Graffiti ghosting on terrace wall.

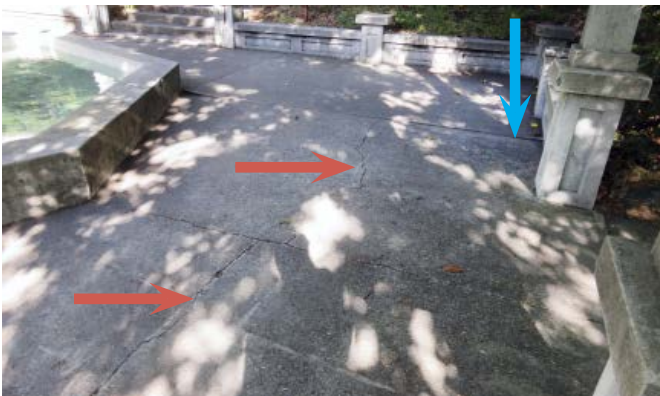
- The flat concrete is in fair condition, with cracking and surface loss on the north end.
- The flat paving has inset wood strips. These strips are beginning to warp in some areas due to moisture in the wood.

Concrete cracks (red) and warped wood strips in terrace floor (blue).

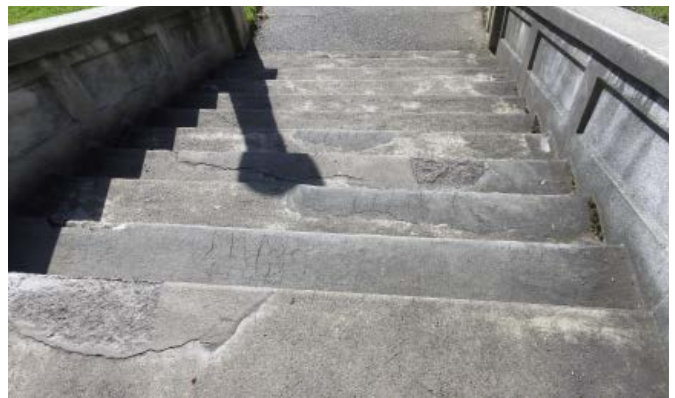
Uneven and failed repairs at the lower stairs.

- Spalls and cracks on the stair treads should be repaired. Failed repairs should be removed and replaced.

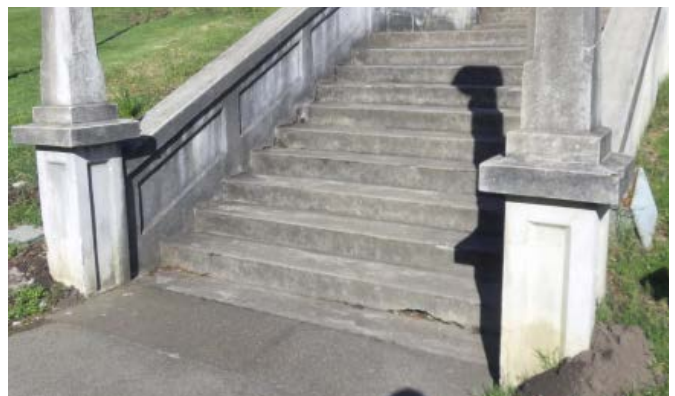
Failed repairs and small spalls at lower stairs.

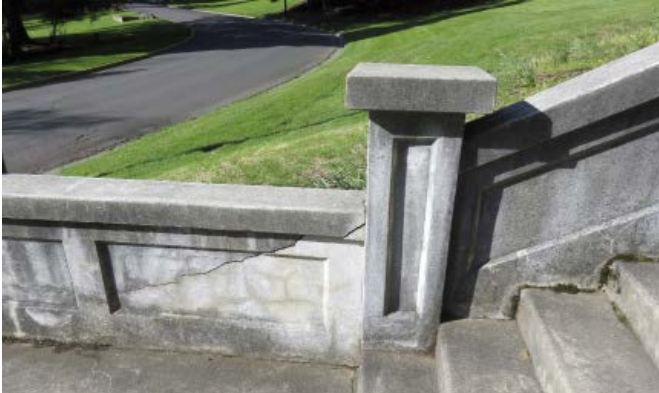
Cracks in the cheek wall. This crack is also visible at the exterior face.

- Cracks in the cheek walls should be routed and repaired. Care should be taken to match the existing color and texture.
- The concrete should be cleaned using a biodegradable, non-acidic cleaner and low-pressure power washer. In order to prevent streaking and wand marks, a distance of at least 6 inches should be maintained between the surface and the tip of the power wash wand equipped with a fan tip 60 degrees or greater.
- While not included in the scope of this project, as it is not a signed or publicized pathway, the staircase from Granite Street should be studied for accessibility, and a handrail should be added if needed.

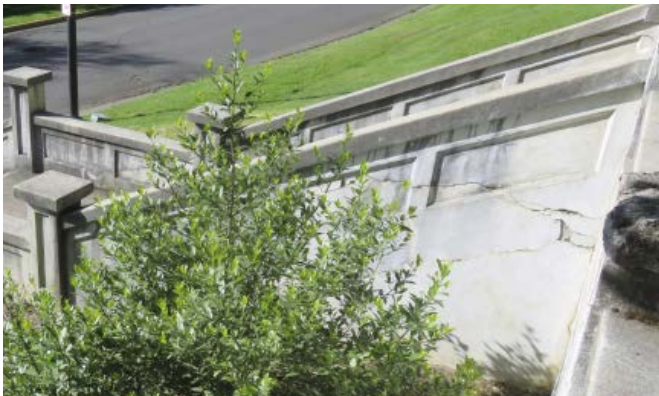
Cracks in the outer face of the staircase. This crack is also visible at the interior face.

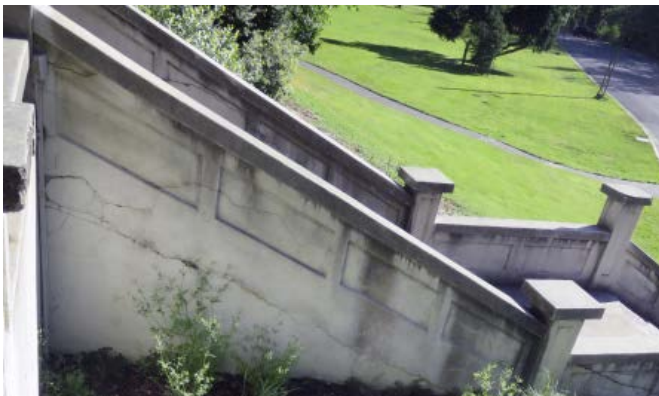
Cracks in the outer face of the staircase.
