CONDITION ASSESSMENT AND RECOMMENDATIONS

Butler-Perozzi Fountain Lithia Park

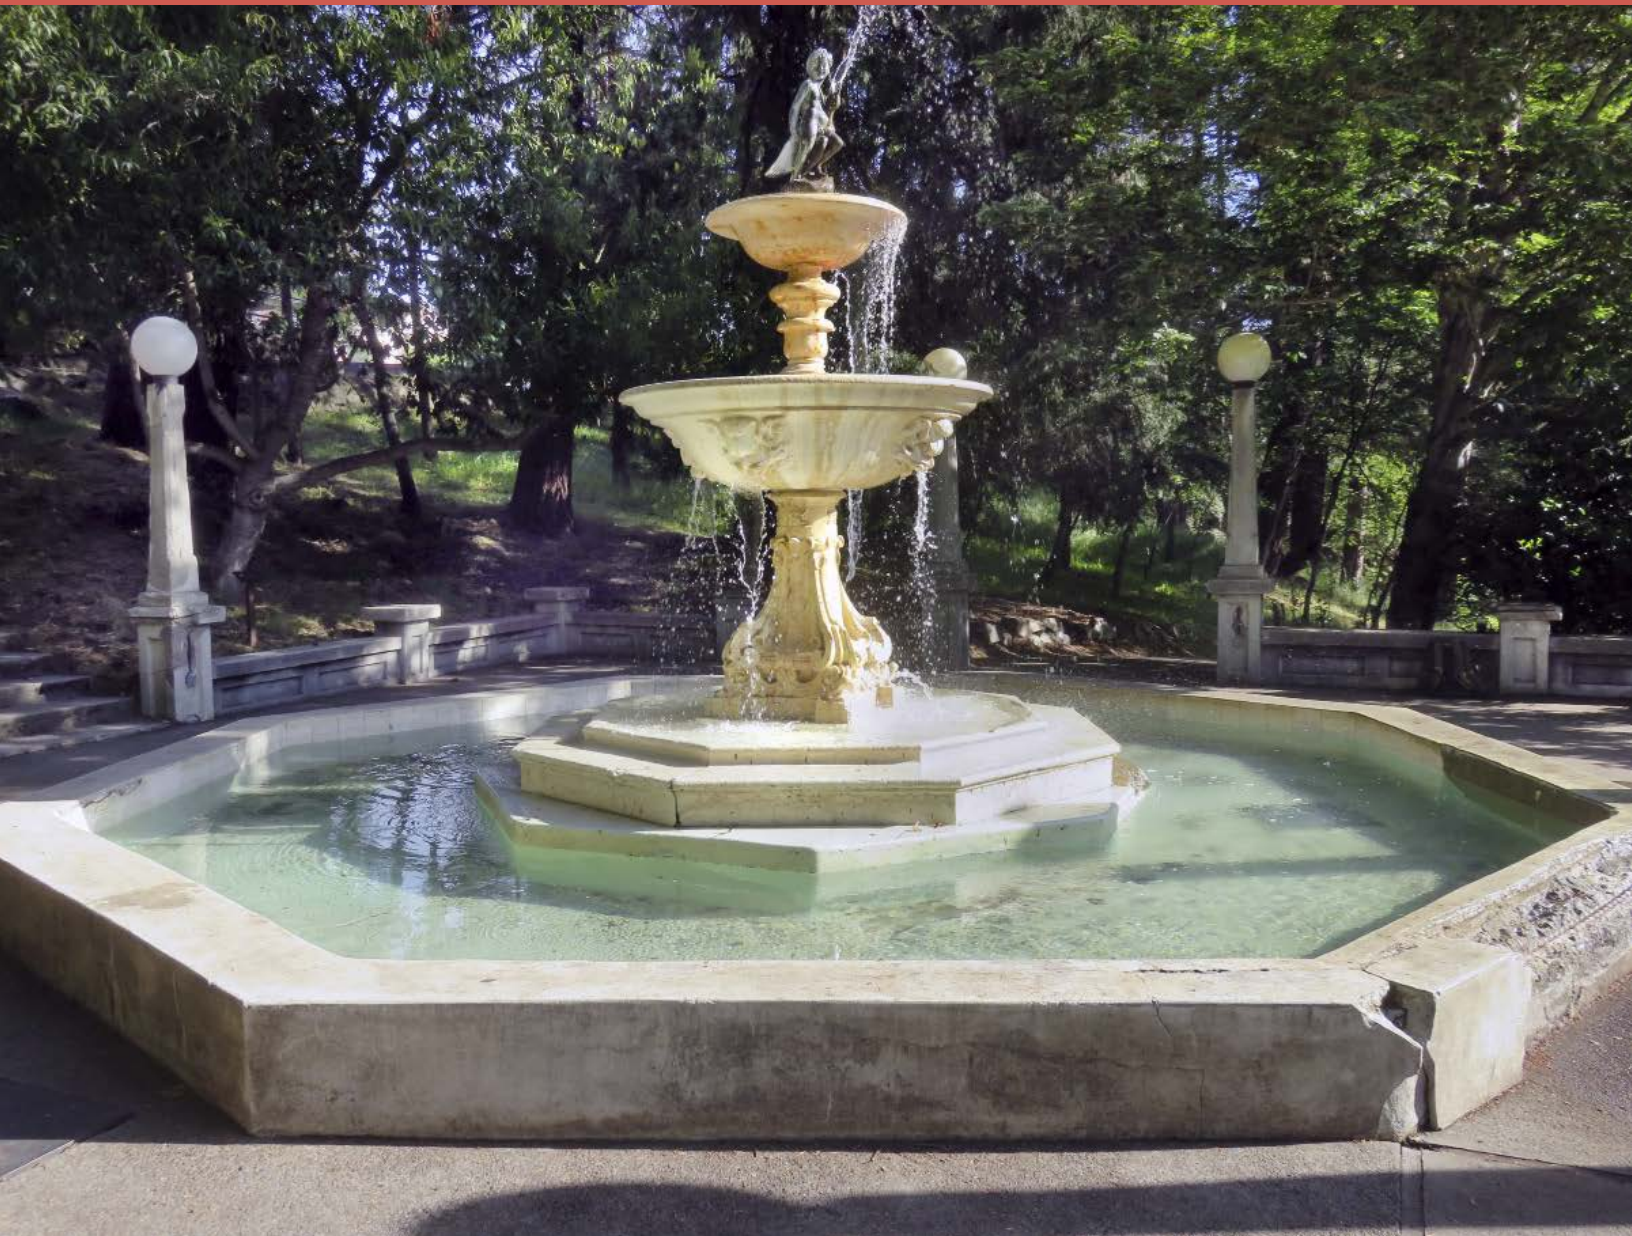
Architectural
Resources Group

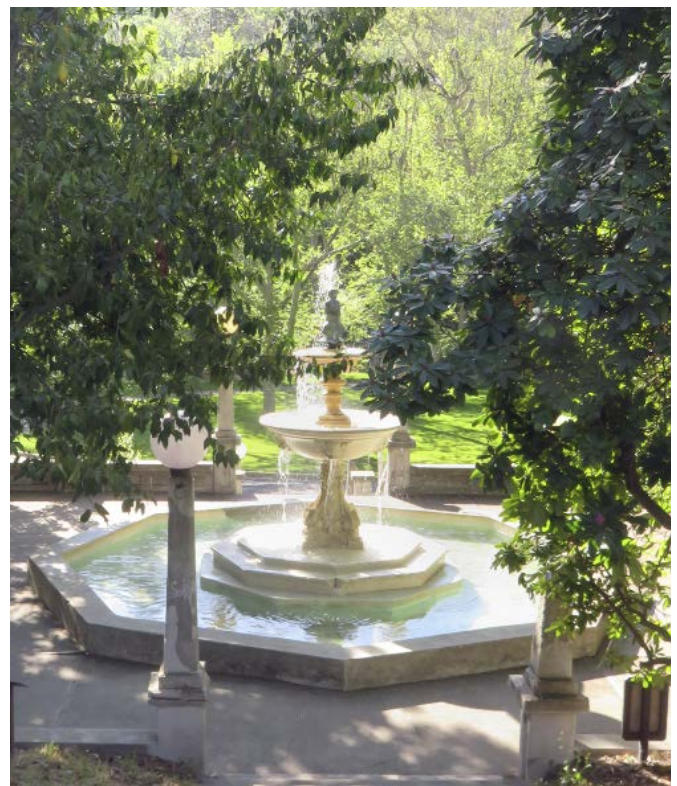
Fountain viewed from steps to Granite Street.

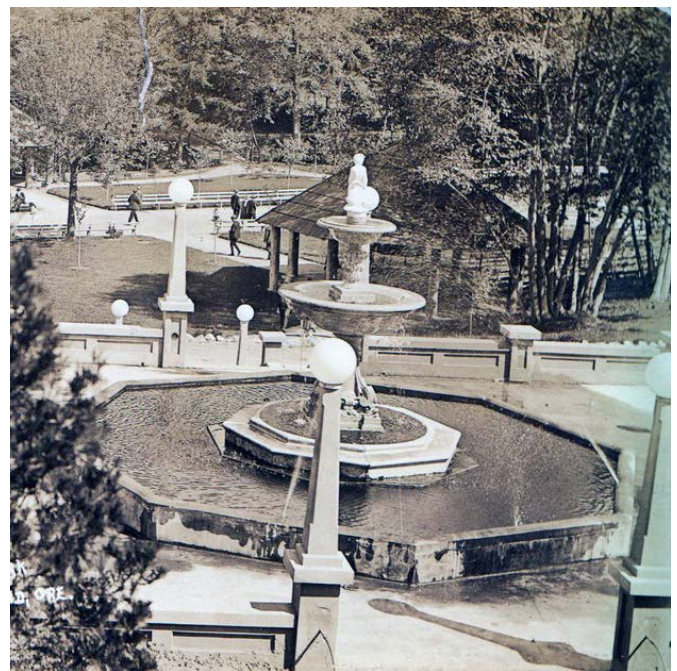
Photo circa 1927 of the fountain, viewed from the steps to Granite Street.

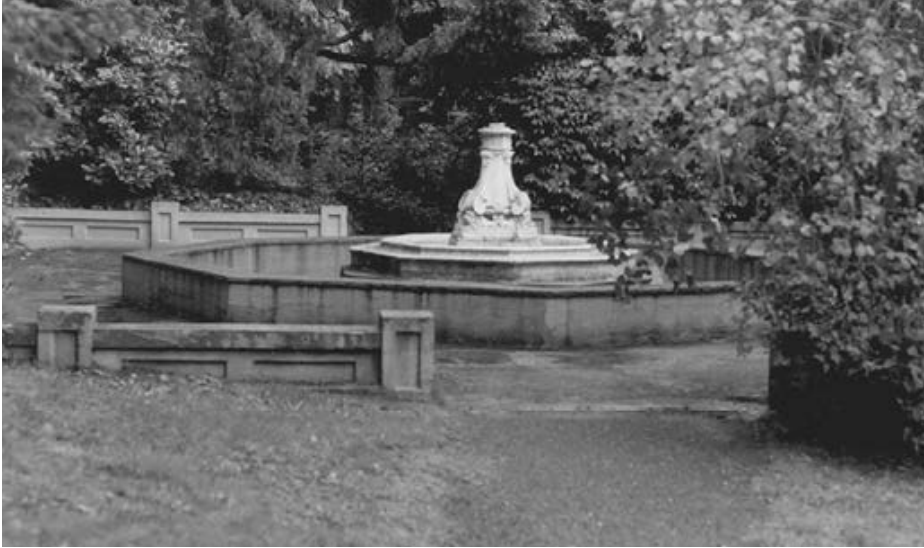
Butler-Perozzi Fountain, circa 1981 before restoration. Note the missing light posts and fountain bowls.

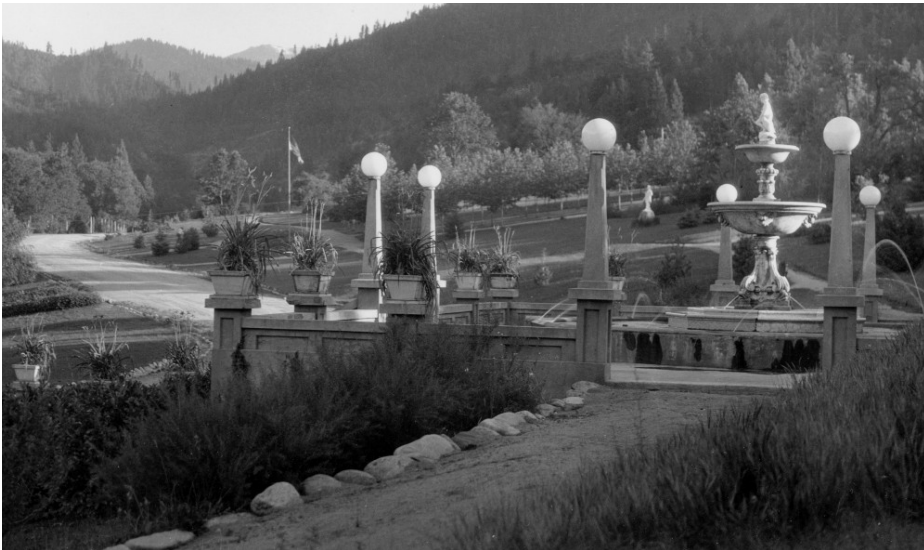
Butler-Perrozzi Fountain, undated. Note the water feature that spouts water from the outer rim of the fountain pool, toward the lower bowl. No sign of this feature is currently visible.

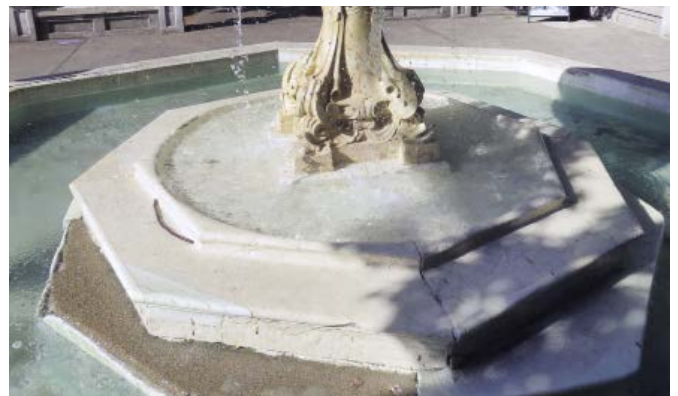
Previous repairs and open joints at lower bowl. Note the plaster failure and exposed concrete at the bottom right.

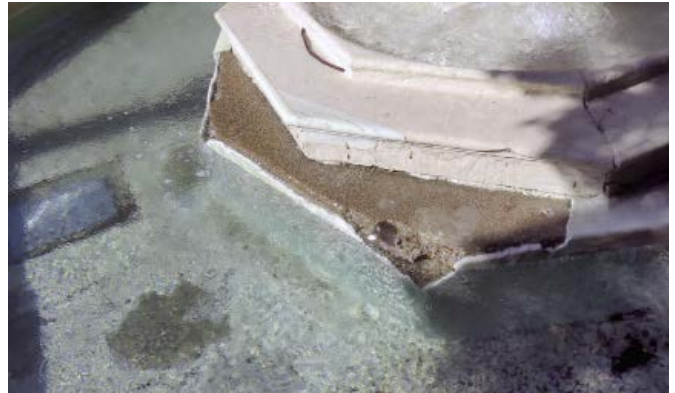
Plaster loss at concrete base. Note plaster loss below the water, on the floor of the pool.

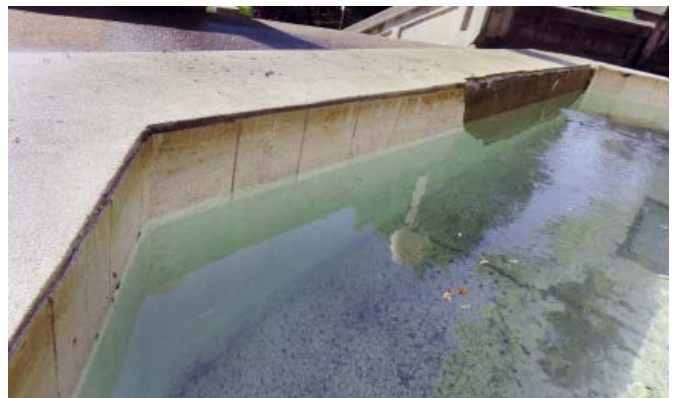
Missing and soiled perimeter tiles.

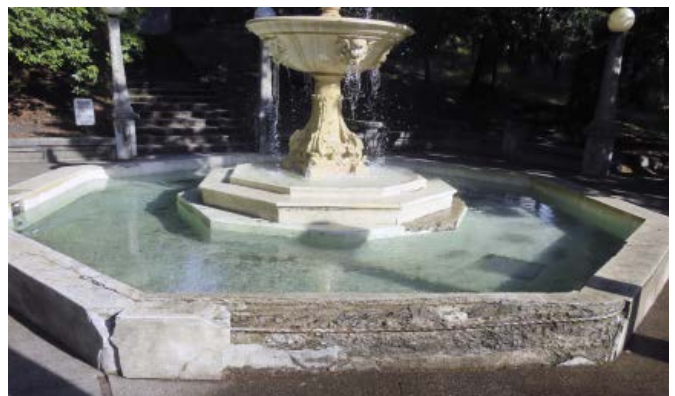
Concrete loss at outer rim of fountain pool.

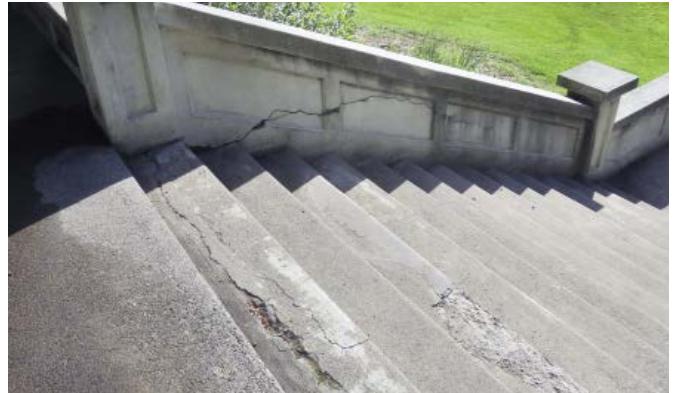
Cracks in cheek wall and failed repairs and cracks in the stairs.

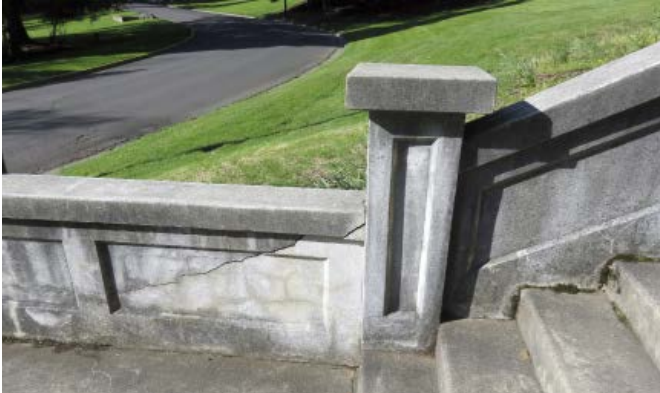
Cracks in the cheek wall. This crack is also visible at the exterior face.

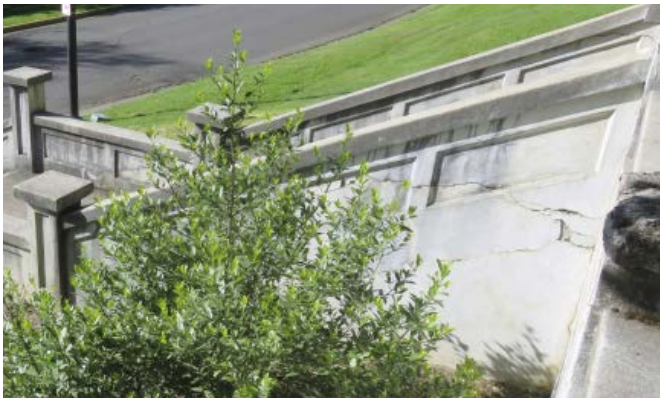
Cracks in the outer face of the staircase. This crack is also visible at the interior face.

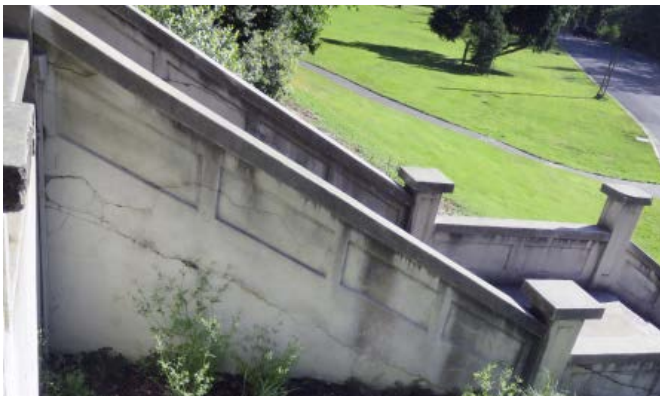
Cracks in the outer face of the staircase.

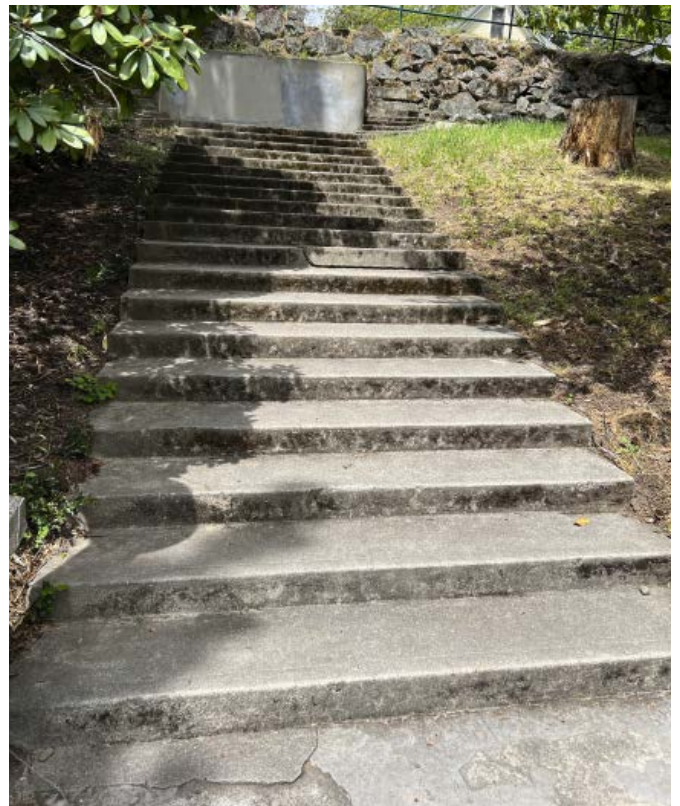
*Staircase to Granite Street, to the west of the terrace.
Note that this is not a signed or publicized pathway.*

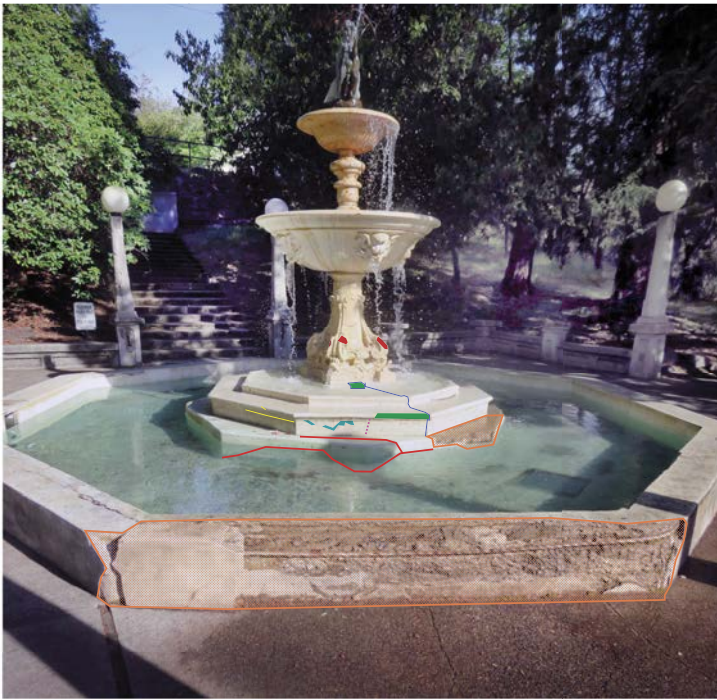
Condition	
	Concrete Spall
	Marble Spall
	Concrete Crack
	Concrete Hairline Crack
	Marble Crack
	Marble Hairline Crack
	Open Joint
	Failed Repair (Marble Only)
	Previous Repair (Marble Only)

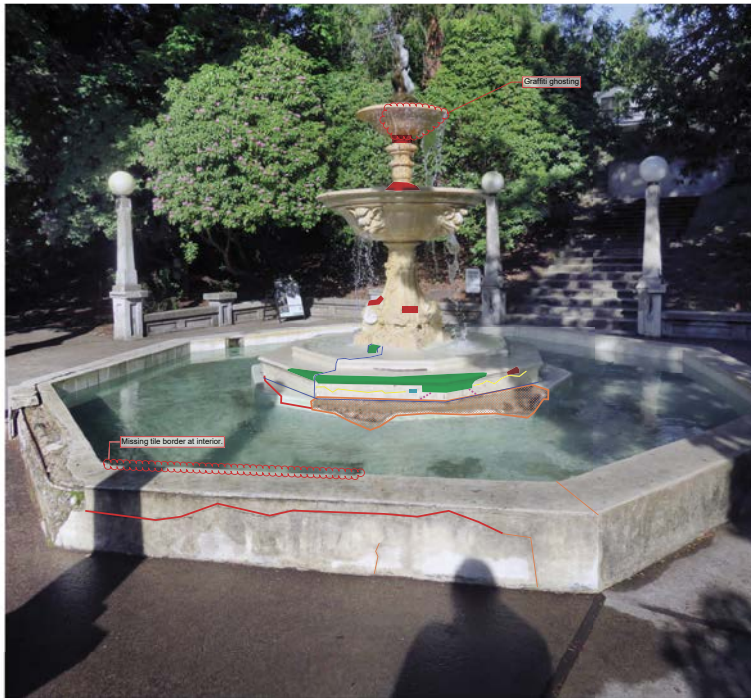
Condition
	Concrete Spall
	Marble Spall
	Concrete Crack
	Concrete Hairline Crack
	Marble Crack
	Marble Hairline Crack
	Open Joint
	Failed Repair (Marble Only)
	Previous Repair (Marble Only)

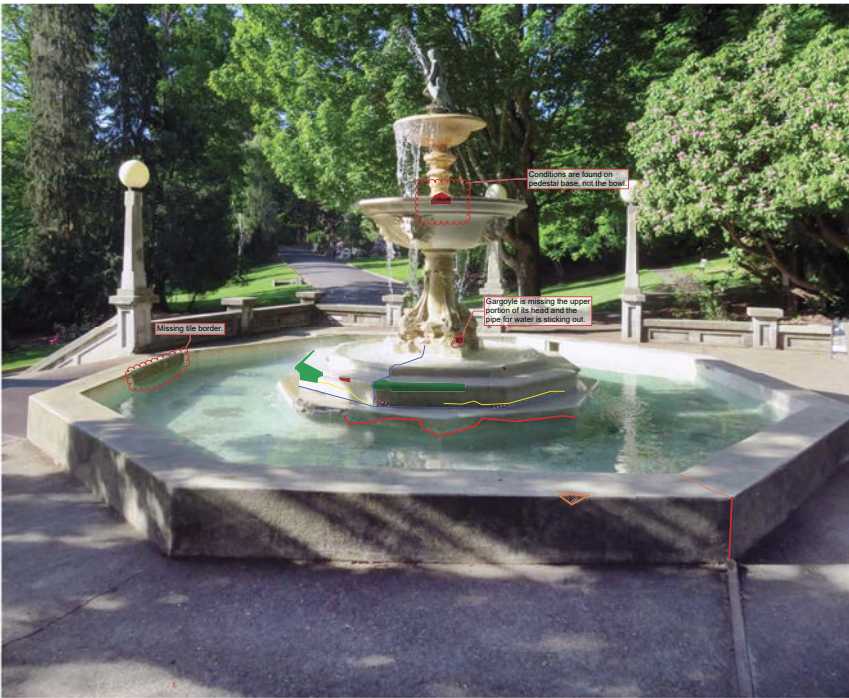
Condition
	Concrete Spall
	Marble Spall
	Concrete Crack
	Concrete Hairline Crack
	Marble Crack
	Marble Hairline Crack
	Open Joint
	Failed Repair (Marble Only)
	Previous Repair (Marble Only)

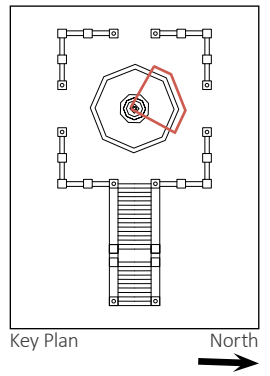
Existing Conditions - Fountain

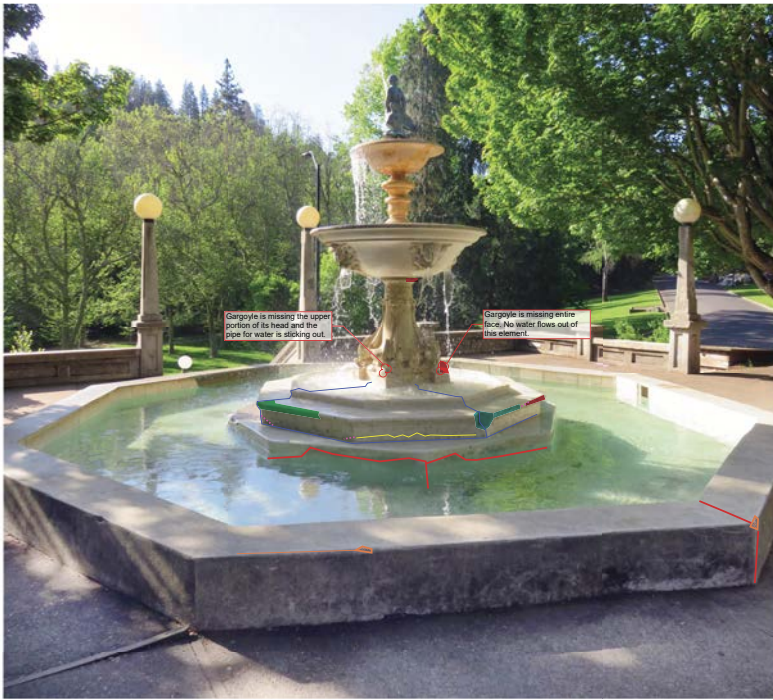
Condition
	Concrete Spall
	Marble Spall
	Concrete Crack
	Concrete Hairline Crack
	Marble Crack
	Marble Hairline Crack
	Open Joint
	Failed Repair (Marble Only)
	Previous Repair (Marble Only)

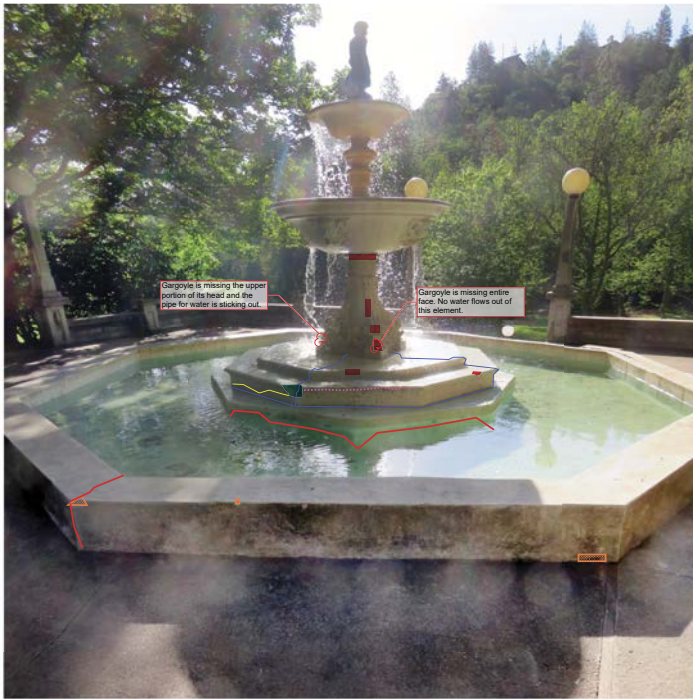
Condition	
	Concrete Spall
	Marble Spall
	Concrete Crack
	Concrete Hairline Crack
	Marble Crack
	Marble Hairline Crack
	Open Joint
	Failed Repair (Marble Only)
	Previous Repair (Marble Only)

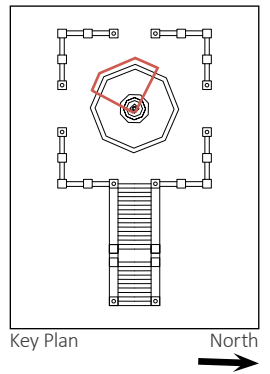
Existing Conditions - Fountain

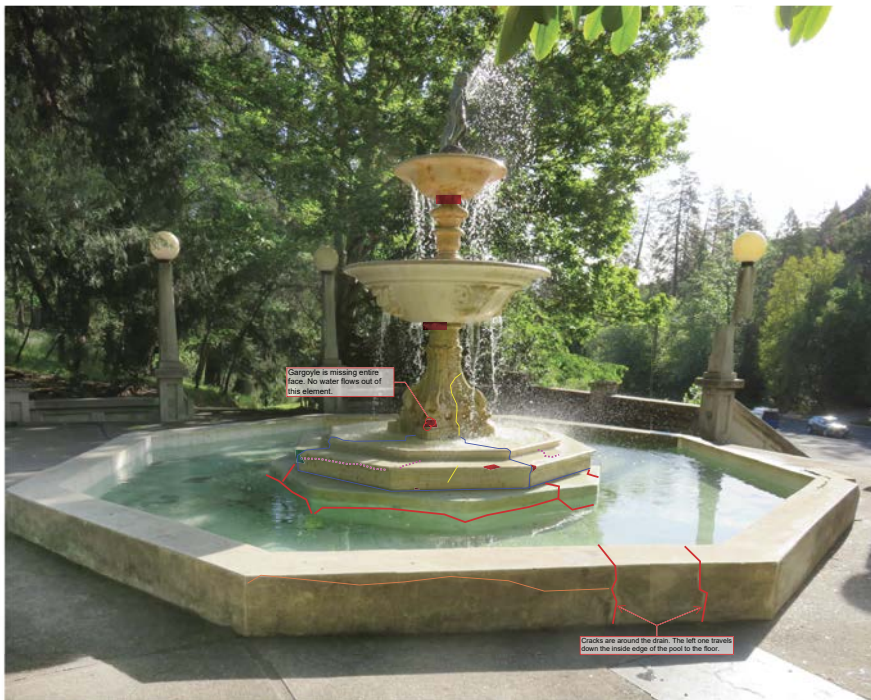
Condition	
	Concrete Spall
	Marble Spall
	Concrete Crack
	Concrete Hairline Crack
	Marble Crack
	Marble Hairline Crack
	Open Joint
	Failed Repair (Marble Only)
	Previous Repair (Marble Only)

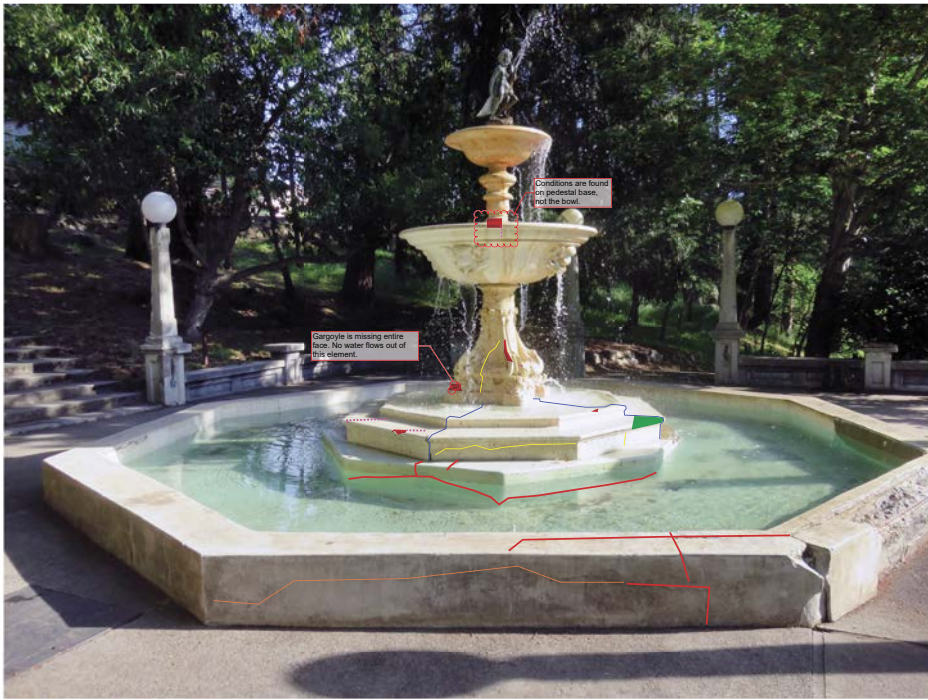
Condition	
	Concrete Spall
	Marble Spall
	Concrete Crack
	Concrete Hairline Crack
	Marble Crack
	Marble Hairline Crack
	Open Joint
	Failed Repair (Marble Only)
	Previous Repair (Marble Only)

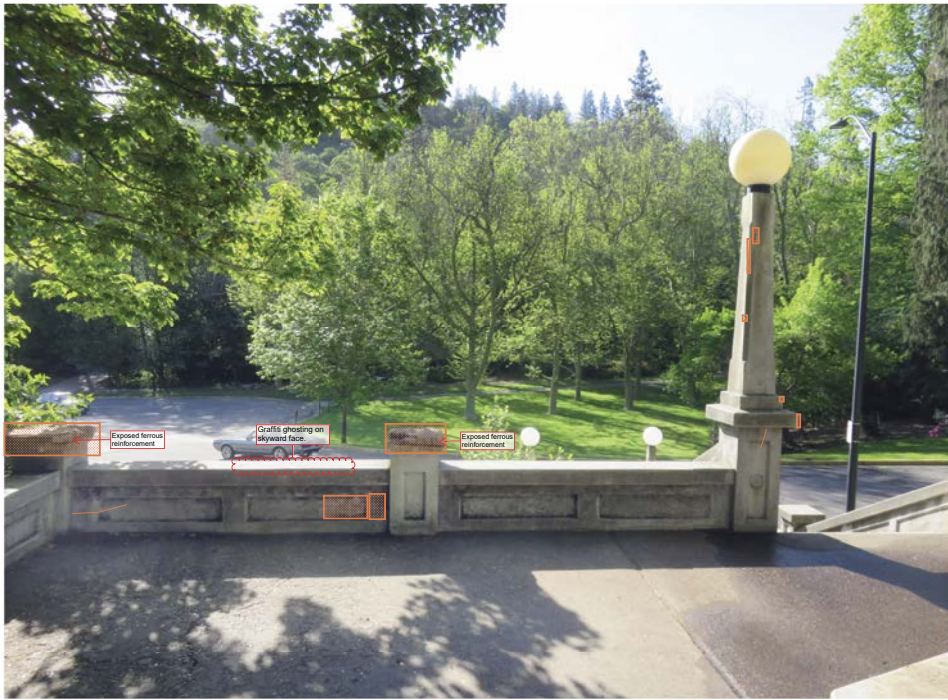
Condition	
	Concrete Spall
	Marble Spall
	Concrete Crack
	Concrete Hairline Crack
	Marble Crack
	Marble Hairline Crack
	Open Joint
	Failed Repair (Marble Only)
	Previous Repair (Marble Only)

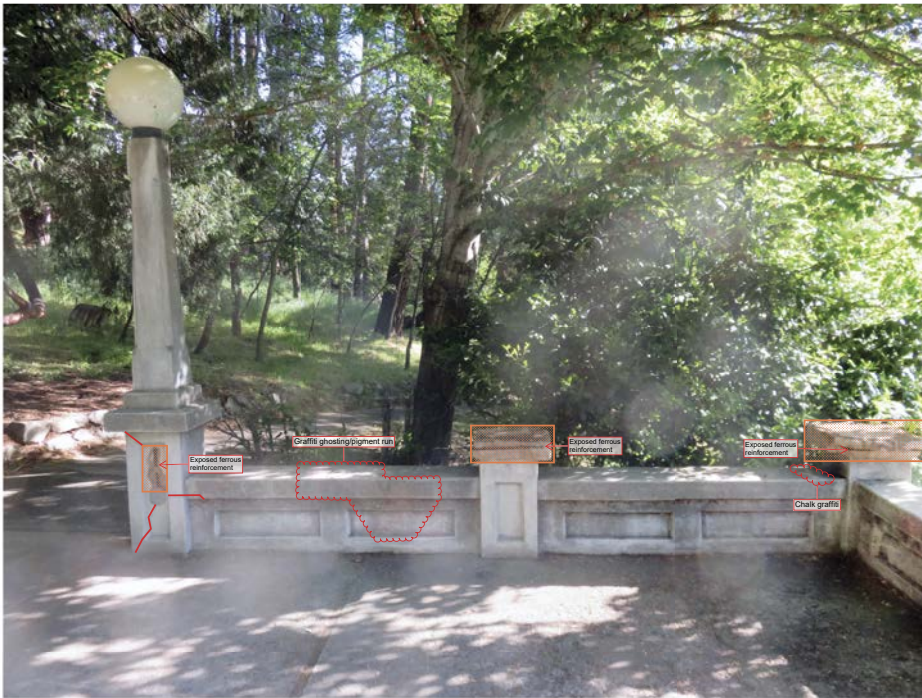
Condition	
	Concrete Spall
	Marble Spall
	Concrete Crack
	Concrete Hairline Crack
	Marble Crack
	Marble Hairline Crack
	Open Joint
	Failed Repair (Marble Only)
	Previous Repair (Marble Only)

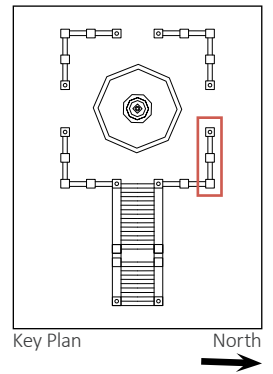
Existing Conditions - Terrace

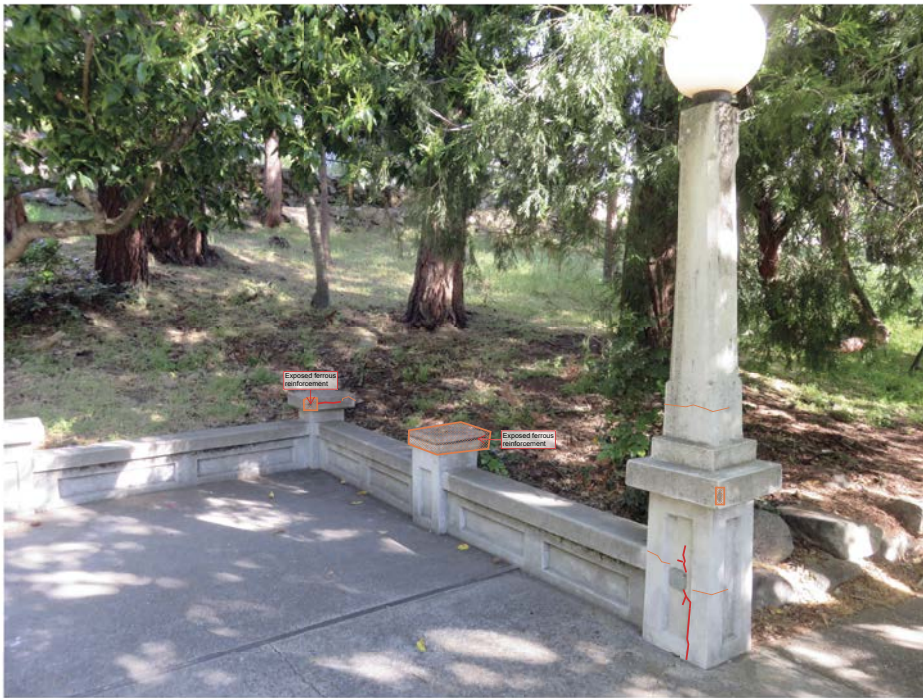
Condition	
	Concrete Spall
	Marble Spall
	Concrete Crack
	Concrete Hairline Crack
	Marble Crack
	Marble Hairline Crack
	Open Joint
	Failed Repair (Marble Only)
	Previous Repair (Marble Only)

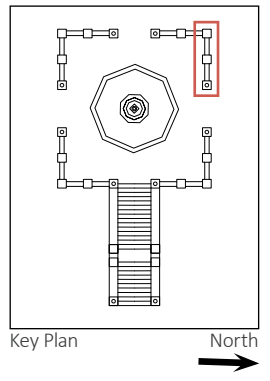
Existing Conditions - Terrace

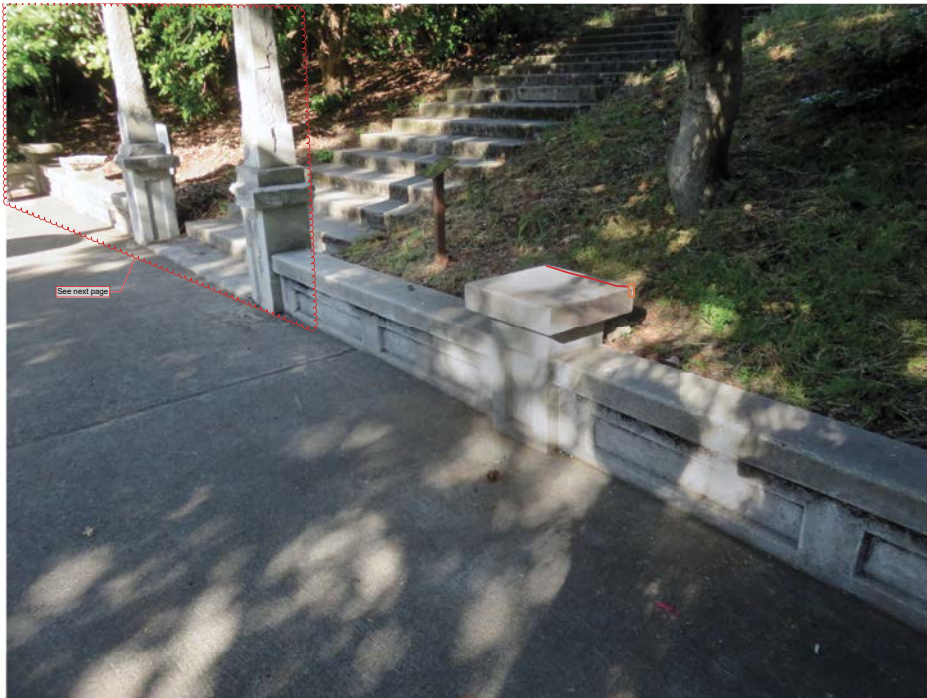
Condition	
	Concrete Spall
	Marble Spall
	Concrete Crack
	Concrete Hairline Crack
	Marble Crack
	Marble Hairline Crack
	Open Joint
	Failed Repair (Marble Only)
	Previous Repair (Marble Only)

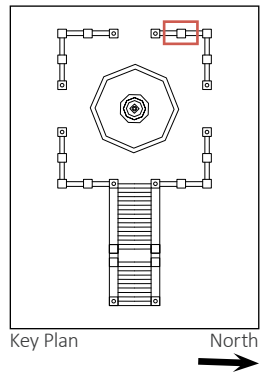
Existing Conditions - Terrace

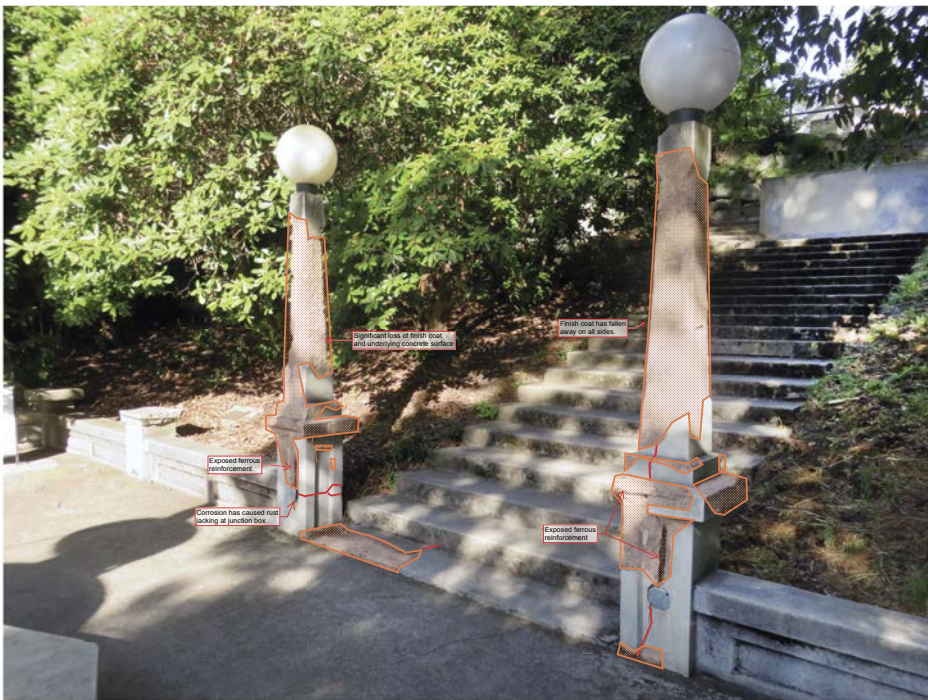
Condition	
	Concrete Spall
	Marble Spall
	Concrete Crack
	Concrete Hairline Crack
	Marble Crack
	Marble Hairline Crack
	Open Joint
	Failed Repair (Marble Only)
	Previous Repair (Marble Only)

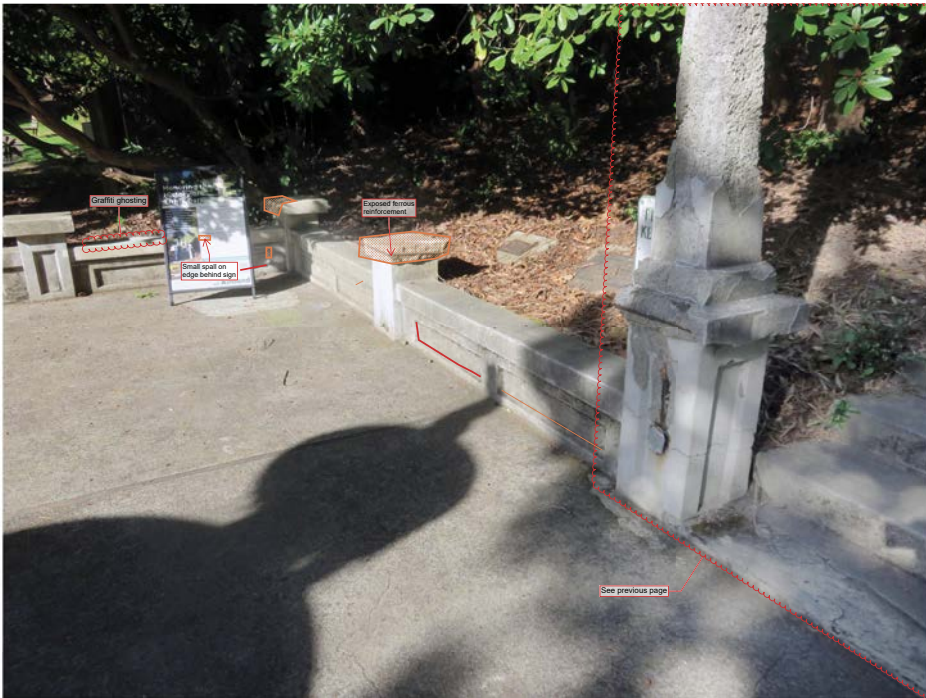
Condition	
	Concrete Spall
	Marble Spall
	Concrete Crack
	Concrete Hairline Crack
	Marble Crack
	Marble Hairline Crack
	Open Joint
	Failed Repair (Marble Only)
	Previous Repair (Marble Only)

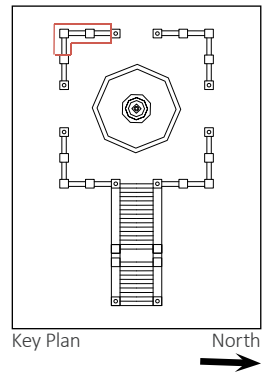
Existing Conditions - Terrace

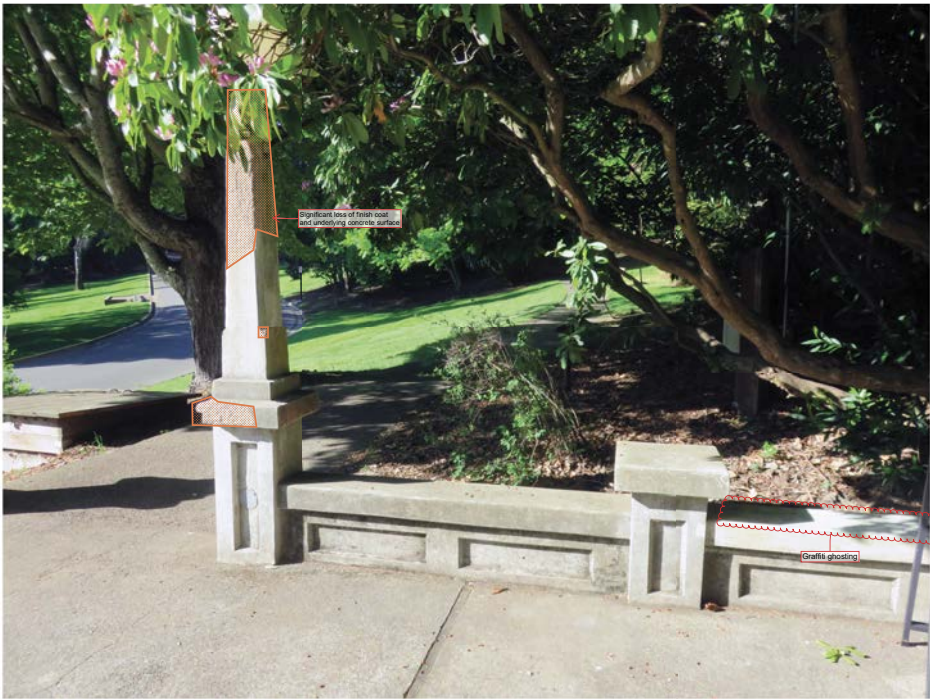
Condition	
	Concrete Spall
	Marble Spall
	Concrete Crack
	Concrete Hairline Crack
	Marble Crack
	Marble Hairline Crack
	Open Joint
	Failed Repair (Marble Only)
	Previous Repair (Marble Only)

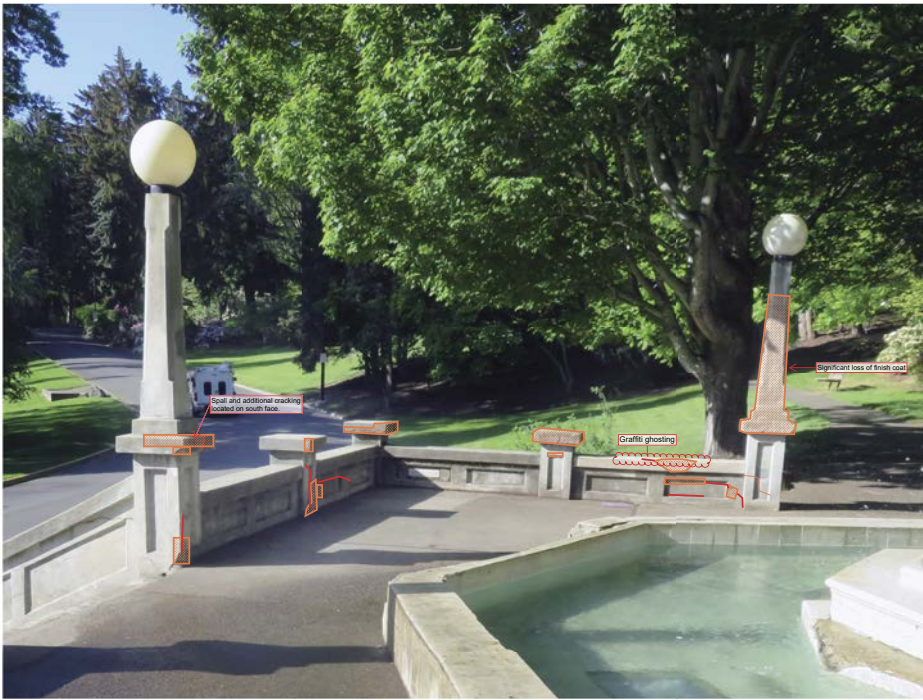
Condition	
	Concrete Spall
	Marble Spall
	Concrete Crack
	Concrete Hairline Crack
	Marble Crack
	Marble Hairline Crack
	Open Joint
	Failed Repair (Marble Only)
	Previous Repair (Marble Only)

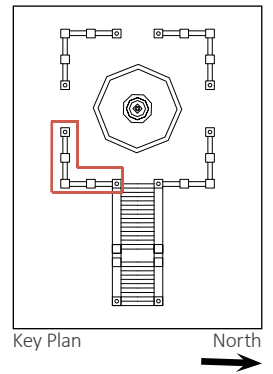
Existing Conditions - Terrace

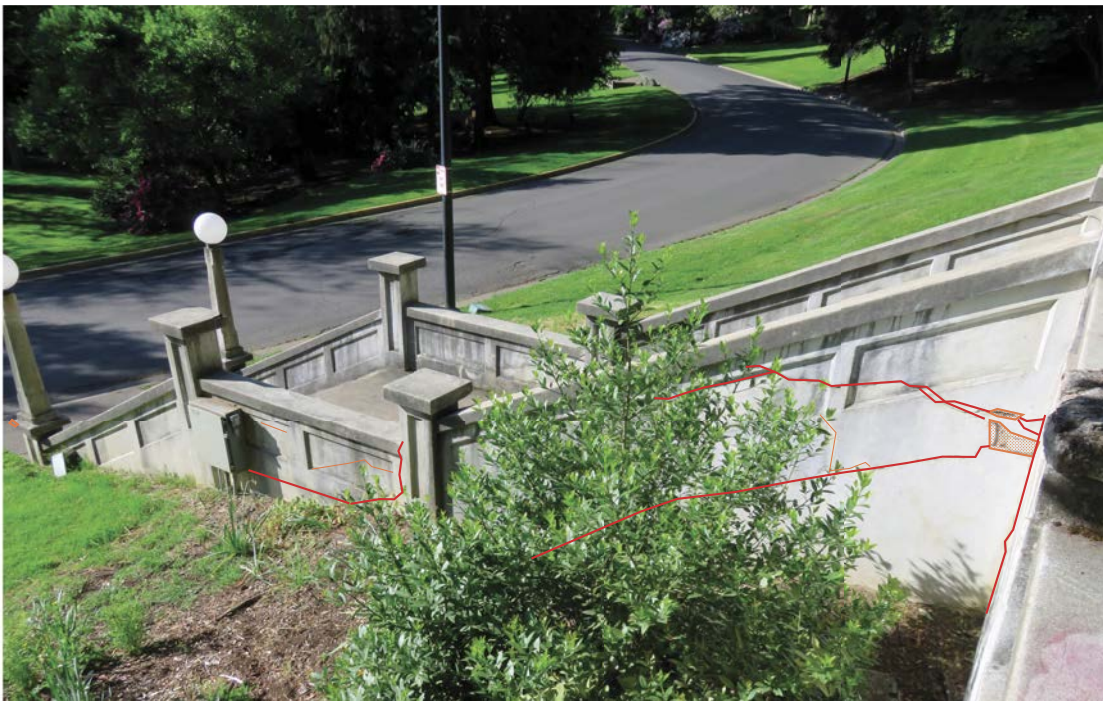
Condition	
	Concrete Spall
	Marble Spall
	Concrete Crack
	Concrete Hairline Crack
	Marble Crack
	Marble Hairline Crack
	Open Joint
	Failed Repair (Marble Only)
	Previous Repair (Marble Only)

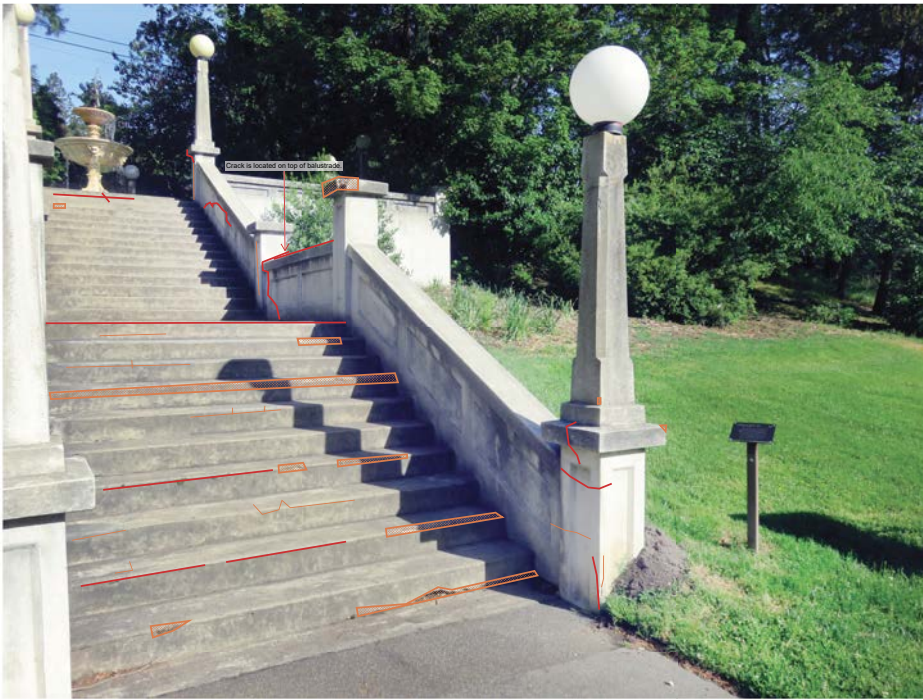
Condition	
	Concrete Spall
	Marble Spall
	Concrete Crack
	Concrete Hairline Crack
	Marble Crack
	Marble Hairline Crack
	Open Joint
	Failed Repair (Marble Only)
	Previous Repair (Marble Only)

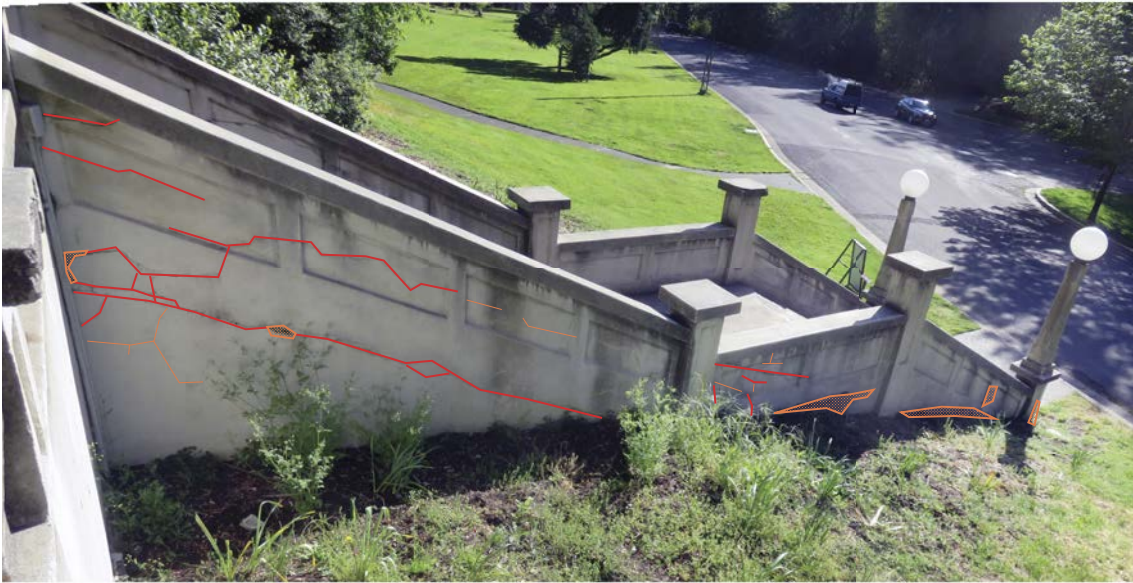
Condition	
	Concrete Spall
	Marble Spall
	Concrete Crack
	Concrete Hairline Crack
	Marble Crack
	Marble Hairline Crack
	Open Joint
	Failed Repair (Marble Only)
	Previous Repair (Marble Only)

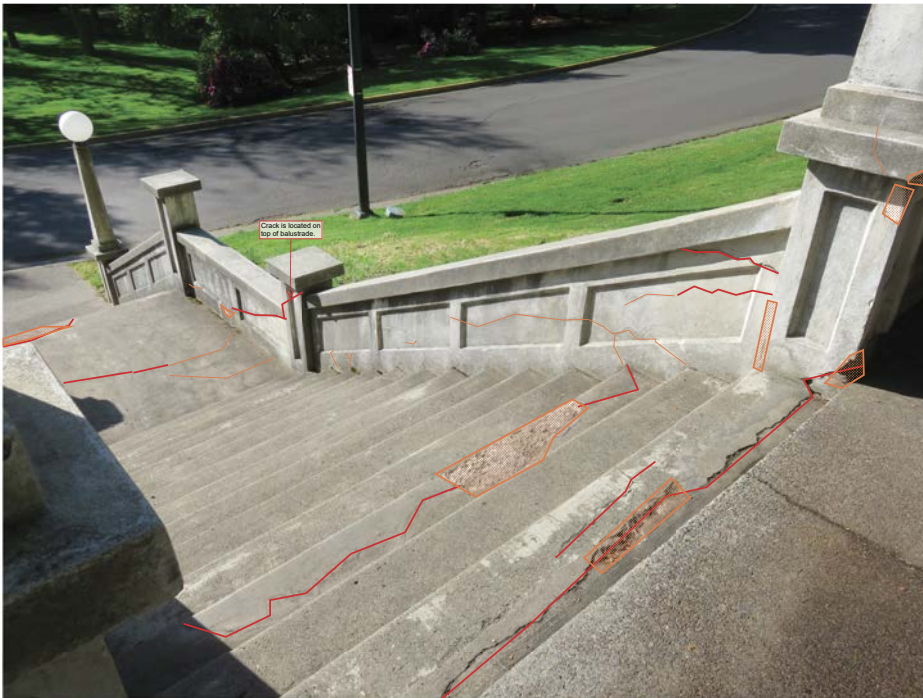
Condition	
	Concrete Spall
	Marble Spall
	Concrete Crack
	Concrete Hairline Crack
	Marble Crack
	Marble Hairline Crack
	Open Joint
	Failed Repair (Marble Only)
	Previous Repair (Marble Only)

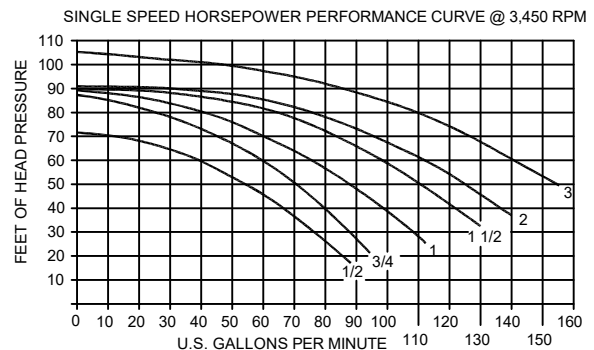
SPECIFICATION DATA: : Series 1 Direct Burial Pump Vault, consisting of a 3'-4" sq. x 2'-8" deep heavy duty FRP vault with white gel-coat interior and brown gel-coat exterior, furnished with 36" sq. fiberglass reinforced plastic lid with stainless steel piano hinge attachment and lock hardware (LOCK BY INSTALLER), containing a self-priming display pump with integral suction strainer, RCCF-050; 50 sq. ft. cartridge filter unit, 3" vent connections with 105 CFM vent fan, 2" floor drain; RTCP-PCLC; UL listed time clocks and power distribution breakers (Class A GFCI as required). Unit is pre-wired, pre-plumbed (Schedule 80 PVC) and factory tested prior to shipment. See power requirement above.
