THE CARTER MEMORIAL FOUNTAIN, ASHLAND, OR HISTORY AND OPTIONS FOR REHABILITATION

for the City of Ashland, Oregon

Prepared by George Kramer, M.S., HP
Kramer & Company, Ashland

April 2015

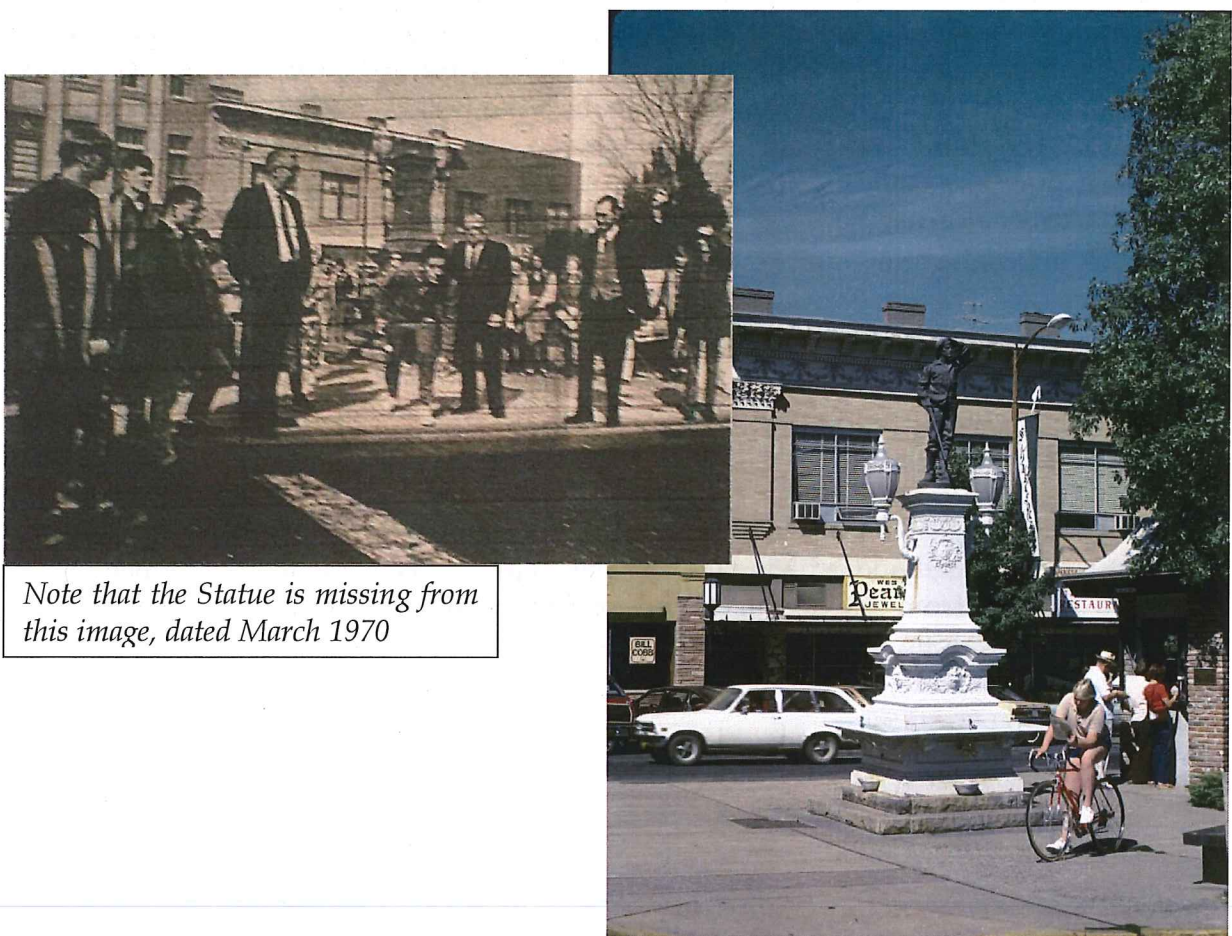
**Figure 6: Carter Memorial Fountain, 1970 (left) and as restored, c1975 (right)
(University of Oregon Image)**

It appears that the c1972 work included the addition of support studs that allowed Mike to be physically bolted to the cast iron top of the fountain, since previously he simply sat on the fountain without any physical attachment points. Changes to Mike's rifle hand as part of the c1972 repairs are unknown, although it seems likely that at this time a bundle of copper tubing and epoxy were inserted into the rifle arm cavity in an effort to provide additional support.¹⁵ It is assumed that the reinstallation of the statue coincided with the decision to repaint the Carter Memorial Fountain base a glossy white, a major deviation from its historic scheme.¹⁶ At some point during this period, likely related to changes to the Plaza, the entire lowest plinth layer was embedded into the surrounding concrete surface, leaving only two layers of the granite exposed.

Note that the Statue is missing from this image, dated March 1970

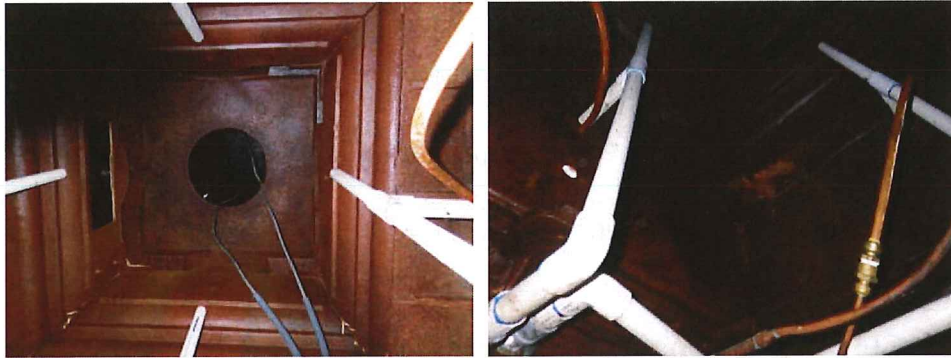
Figure 7: Carter Memorial Fountain, Interior Views, 2015 (note rusted surfaces)

Discussion: The interior of the cast iron fountain base, as shown in Figure 7, is coated with an evenly rusted surface while some portions of the exterior also exhibit rust or rust staining. This is almost certainly due to the presence of standing water year round in the fountain vault with limited air flow and high humidity. Successfully addressing the water infiltration in the fountain vault involves the risky proposition of either disassembling the fountain or relocating it as a unit to allow below grade excavation, installation of drainage, and the creation of a more water-resistant vault. In order to reduce the impact of rust while avoiding that level of cost and risk, installation of an improved sump pump along with an active ventilation system is recommended. Active ventilation, likely tied to sump operation, will include the installation of an electric fan(s) to create positive air movement along with increased ventilation ports to allow water vapor to escape the fountain interior.

Existing rust on the inner surfaces should be addressed with a spray-on "Rust Converter" similar to *Must for Rust* or other Phosphoric Acid-based products. Once rust has been neutralized, the interior cast iron surfaces of the fountain base can be treated with a rust inhibiting primer to reduce the potential for future rust buildup. The exterior of the foundation, last painted in 1982 as near as can be determined, should be cleaned and either repainted or touched up in matching colors following necessary repairs to damaged and rusted elements.

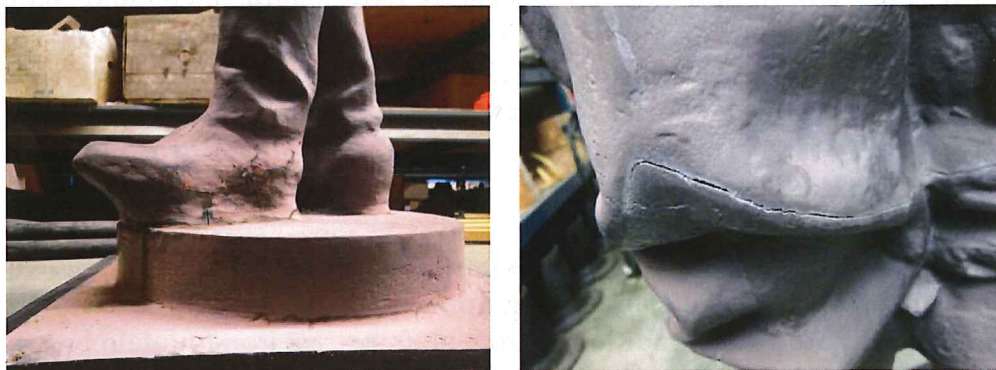
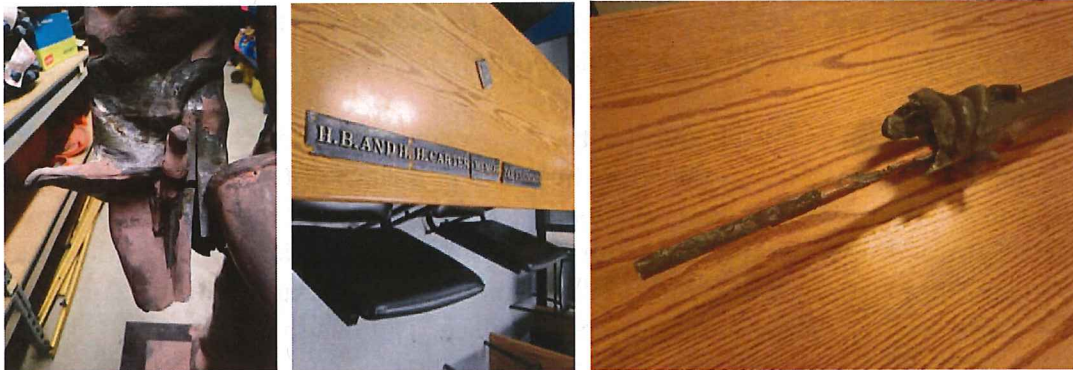
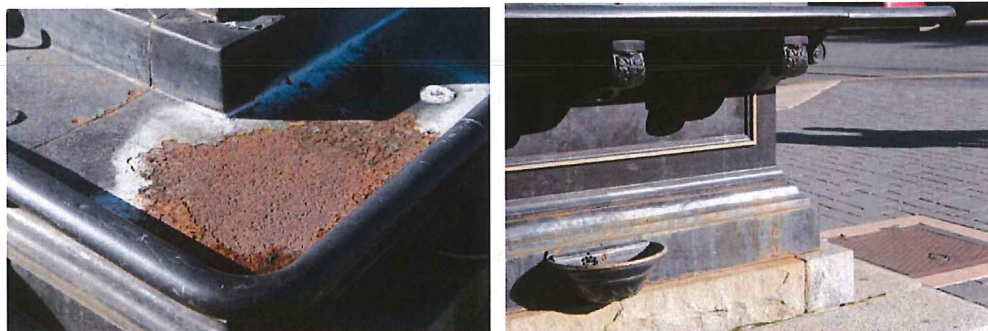
Figure 8: Carter Memorial Fountain, Current Conditions

Statues like the pioneer were cast in pieces, or plates, and then soldered together to form a hollow shell. Portions of Mike, through normal wear as the result of exposure, as splitting at the seams, as the result of thermal expansion (See Figure 7). Soldered cast-zinc plates have little inherent structural capacity and the crystalline structure of cast-zinc offers minimal resistance to impact. It is this latter fault that has led to Mike's damage from vandals who attempt to boost themselves up by relying on his right arm for support. This is evidenced most clearly by the simple fact that all documented instances of damage to rifle hand are in the same place, failing at the solder seams. 2002 efforts at internal reinforcement (the insertion of a bundle of copper tubing and epoxy) were likely effective in providing support *during* the repair process, but did little to create any actual weight bearing ability to the zinc casting afterwards. This modification may, through increased leverage, have actually created additional damage to the statue when placed under stress, by radiating force further away from the failing joint. In most situations, both the damage to both of Mike's boots and to his hand/arm, much of the damage also tends to follow the original solder or joint lines where the original thin cast zinc pieces were assembled into a whole. Both of the lower legs/boots exhibit a high degree of damage. The boots are reinforced with fiberglass, while his rifle hand had been repaired at least once (c1969) to repair breakage, with the rifle and hand undergoing serial repair to damage in the same basic area, including the October 2014 vandalism. Additional evidence of fiberglass reinforcement, especially on the back, are evident upon close examination of the statue.

The undamaged portions of the statue are in reasonably good condition, subject to normal weathering, however there are still cracks at plates seams, some of which are quite severe, that reduce the statue's overall structural integrity. These areas of damage will require repair no matter what option the city chooses for the statue's future, with an intent to return to exterior display naturally requiring more substantial intervention

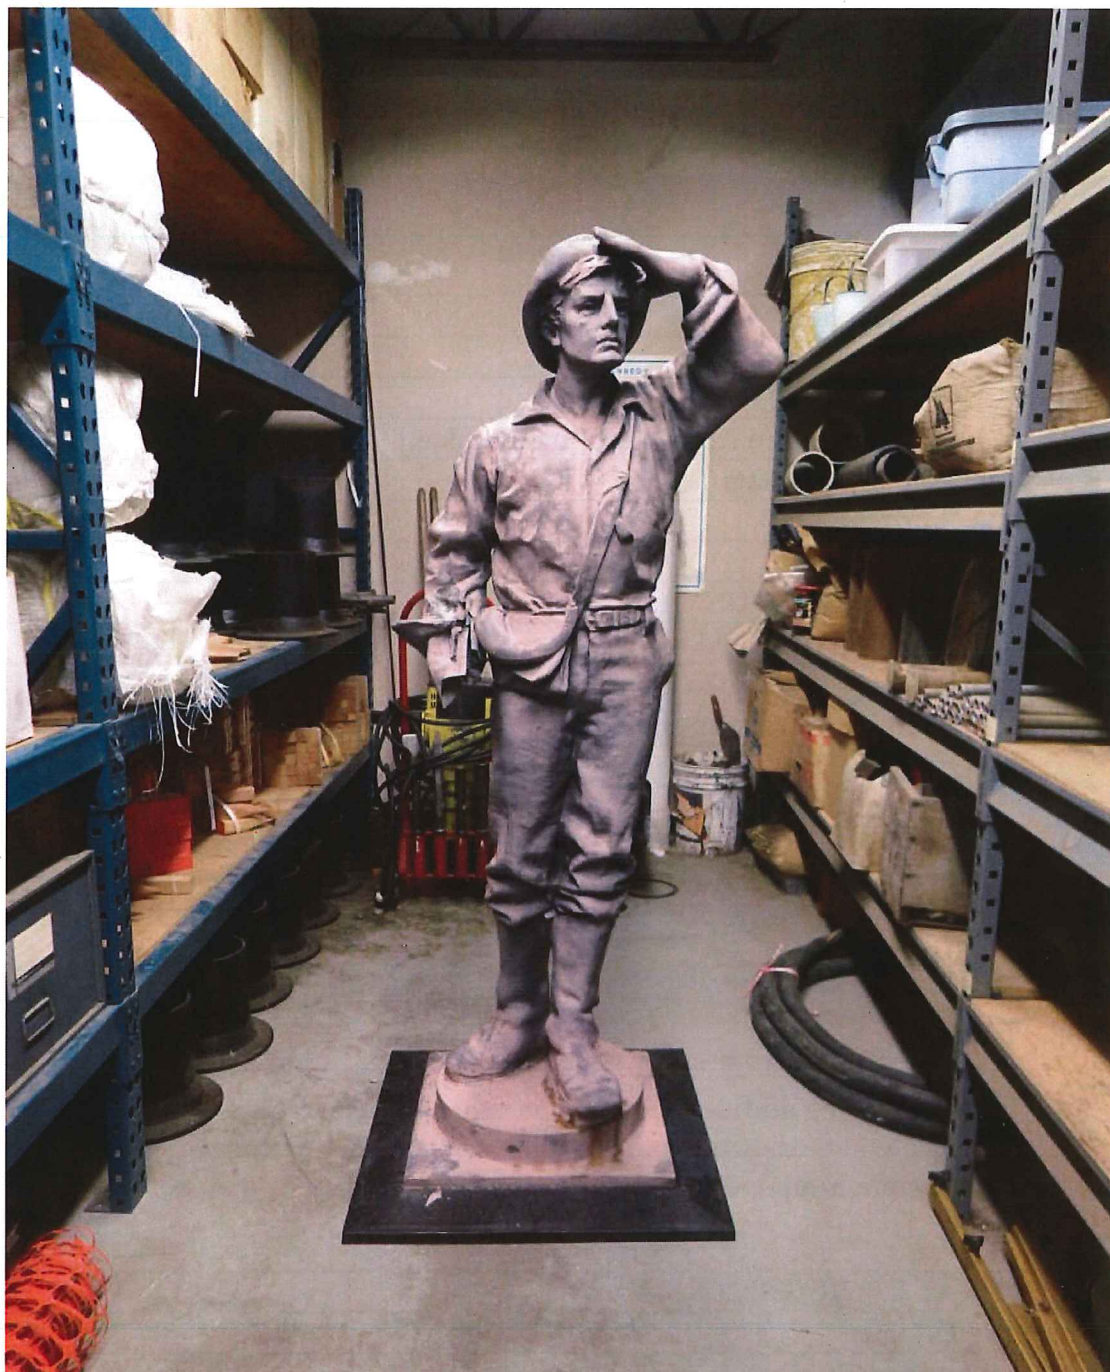
Figure 9: Pioneer Mike, at City Public Works Warehouse, February 2015

Most recently, in October 2014, Pioneer Mike was again damaged by vandals who, likely while attempting to climb the statue, broke off the rifle and rifle hand in the same seam that had previously failed. The rifle and attached hand were found later, in the planter box outside a nearby restaurant. The bronze plaque in honor of the Carters, a long narrow panel with raised lettering that is mounted directly above the fountain tray facing south, had been damaged and broken into four pieces prior this incident. The Pioneer Mike statue was removed from the fountain and placed in storage at the Ashland Public Works warehouse awaiting repair.

As a result of its design and history, Pioneer Mike is a mixture of old, weakened, soldered seams that have been exposed to the weather for over a century and a series of failed seams and material damage that have been repaired through a mixture of solder, fiberglass and mechanical reinforcement with mixed success. Ashland has been incredibly lucky in that despite being hit by a truck (in 1931) and having fallen off the fountain (in c1967), Mike has only suffered damage to his extremities. "The most common damage to cast-zinc sculpture

Although a variety of materials options were considered, based on durability, appearance, long-term maintenance costs and consistency with the original character, the recommended material for replication is BRONZE. Bronze is durable, resistant to weathering, and has a naturally historically appropriate finish, significantly reducing any future maintenance.

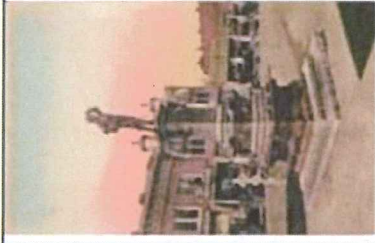
<p>Circa 1932</p>	<p>Note change to lamps, this image is assumed to show the fountain post-truck damage of October 1931. See AT 28-Dec-1931, 26-Feb-1932. Repainted 5/1937, Council considered moving the CMF in 7/1938 but did not.</p>

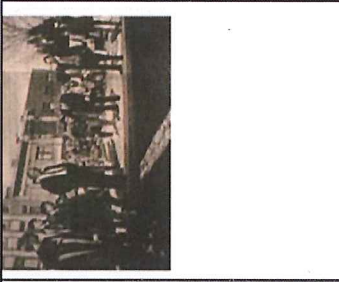
<p>Circa 1968</p>	<p>Pioneer statue is "lassoed" and topples from its base, suffering severe damage. The statue was removed from fountain and not replaced until Summer 1972, following restoration, with change to flatfooted posture.</p>

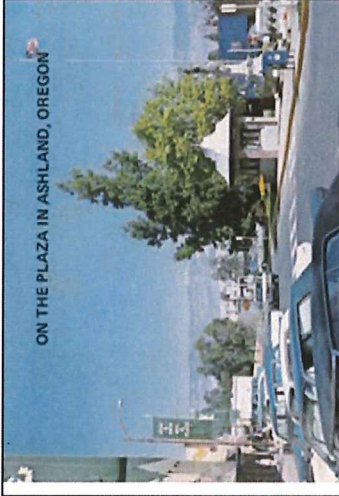
<p>Circa 1975</p>	<p>Repaired and repainted \$8K, ADT, 2-Nov-1982. Damaged by vandals, 31-Oct-2002, lights, replaced with globes, MMT 31-Jan-2002. Damaged by vandals, October 2104, removed to Public Works Shops pending repair.</p>
