CITY OF ASHLAND

TREE COMMISSION - REGULAR MEETING January 7, 2021 AGENDA

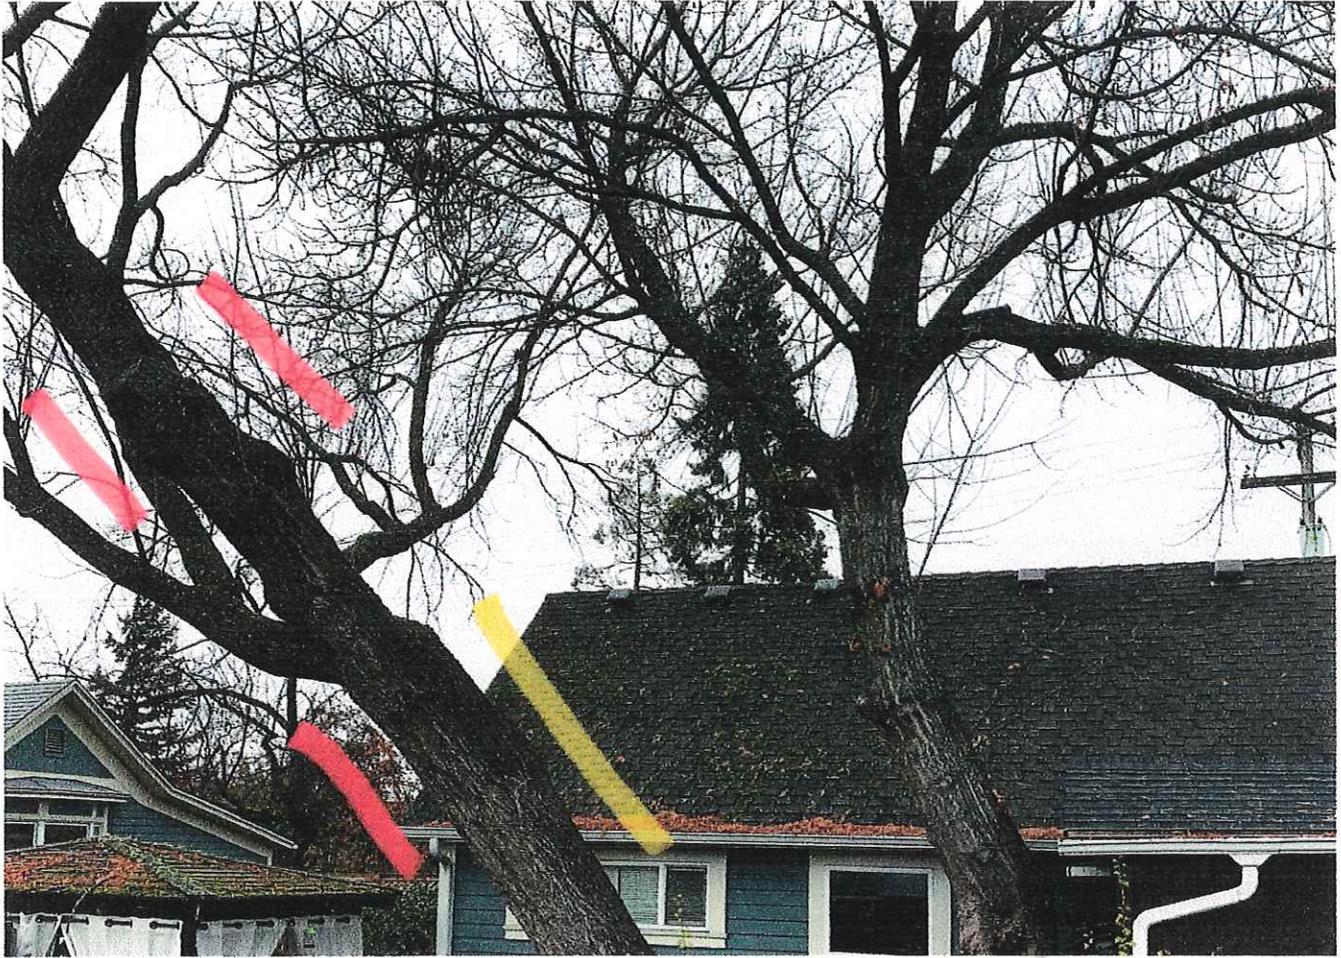
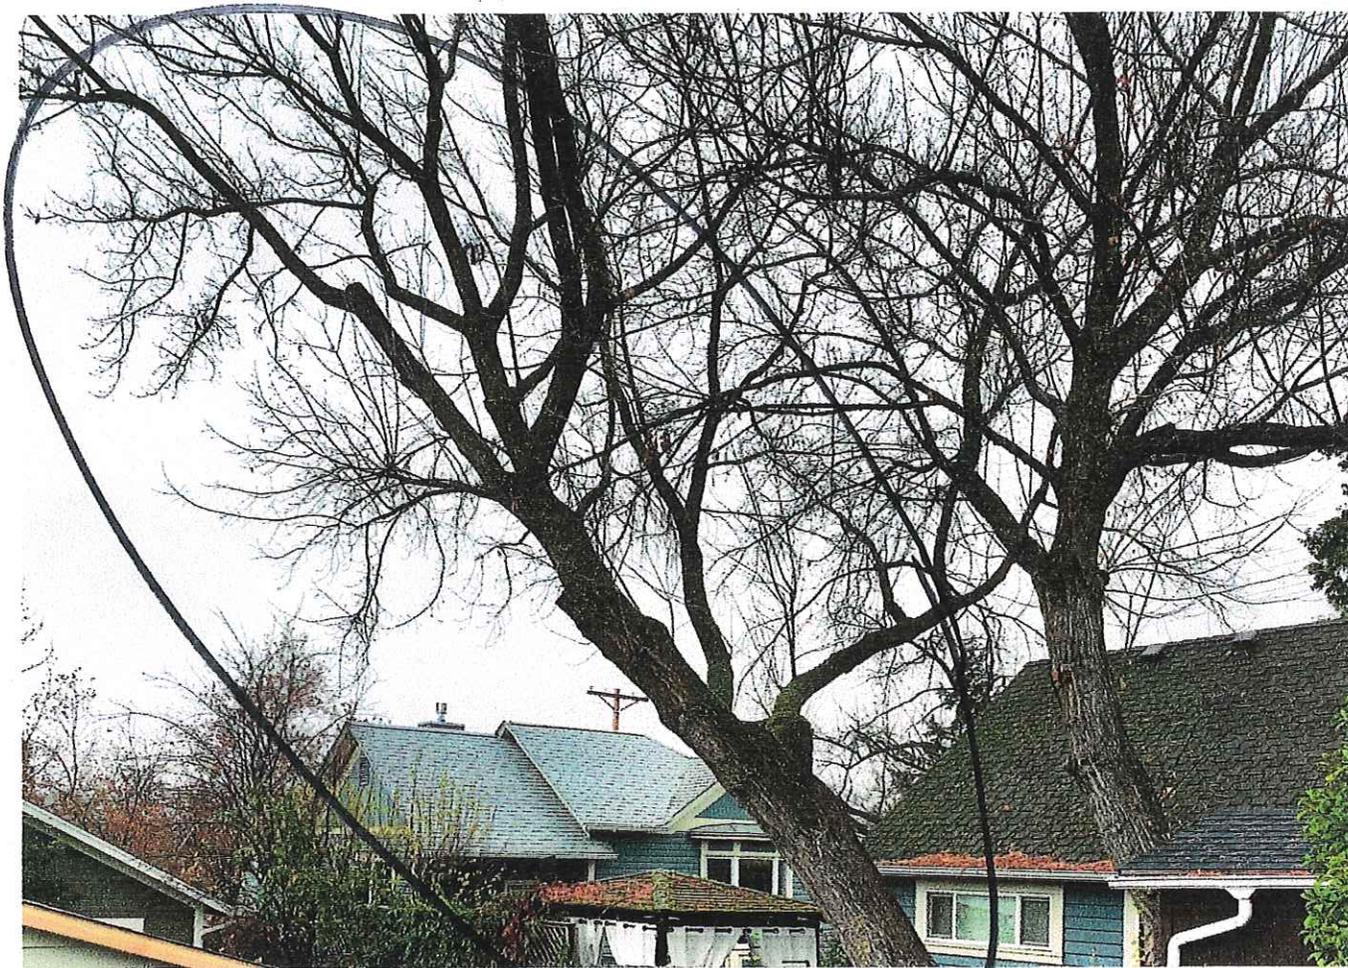
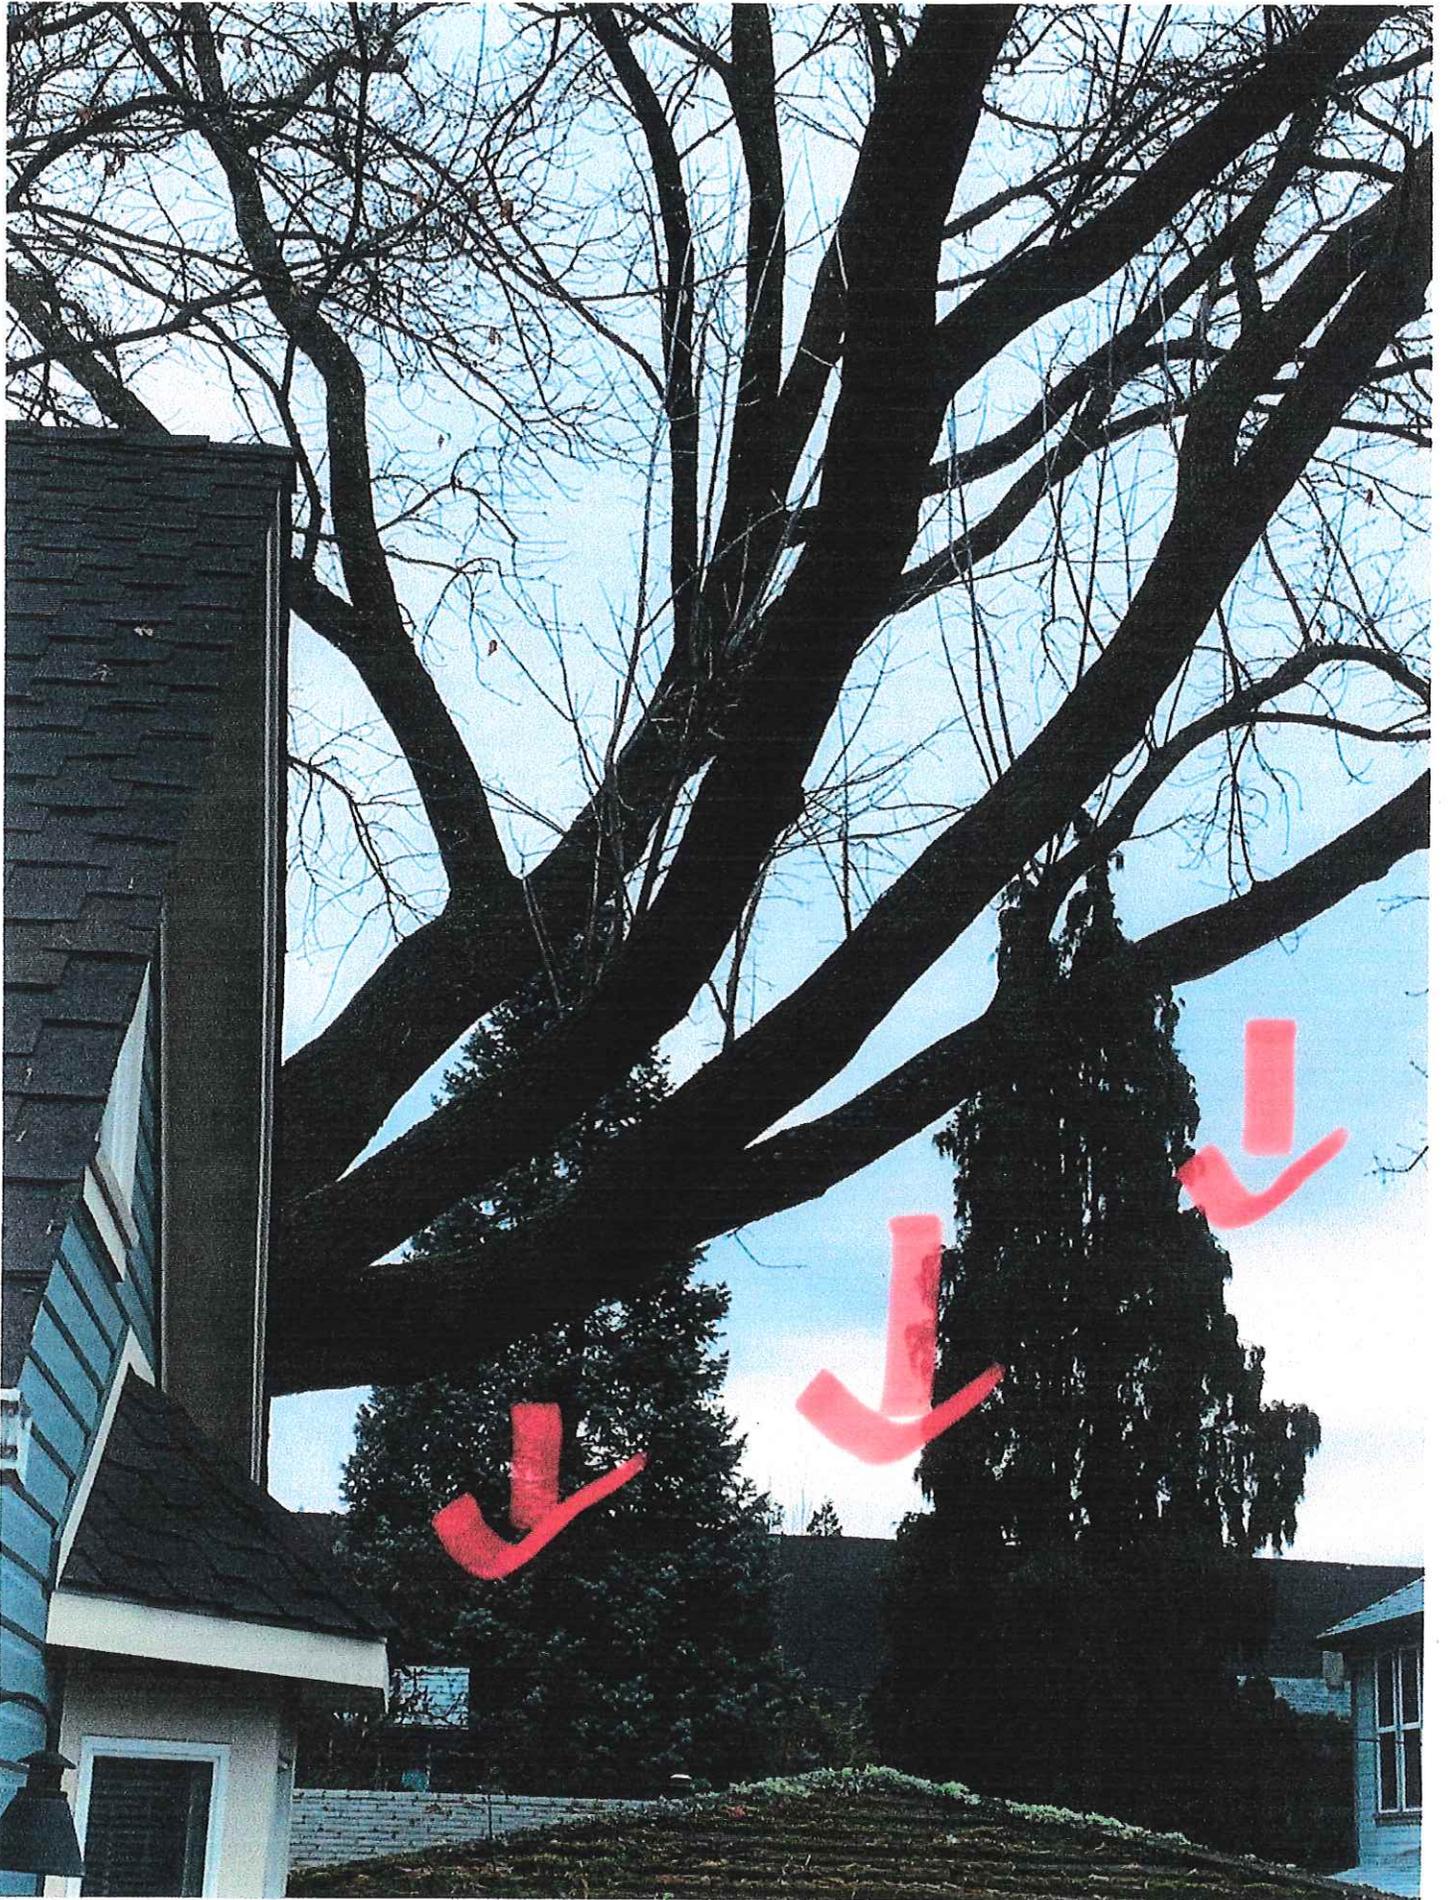
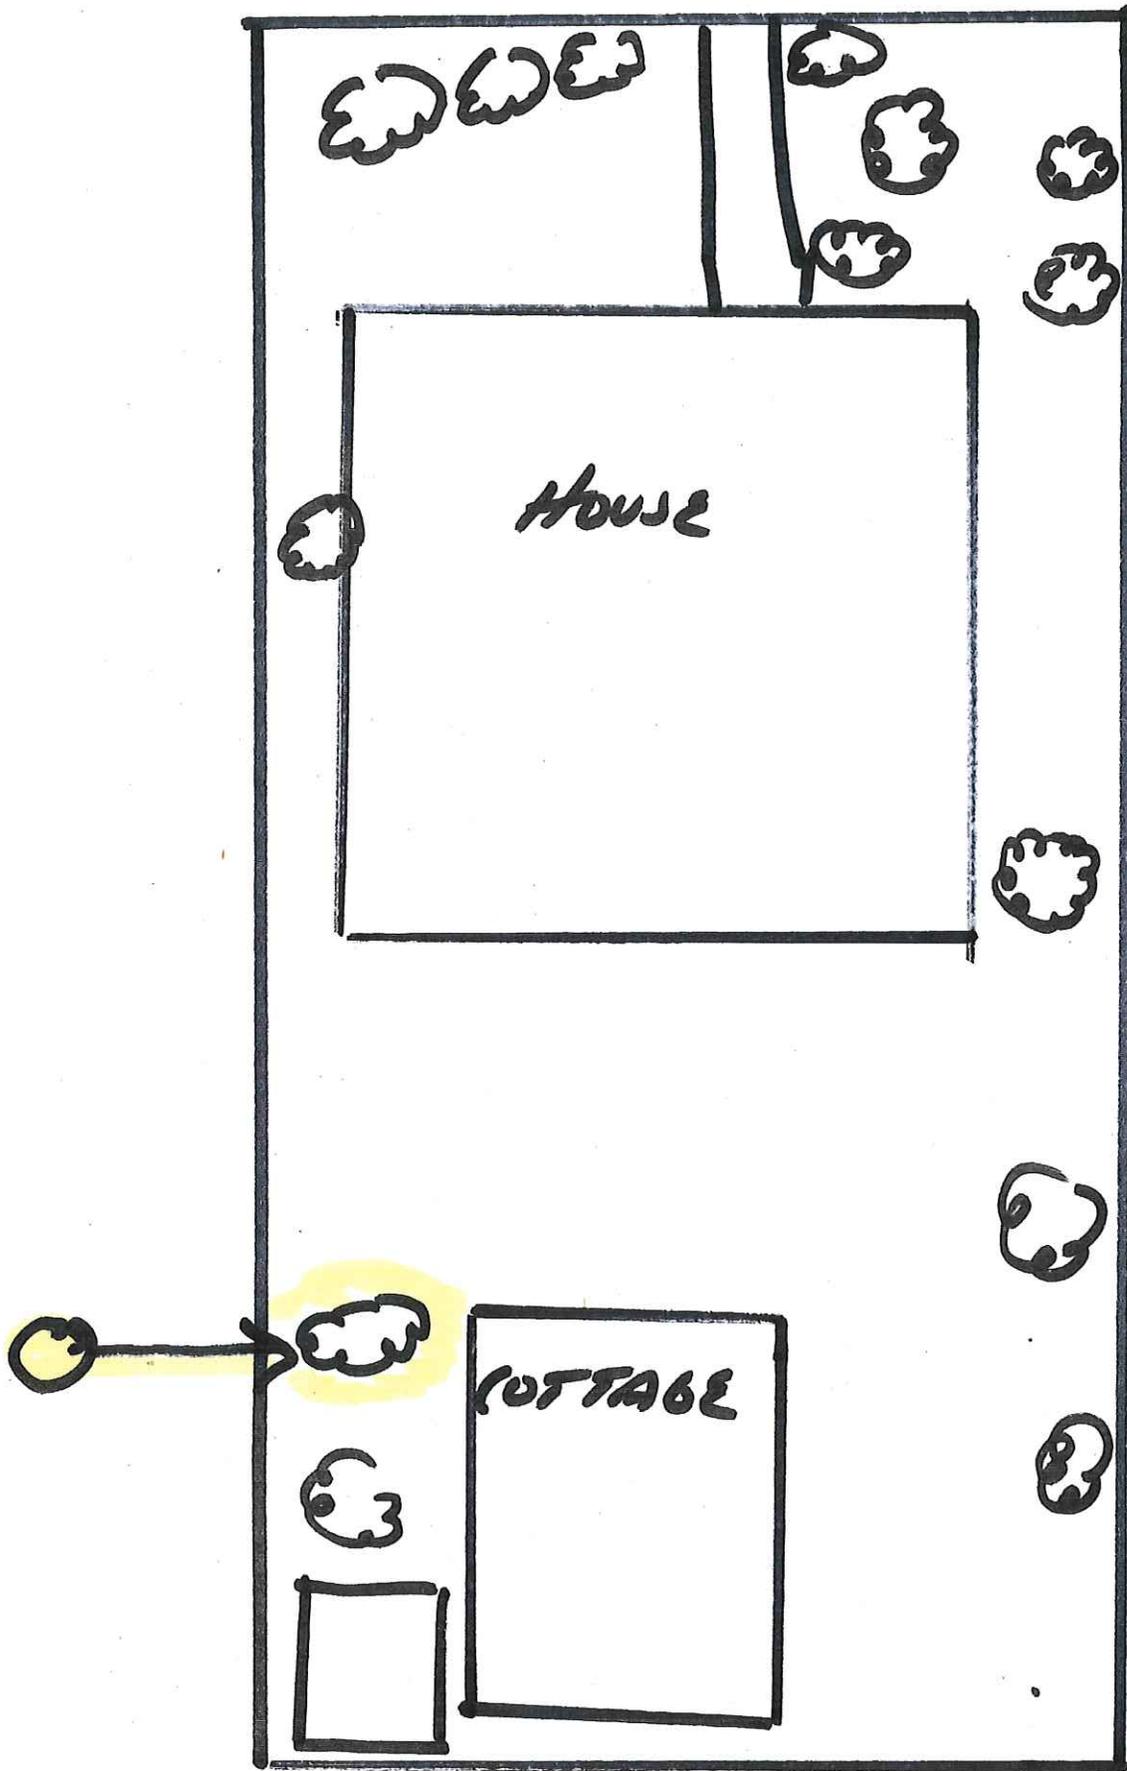
The reason for removal is the angle that the tree has taken over the last 10 years, and the danger of it causing structural damage or harm to inhabitants.

Two weeks ago I had the arborist from Southern Oregon Tree Care come out and evaluate the tree, hoping just to have the canopy cut back. At that time he noted the tree was healthy, but was showing stress from the lean. A major tree limb comes off the already angled main trunk at 90 degrees. He noted cutting back the canopy any more would have detrimental effects on the Tree and only minimally take weight off.

LEANS
OUR FEELINGS - BOTH OUR
NEIGHBORS & OUR HOME.

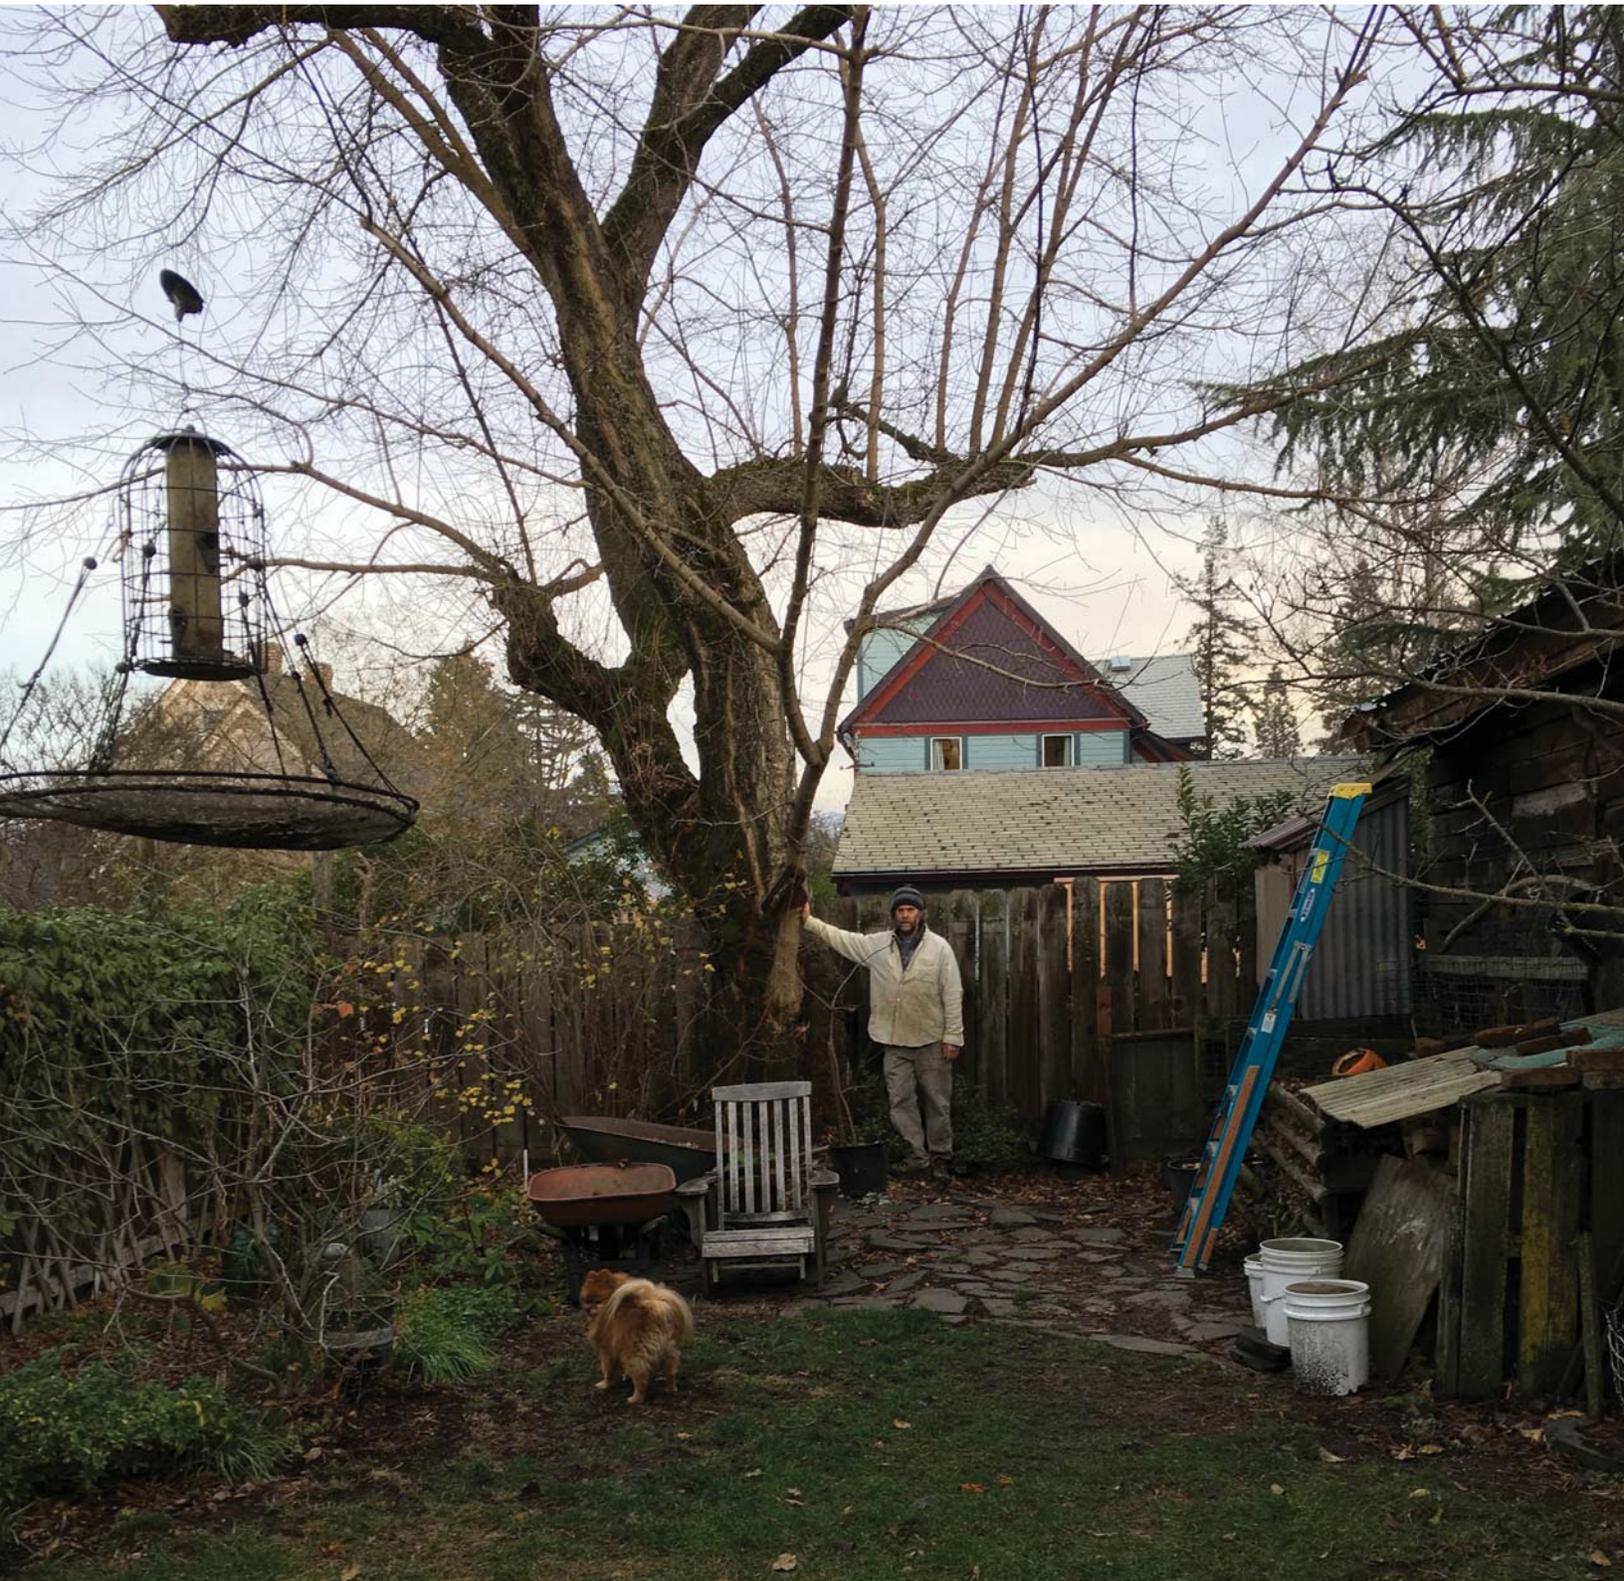
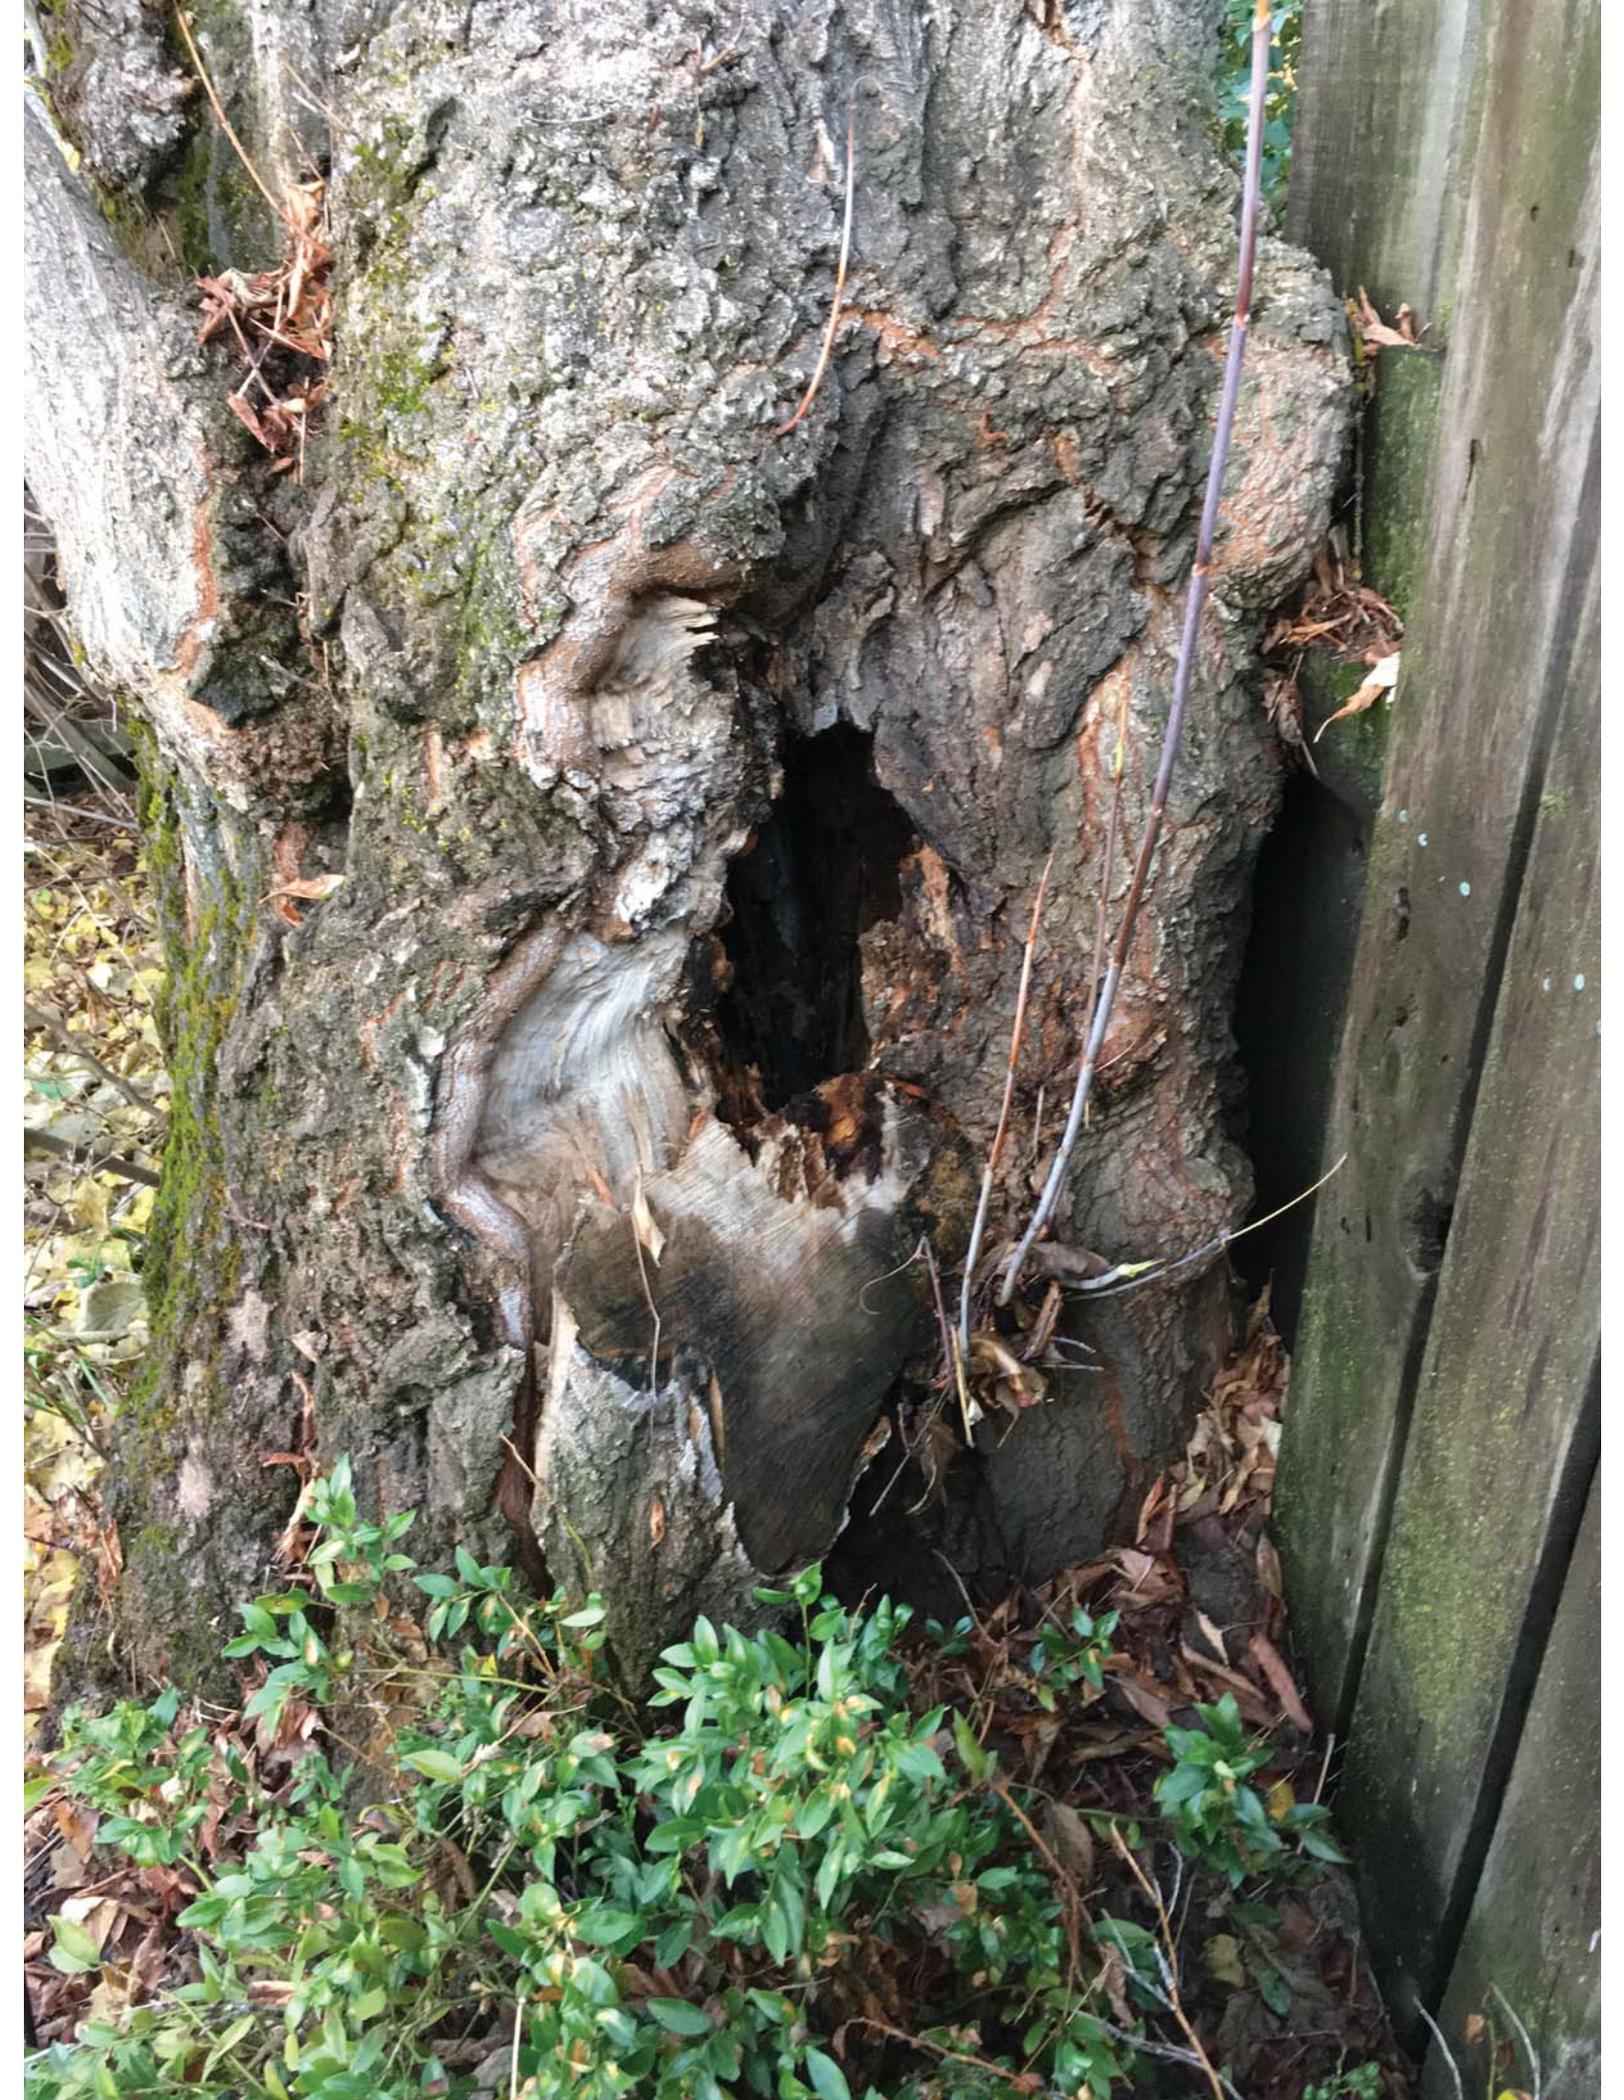
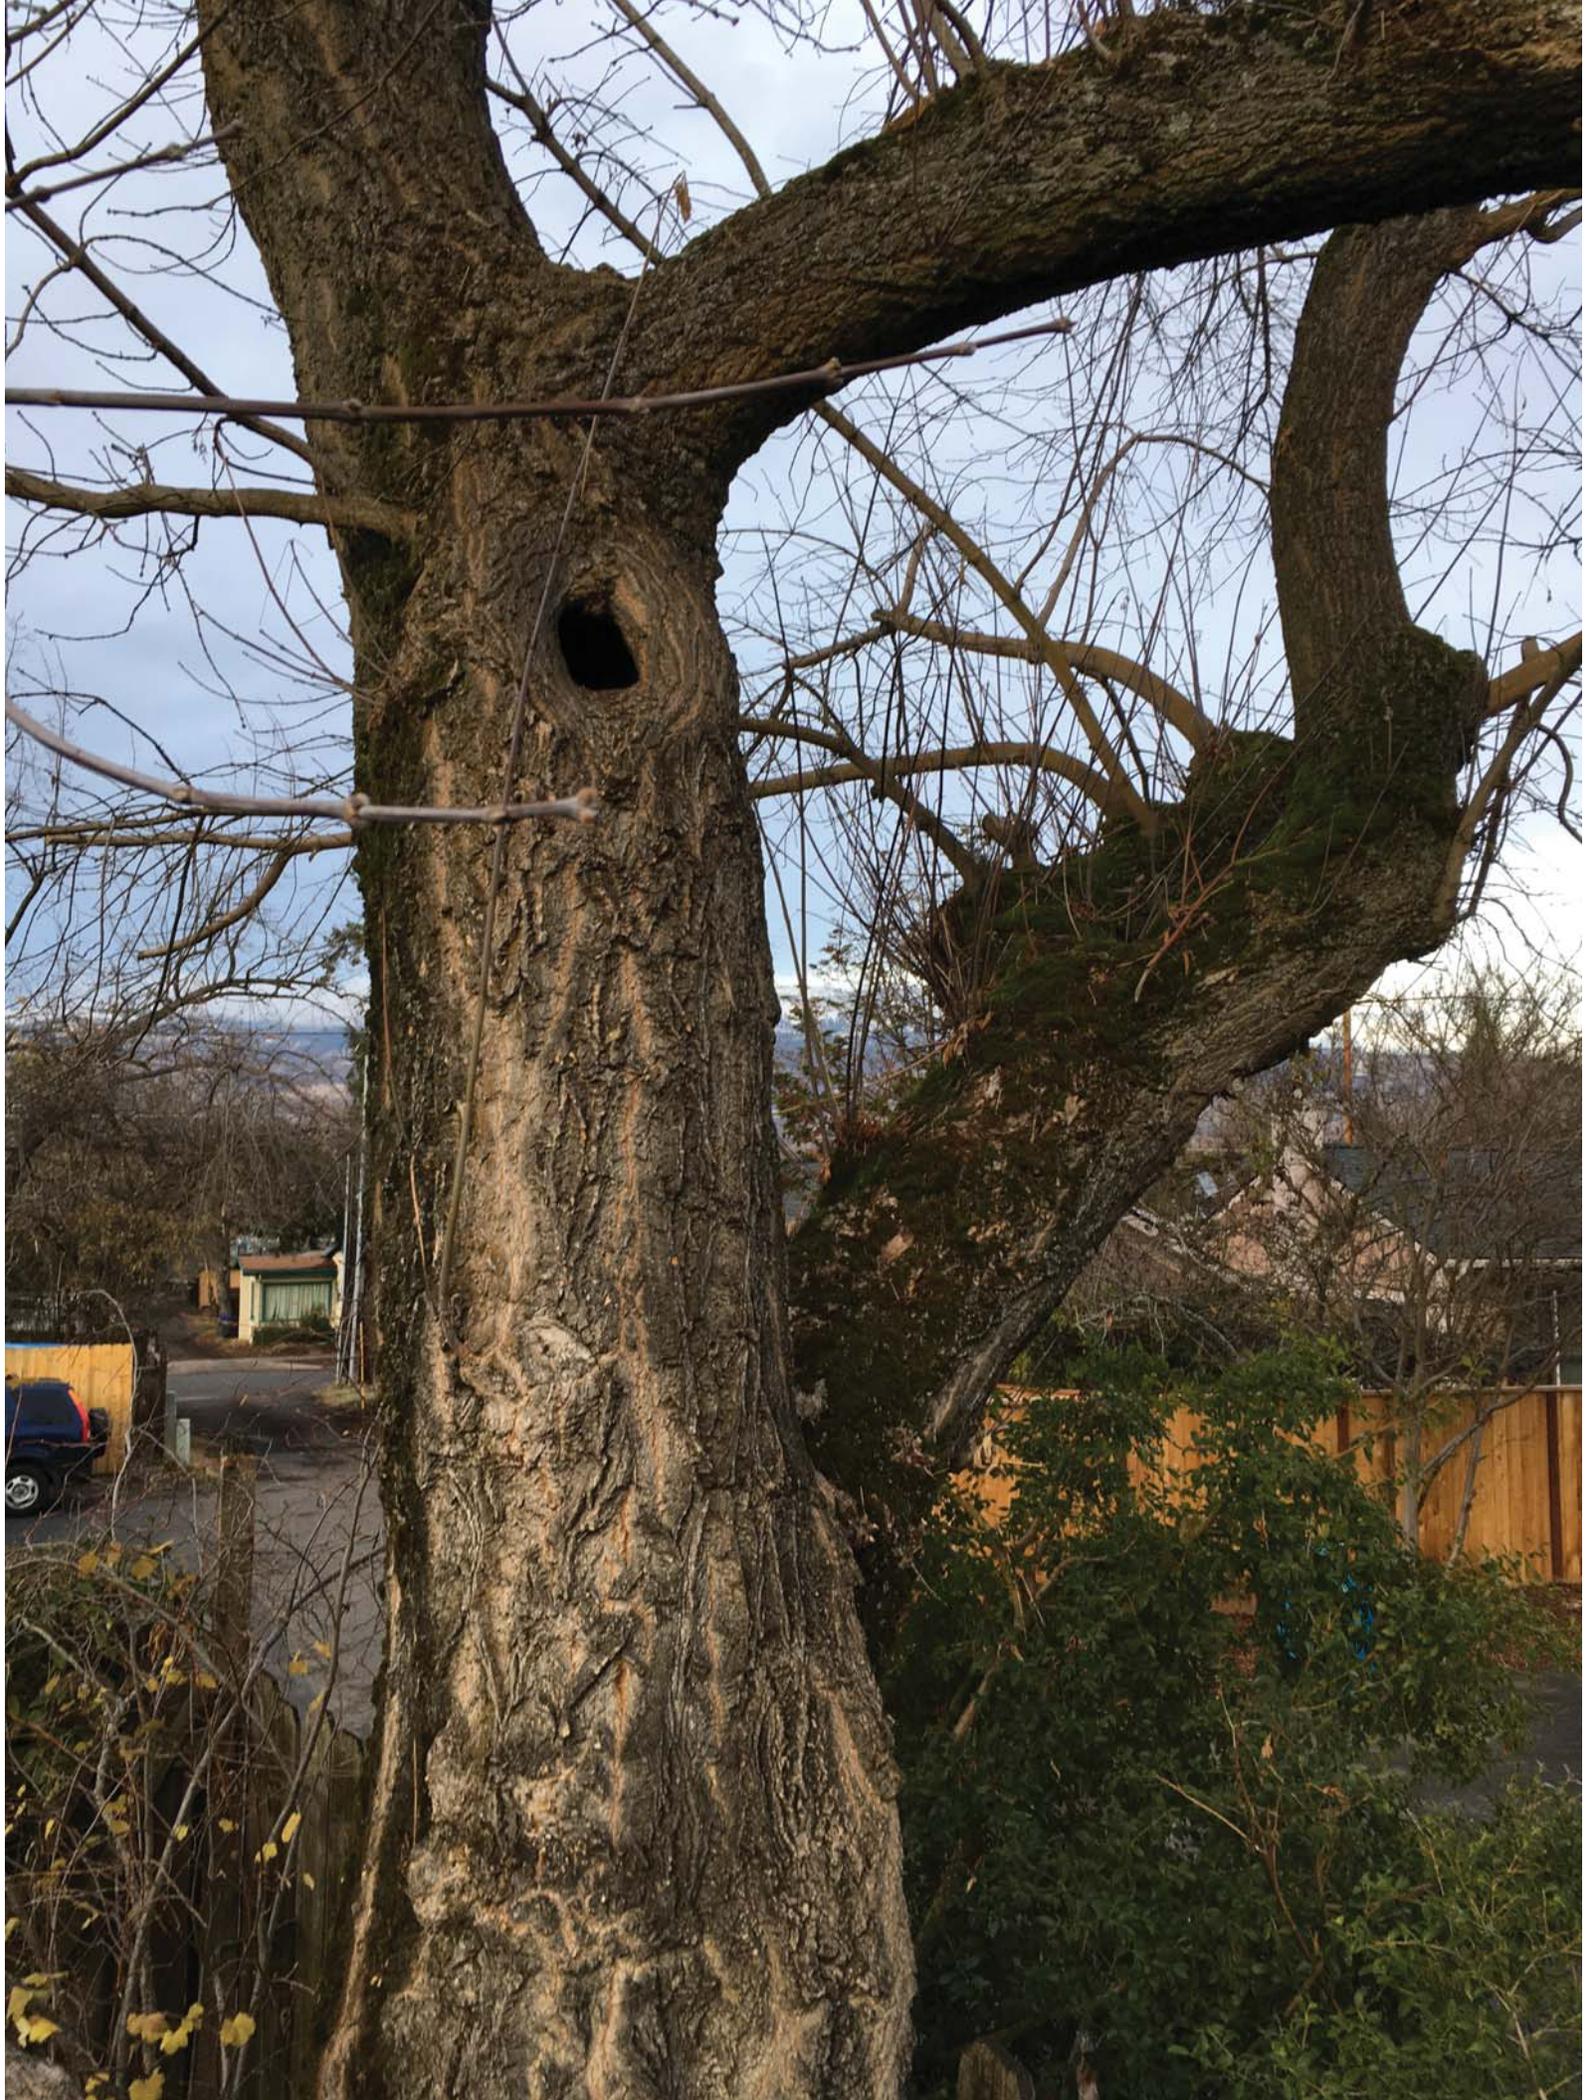
DESCRIPTION: A request for approval to remove one large Box Elder in the back of the property at 60 Fifth St. The tree is described as approximately 30" across and 50-60' tall. The tree has a large cavity about three feet above the ground with signs of extensive decay. The tree has dropped several large branches posing a hazard to pedestrians and vehicle traffic. The application

Though we will dearly miss this tree, we do hope to bring it down safely before it causes problems. Box Elders are not 'strong' sturdy trees & there are enough signs of decay to cause us real concerns. The bigger cavity is visible best from inside our yard. If you would care to examine that, please call & schedule a visit to be sure that our dog does not bother anyone---

Hi Aaron and Tree committee,
Here are some photos of our mature Box Elder located by an alley behind tax lot #7400 in Ashland's railroad district. As I mention in the note included w/ the application for removal, this tree has had limbs breaking off during these last few years. The cavity shown in photo #3617 is so deep I can put my arm all the way into it. That hole is about waist high from the ground, and must be affecting the integrity of the main trunk. We wish to replace this tree w/ a Scarlet Oak, *Quercus coccinea*, during this winter season. We will certainly miss this big established tree, but fear that it will break more and/or fall into the alley-way during the stormy season. We hope that you can approve this take-down and replanting strategy. Thank you for your assistance, Tom Phillips 541-482-4829
