CITY OF ASHLAND

TREE COMMISSION - REGULAR MEETING January 7, 2021 AGENDA

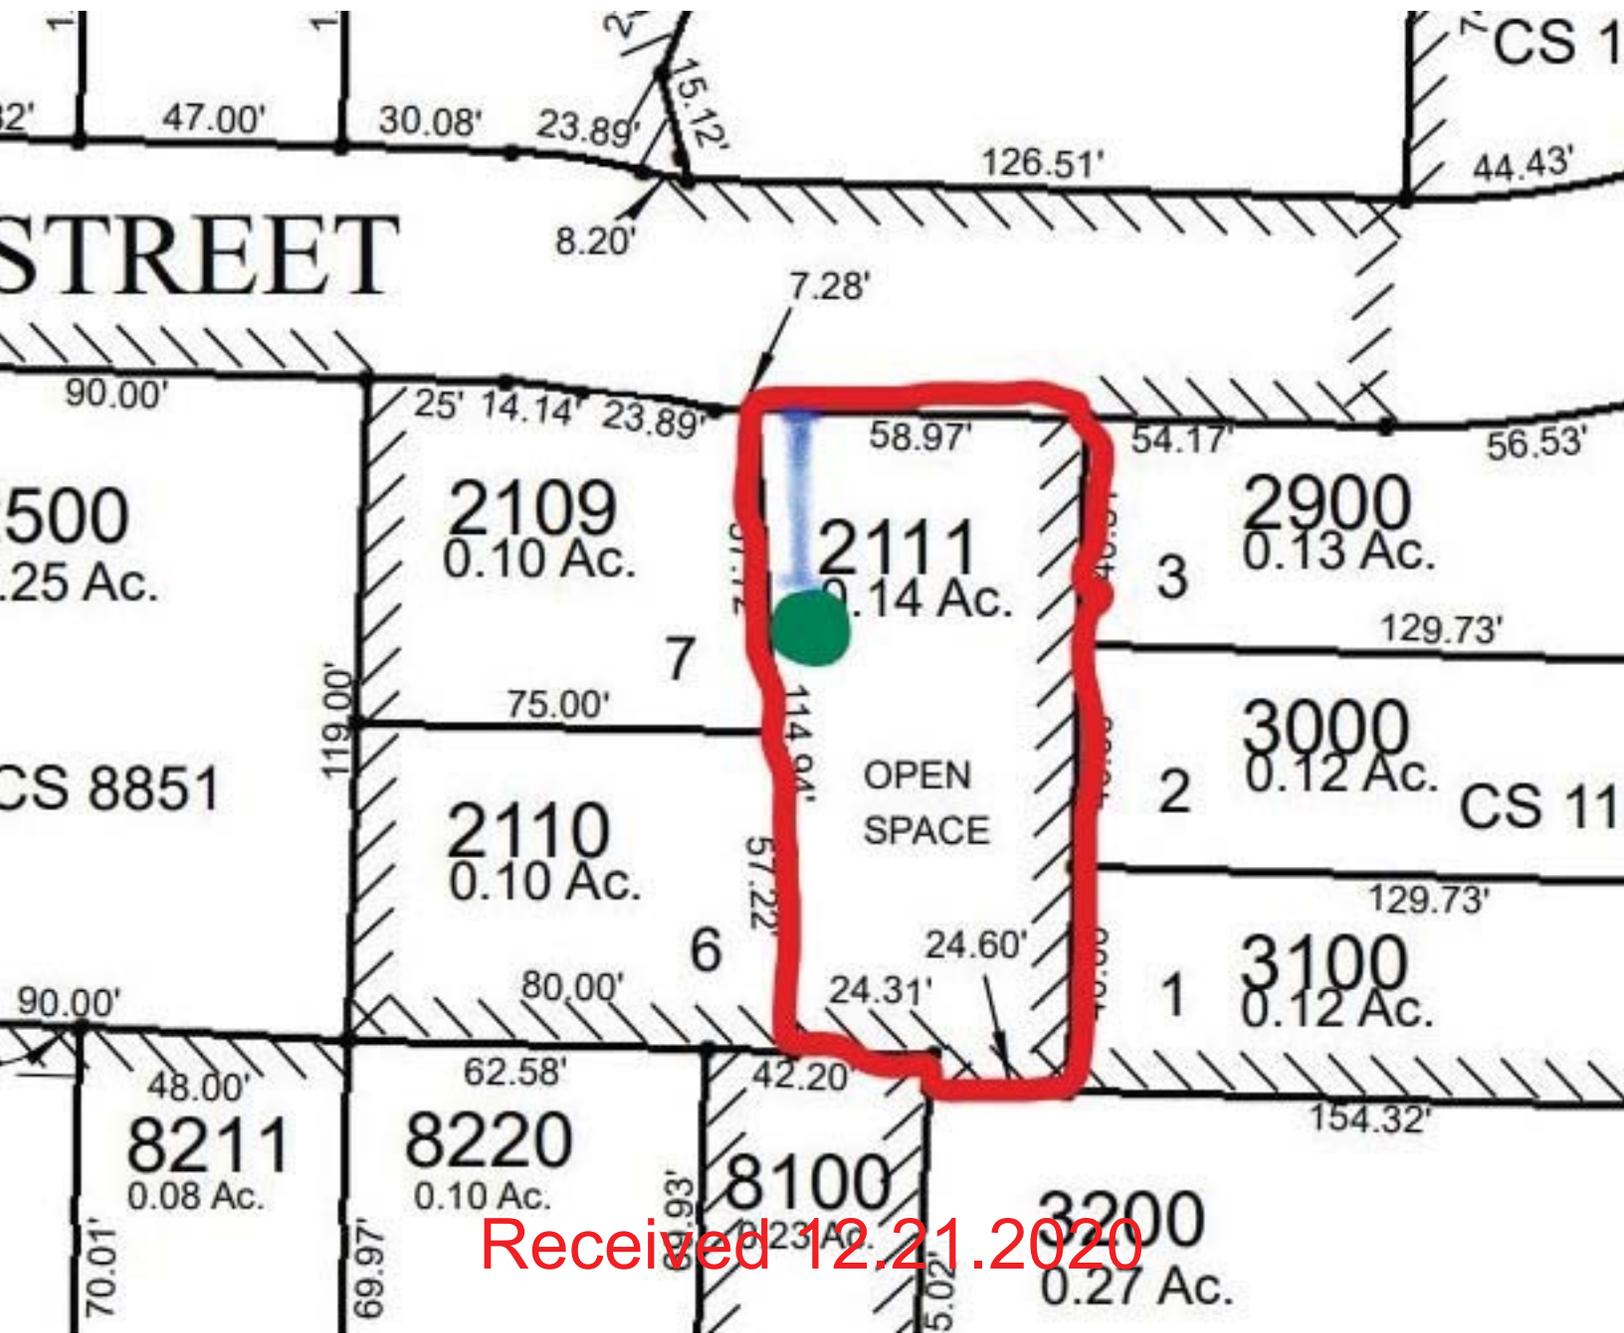
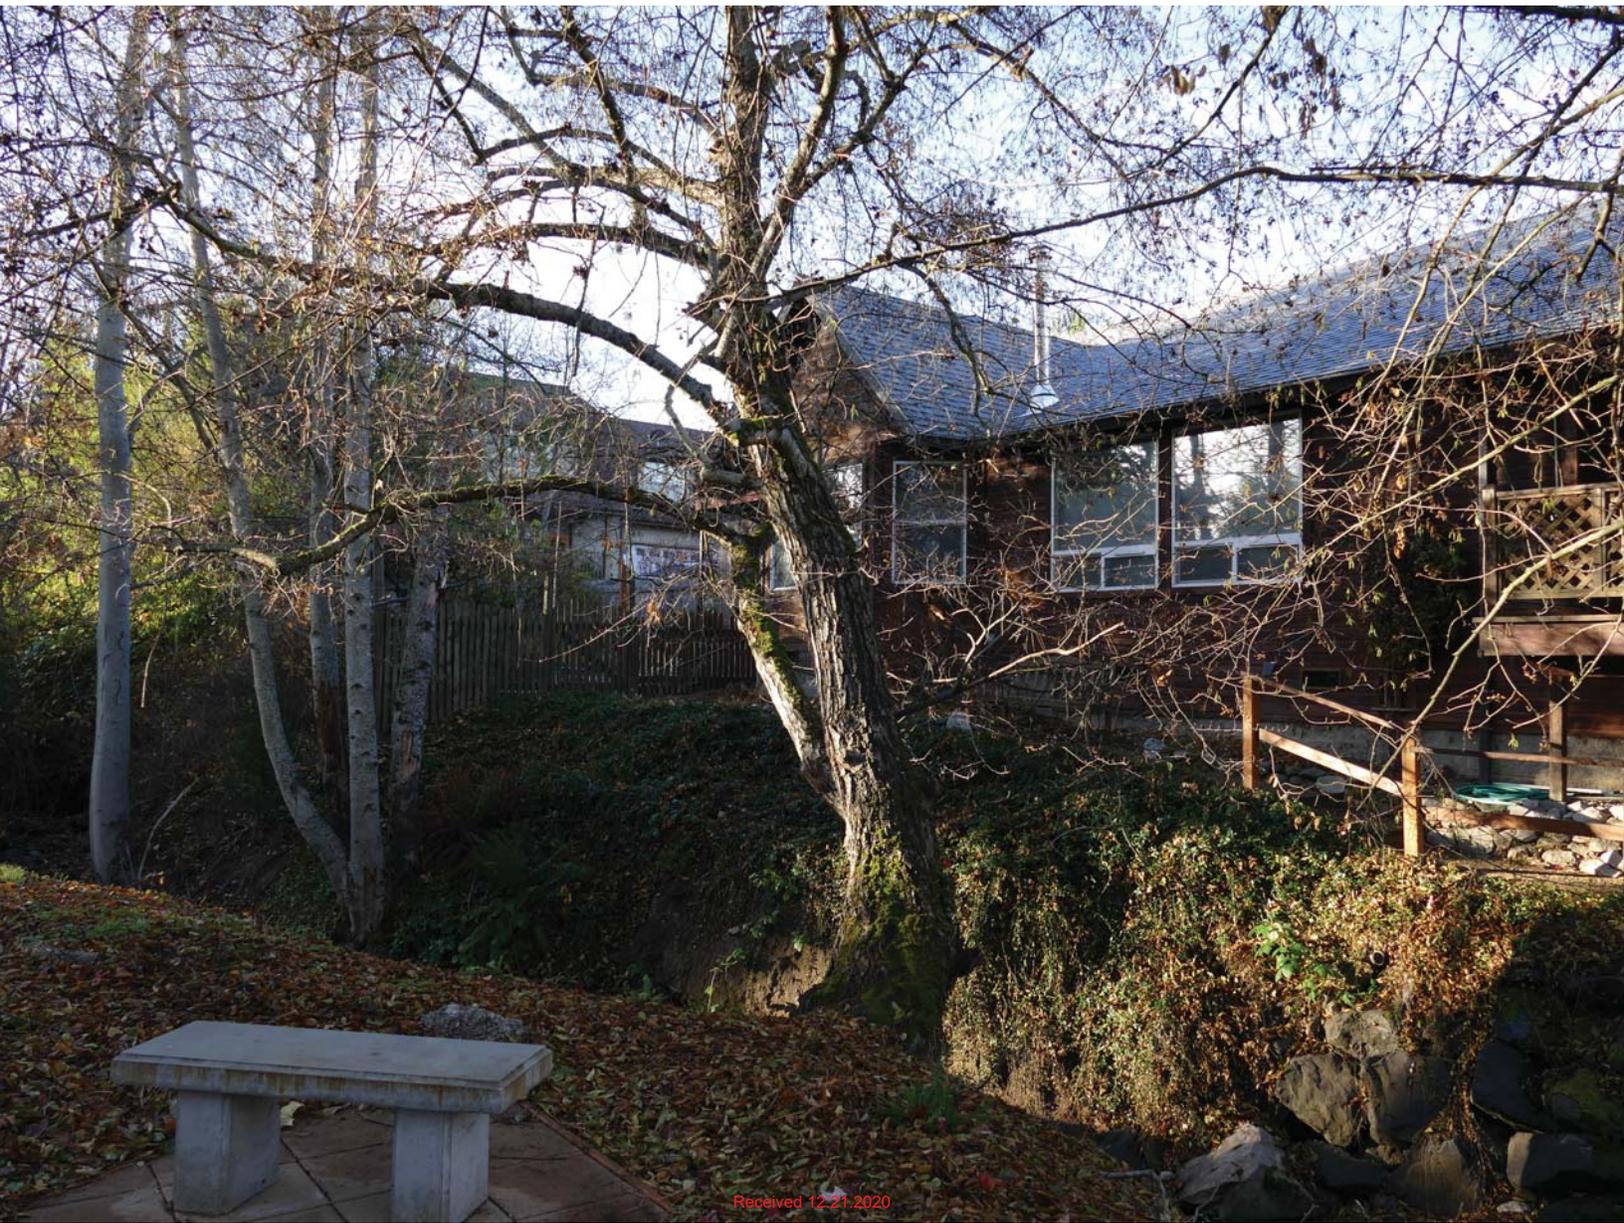
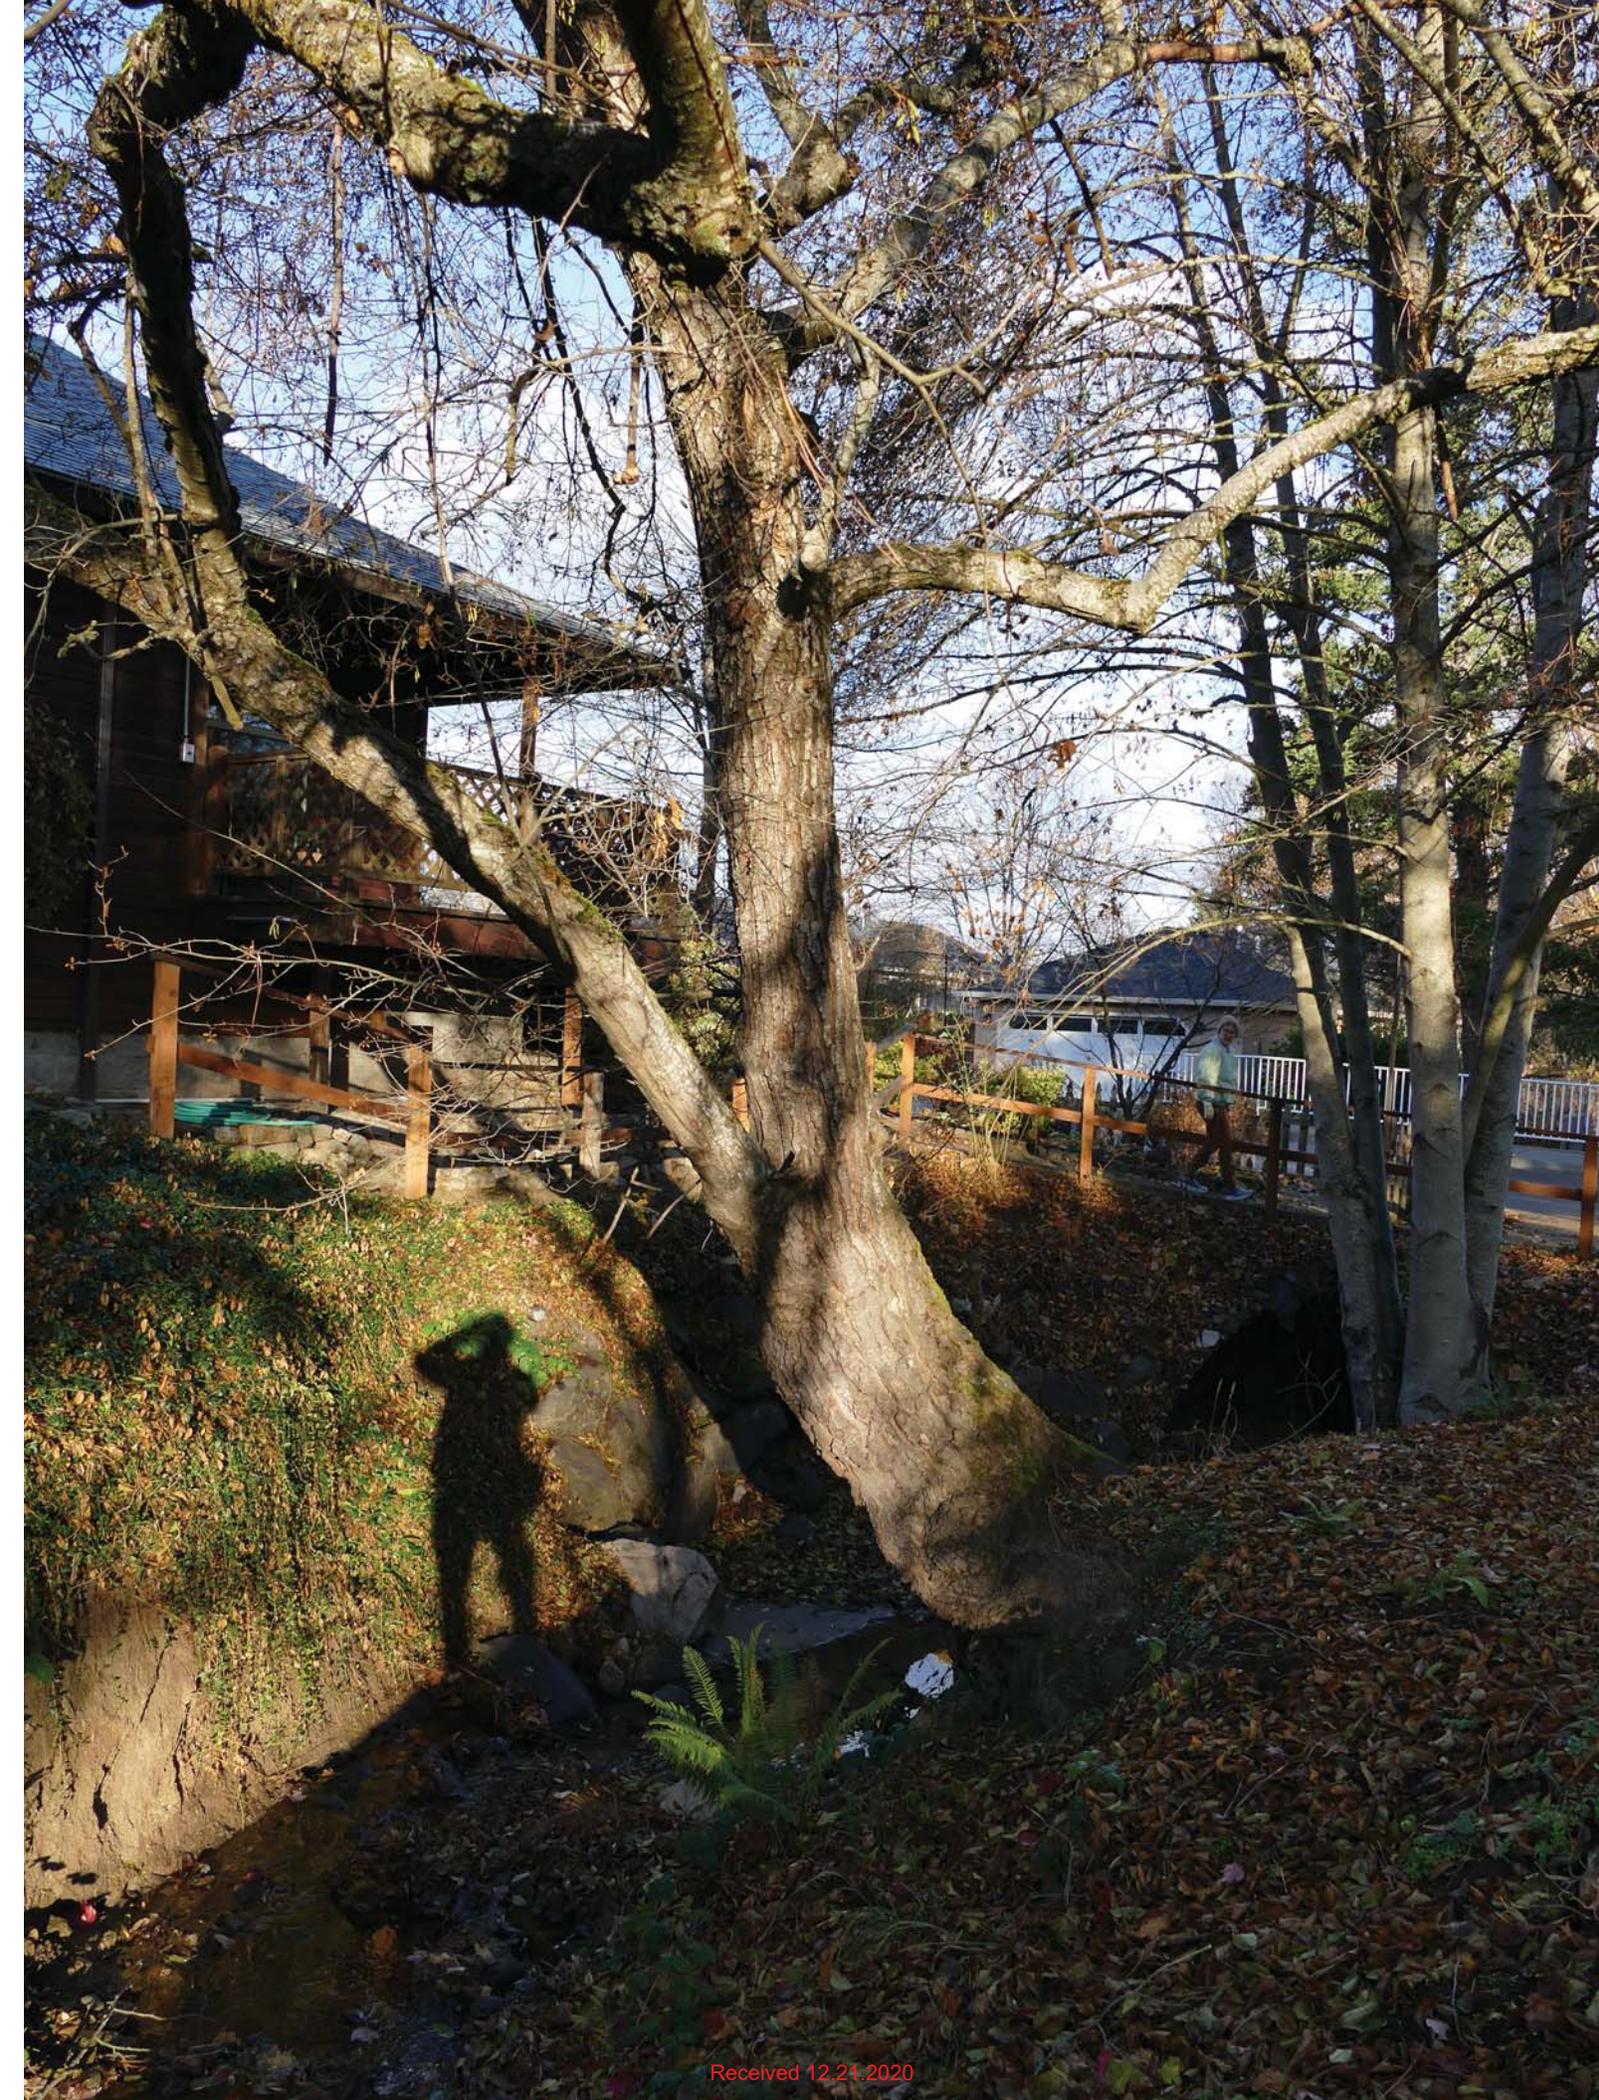
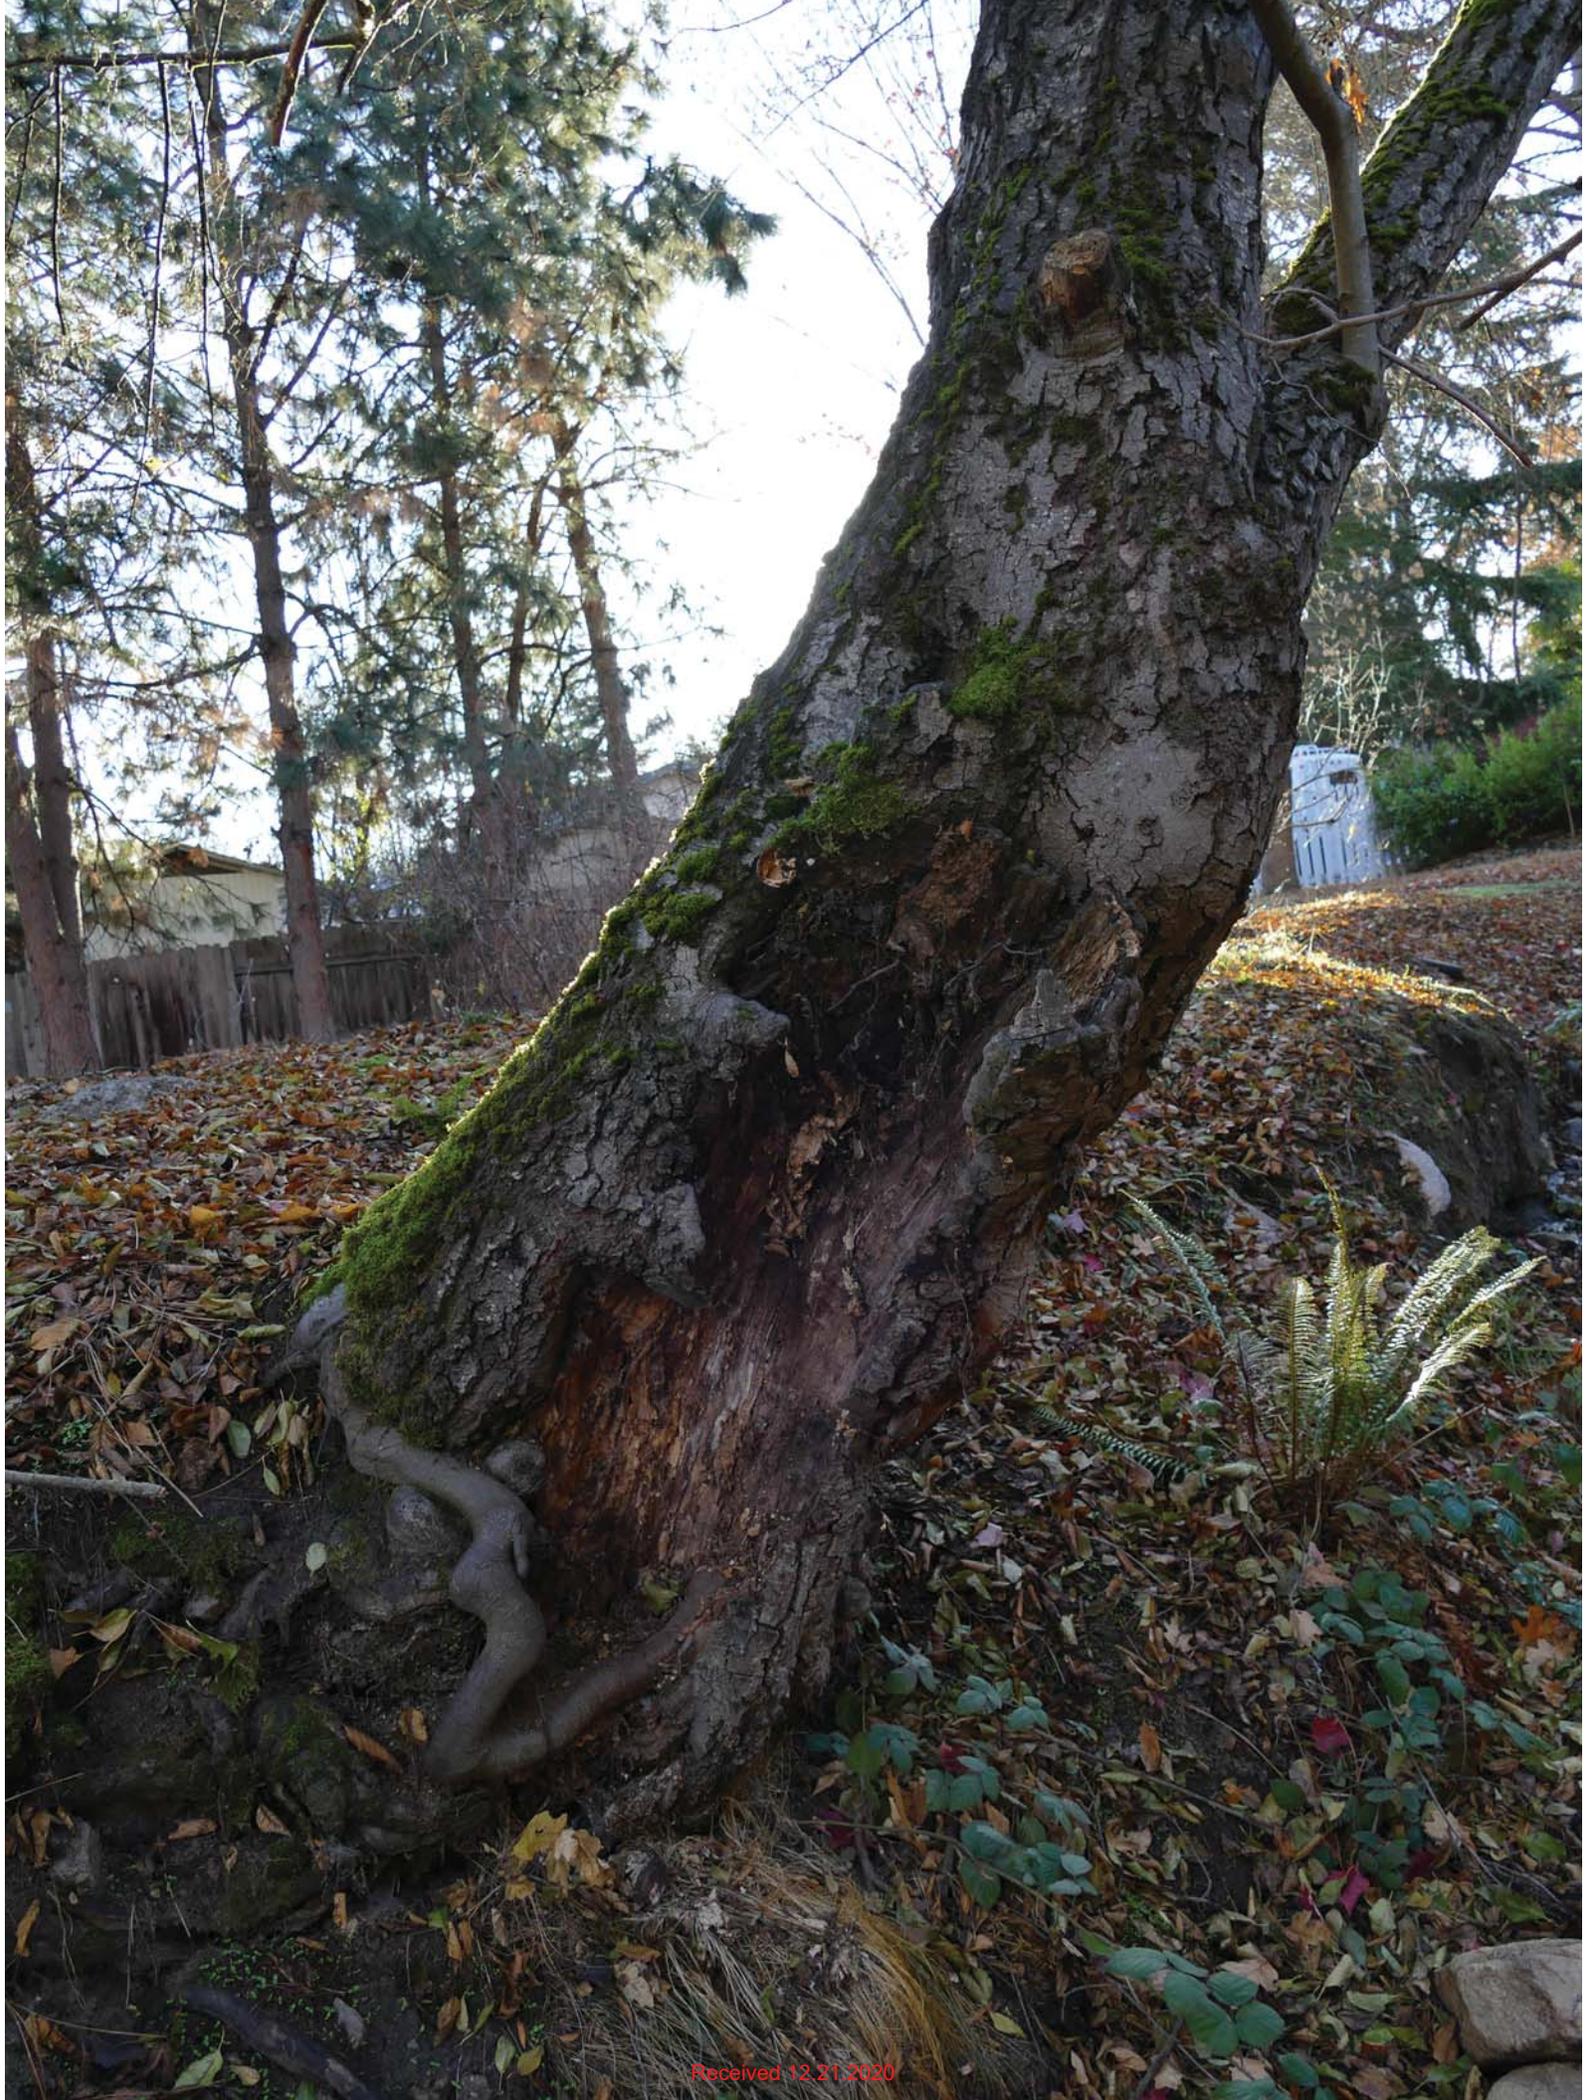
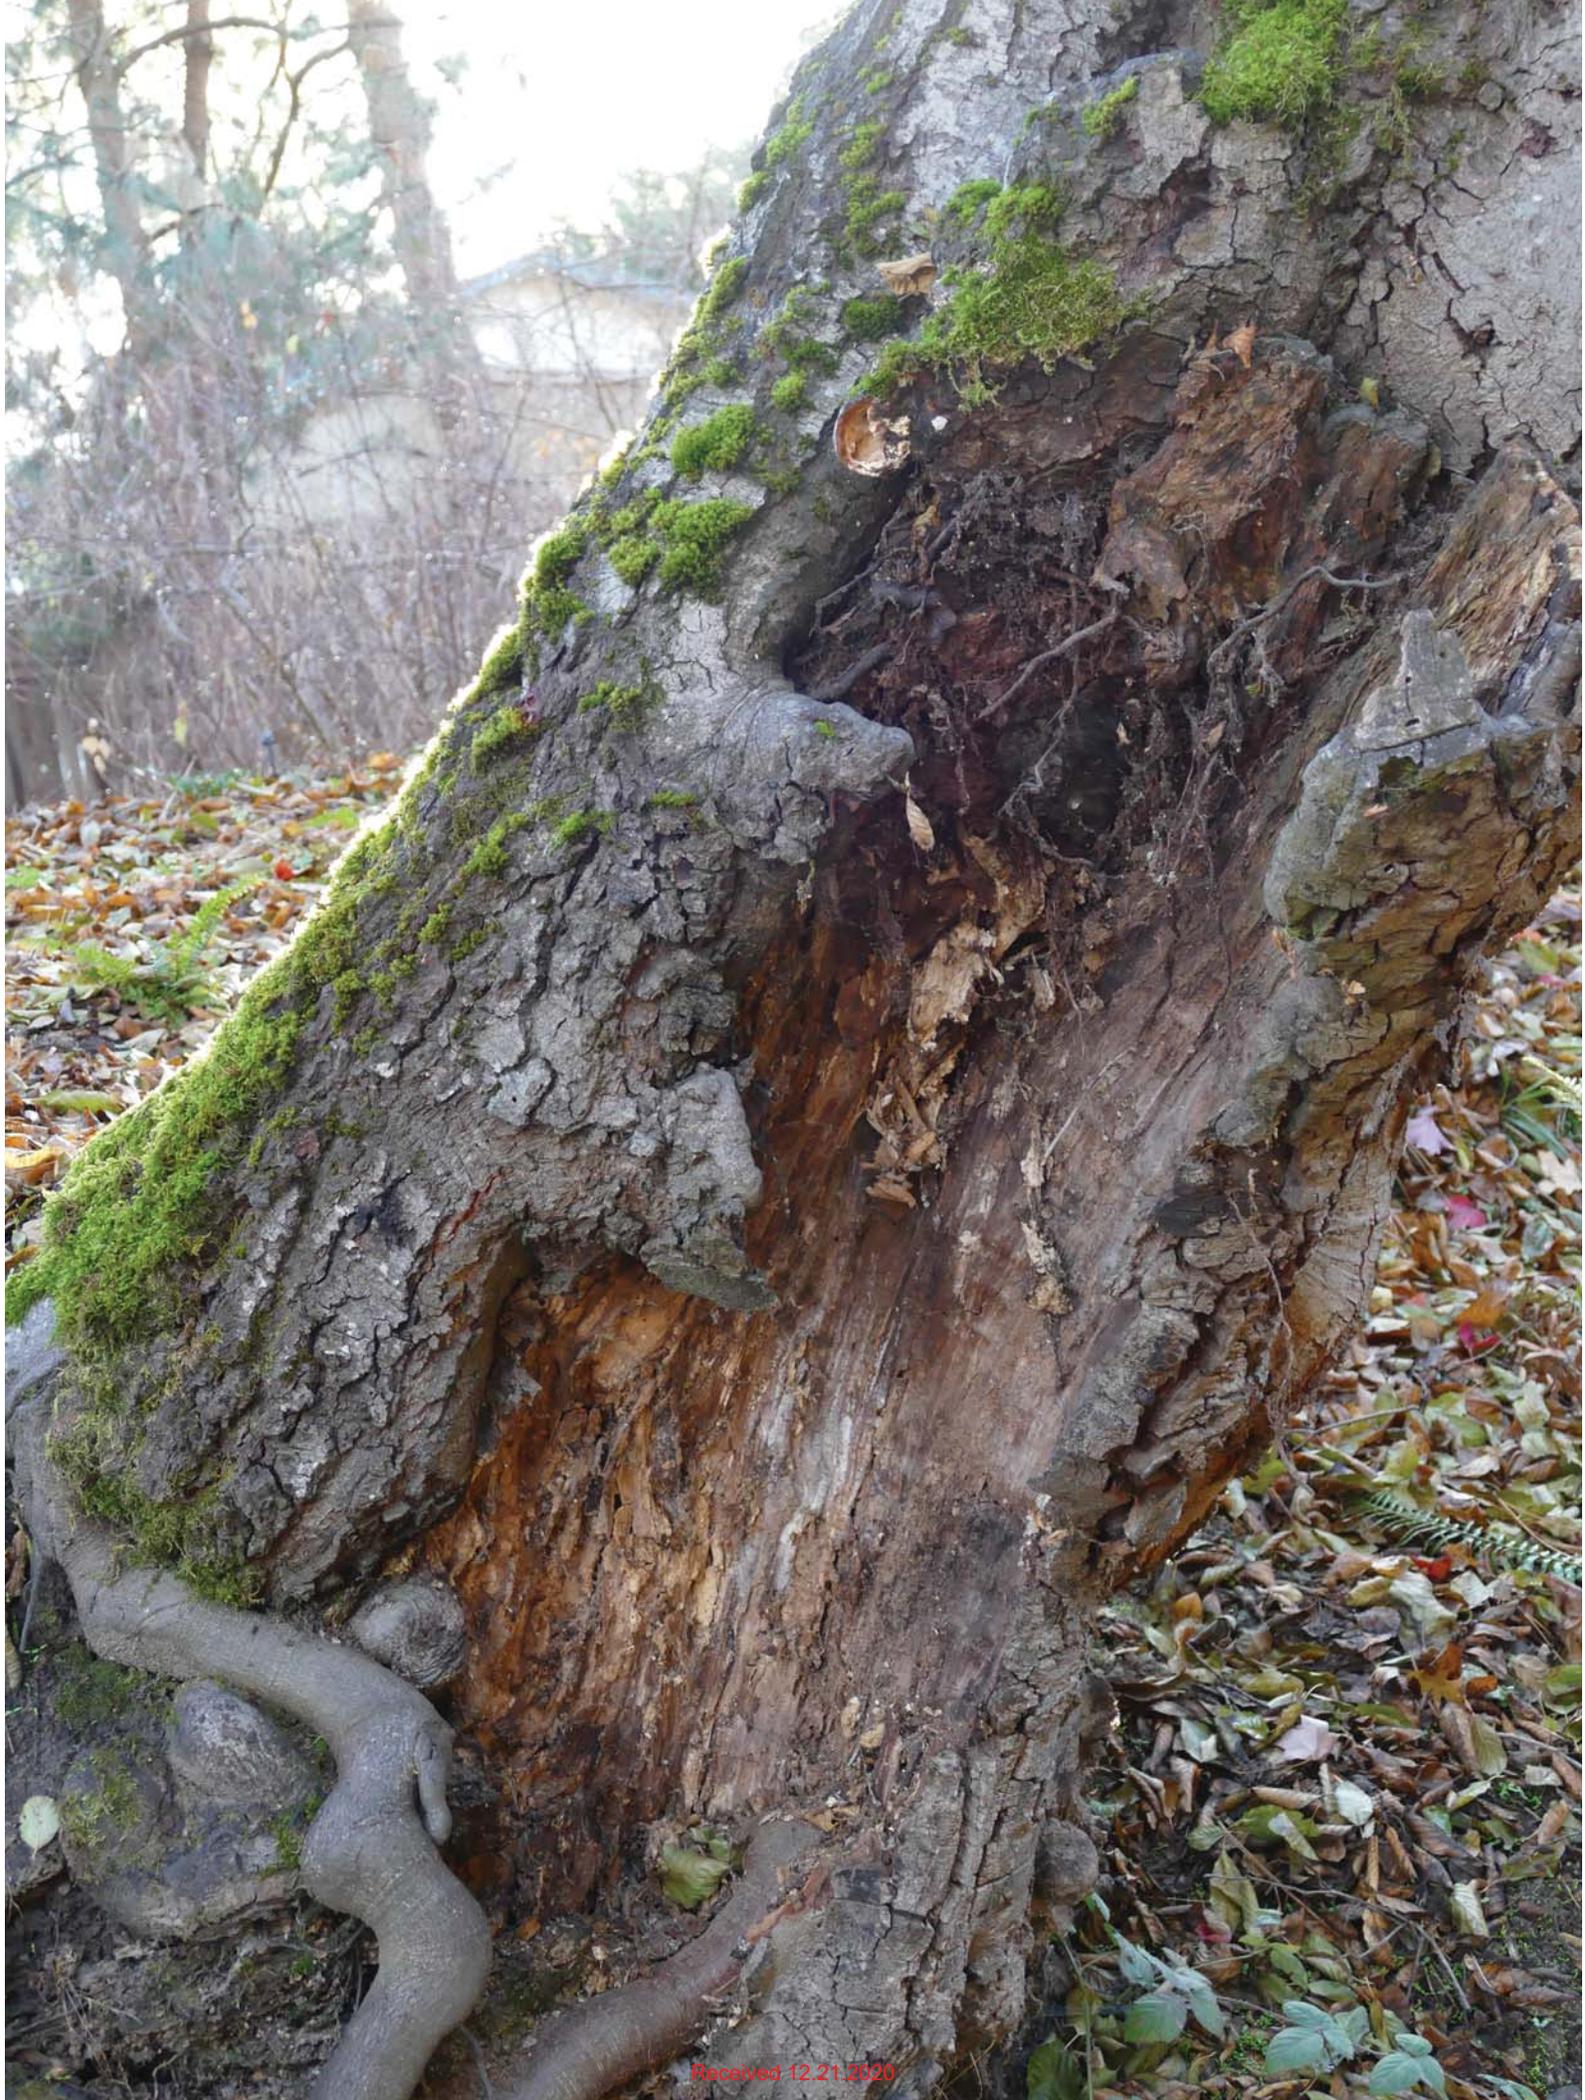
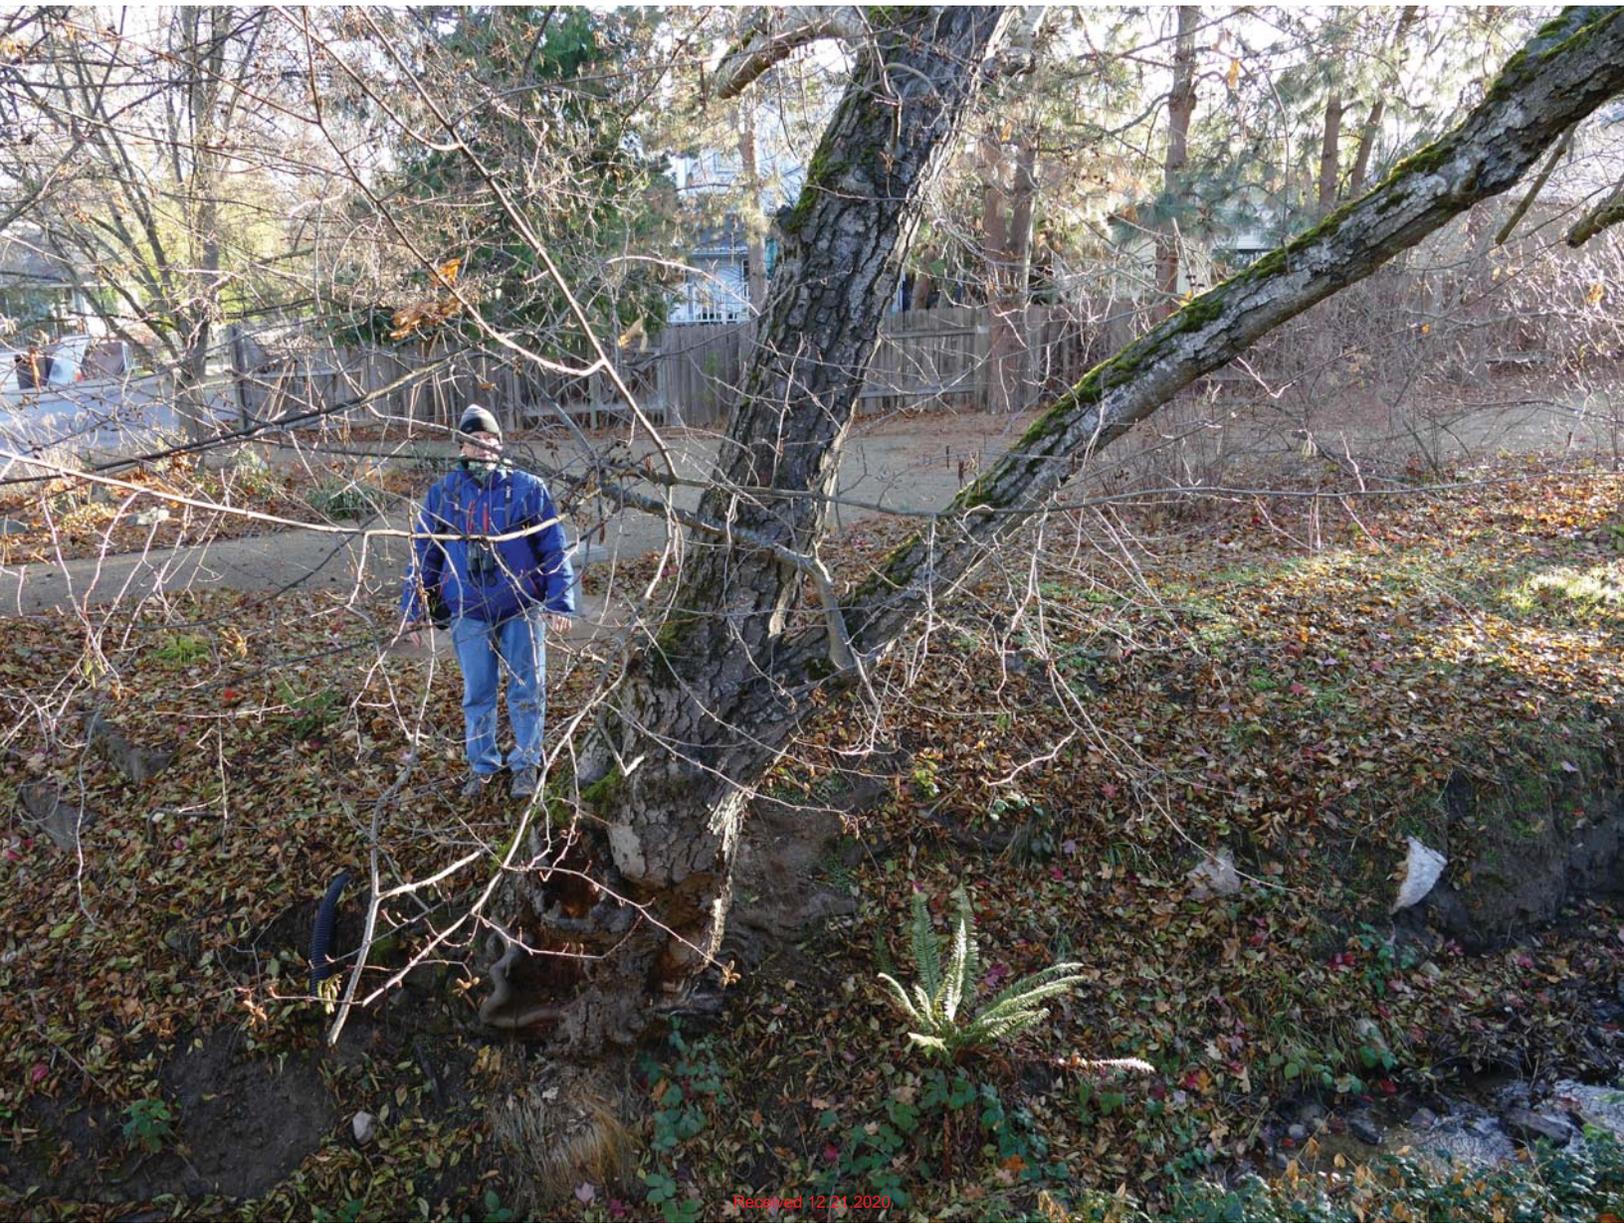
1. The tree to be removed is an alder with a DBH of 96" and is adjacent to Clay Creek and 40' south of Diane Street. The tree is located in an unoccupied common area maintained by the Clay Creek Homeowners Association which consists of 14 lots located in the Diane Street neighborhood. (See Plot map)
2. The tree is expected to be removed as soon as city approval is obtained and is to be replaced by a 1 ½" caliper Oregon Ash in the area further back from Clay Creek.
3. The tree is rotted near the base of the trunk as can be seen from pictures included with the tree removal application. It appears to be a hazard tree in that it presents a public safety hazard that cannot be alleviated by further pruning, treatment or relocation. (See letters from Victor's Tree Service and from neighbor, Mary Kay Michelson))

In my opinion I believe that this tree presents an immediate and present danger of falling and would likely result in damage to the adjacent structure. If you have any questions please contact me at the above number.

I am writing in support for the Clay Creek Homeowner's Association's plan to remove the large Alder tree that is on the ^{east} bank of Clay Creek. For some years now, I have been concerned that this tree could fall in the direction of my home, which is on the other bank of that same creek. It leans in the direction of my house and is sufficiently tall to damage my roof and the side of the house. I have watched it suffer increasingly dead sections for the past five years and notified the Association after securing bids to remove it. Due to a shortage of funds, the association could not previously remove it, and more and more branches have failed since that time.

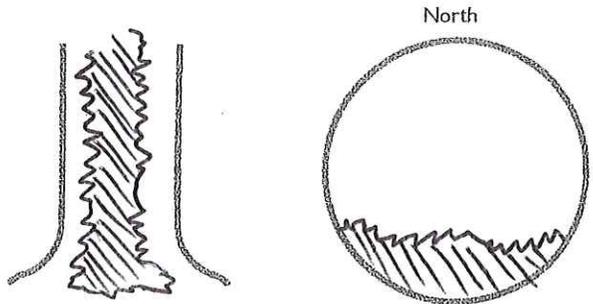
Notes, explanations, descriptions
SUNKEN BANK, Oozing, DEAD
TISSUE AS NOTED IN DIAGRAM

- Mitigation options
1. REMOVE & REPLACE WITH APPROPRIATE SPECIES Residual risk _____
 2. _____ Residual risk _____
 3. _____ Residual risk _____
 4. _____ Residual risk _____
