Remedial Action Plan

Lithia Springs Property
555 Emigrant Creek Road
Ashland, Jackson County, Oregon
ECSI ID 5384

Prepared by:
Stantec Consulting Services Inc.
225 NE Hillcrest Drive, Suite 5
Grants Pass OR 97526-3547
Phone: 541.479.0050

October 15, 2015

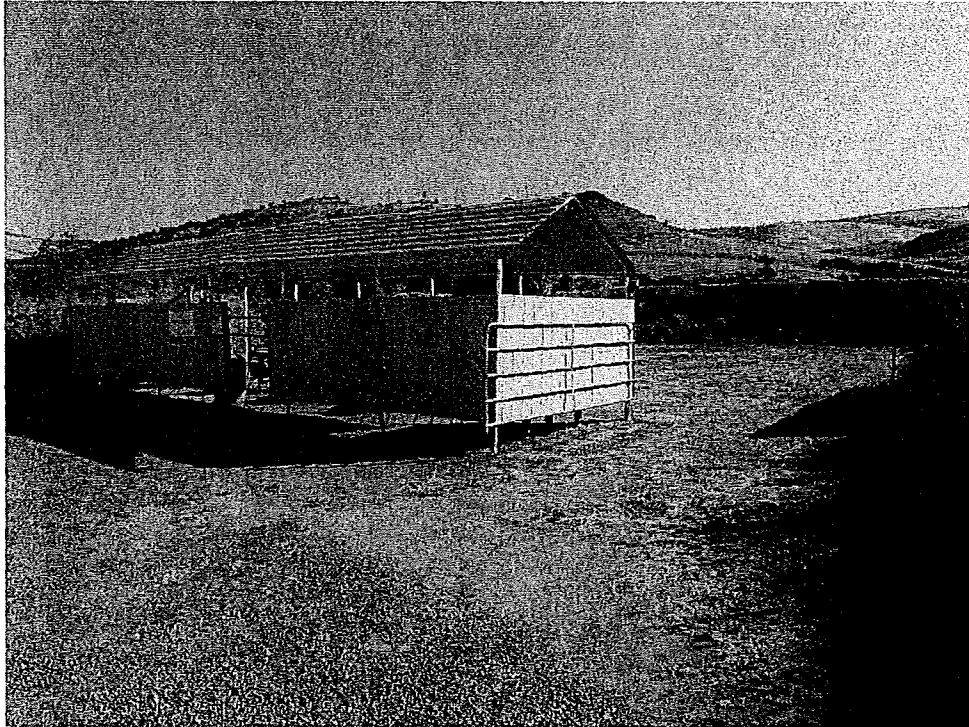
Photo 1

Law Enforce Range firing line shed with impact berm.

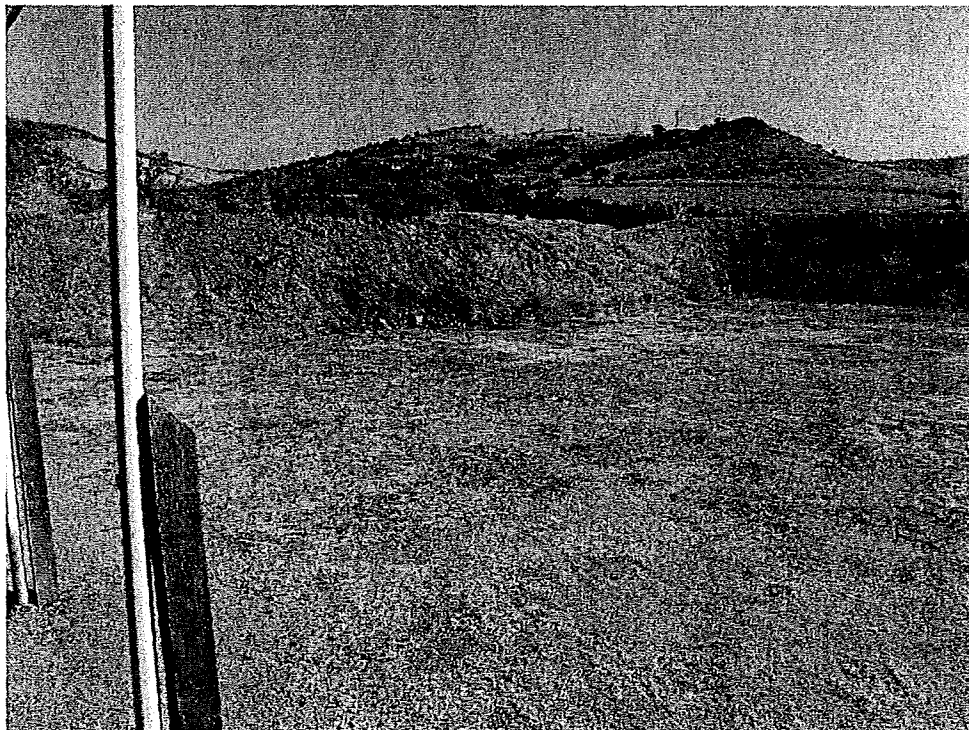
Photo 2

Law Enforce Range side berm. Note additional material deposited recently from City of Ashland.

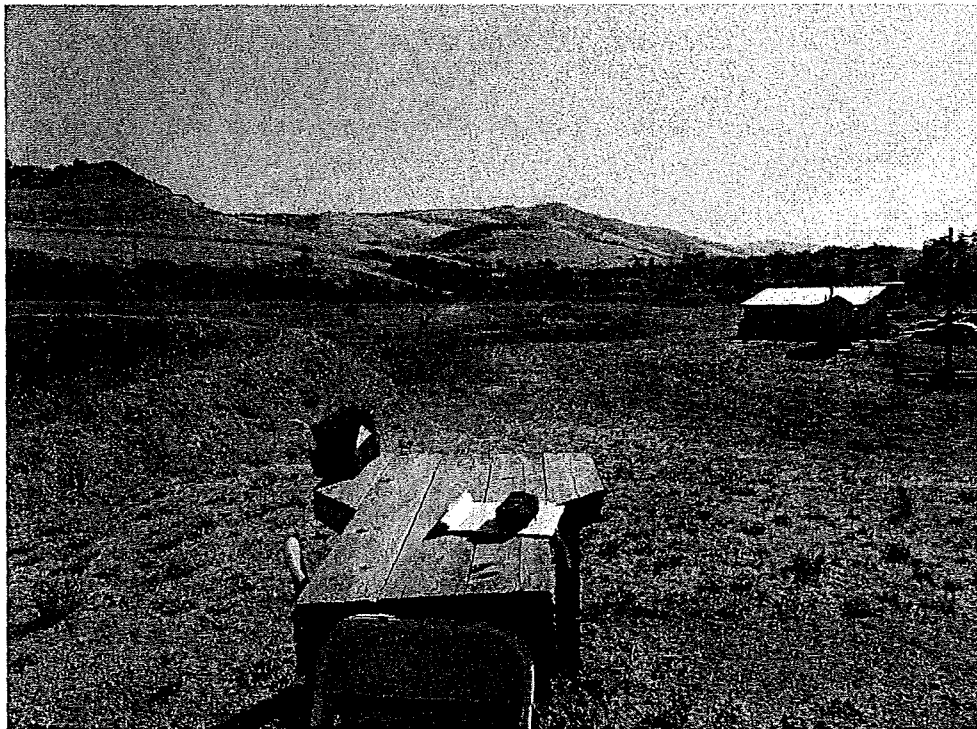
Photo 3

600 Yard Range shooting bench. Most use occurs in prone position on flat area adjacent to the bench. Range is used infrequently, and only when other ranges are closed and a Range Safety Officer is present.

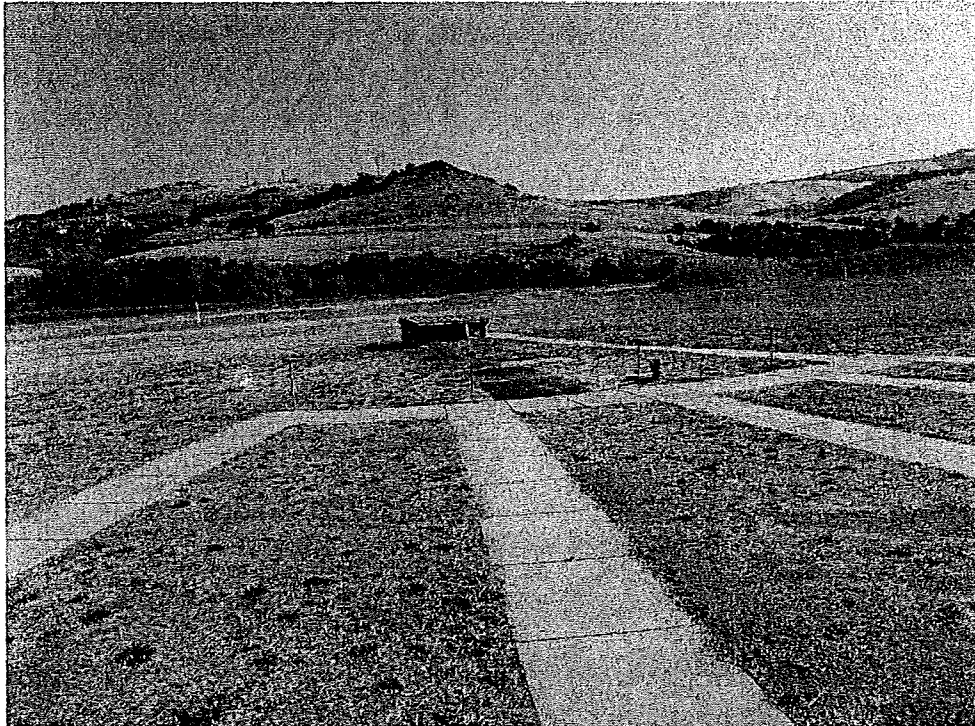
Photo 5

Trap range with shot fall zone in background.

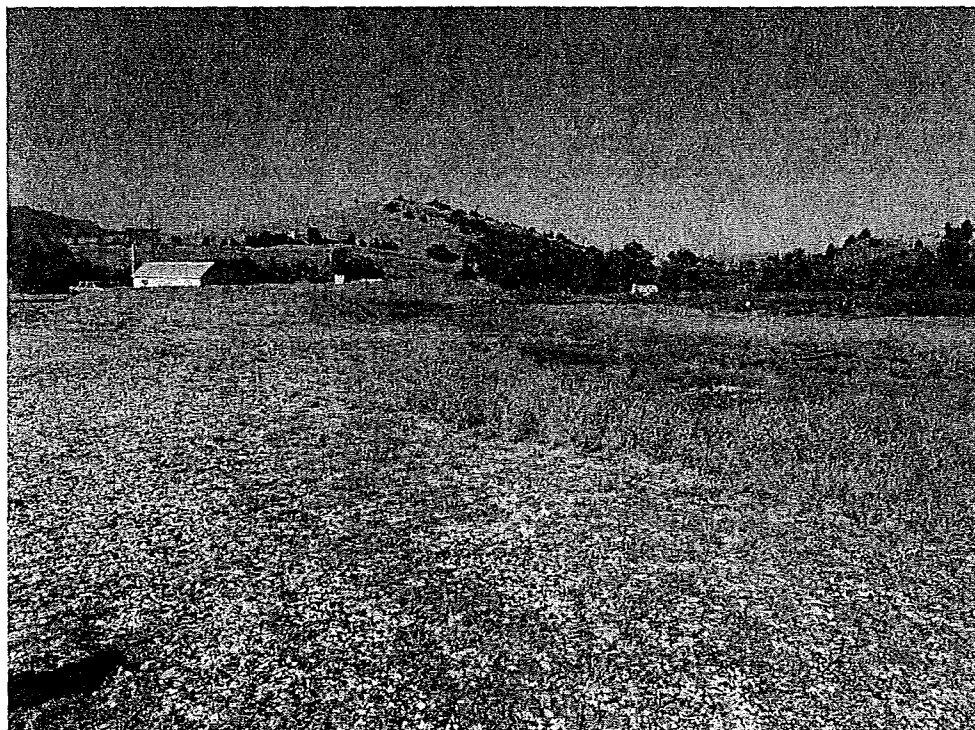
Photo 6

Edge of shot fall zone for trap, skeet and sporting clays range.

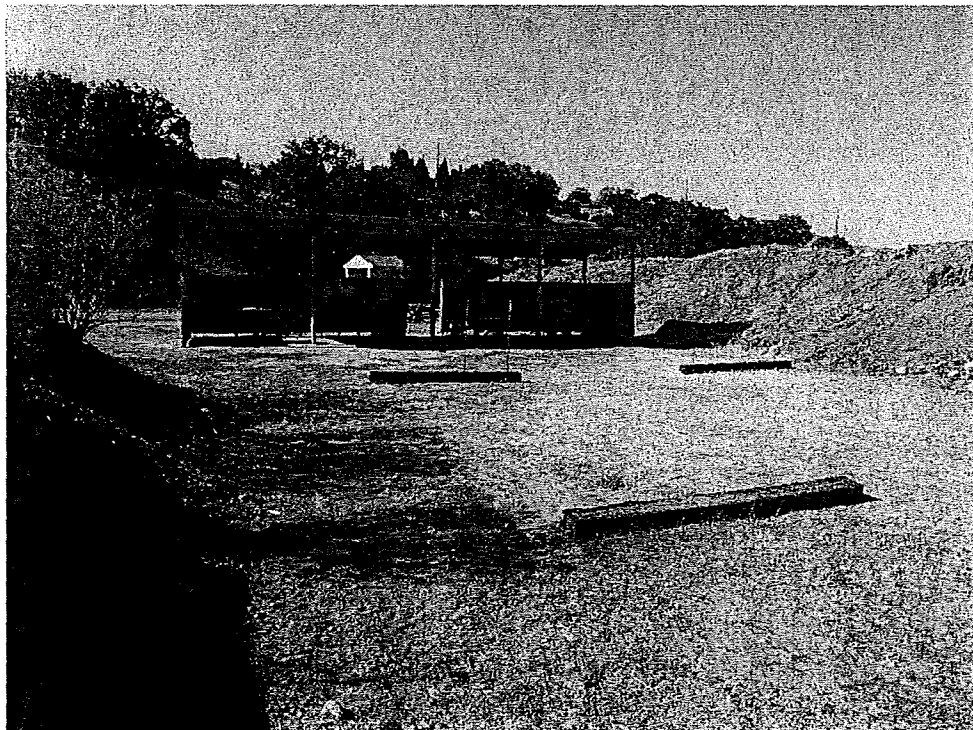
Photo 8

Pistol Bay #1 firing shed and side berms.

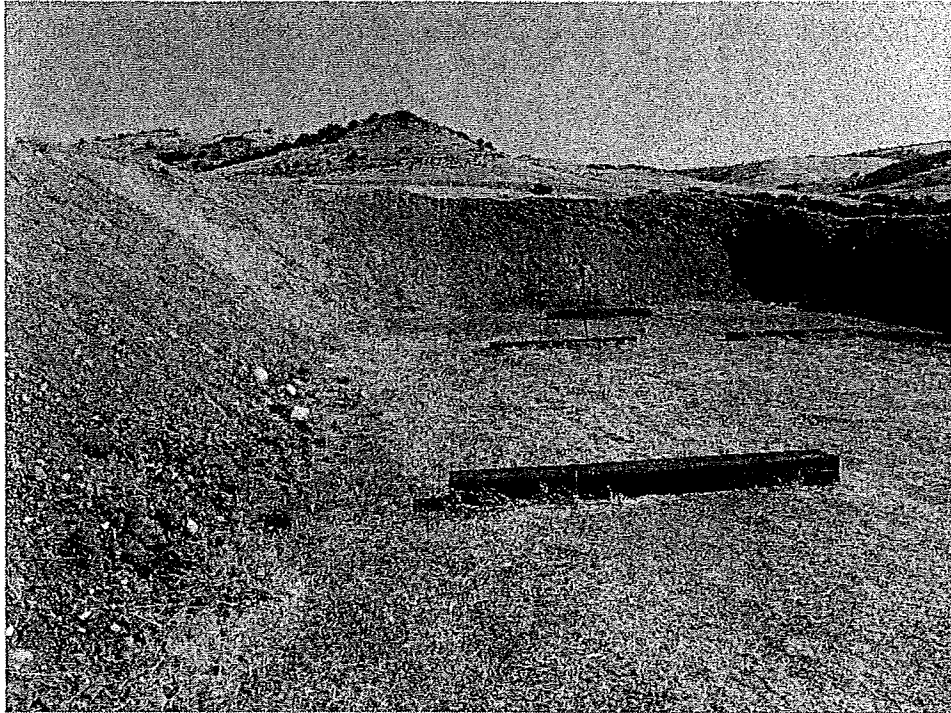
Photo 9

Pistol Bay #2 bullet impact berm and side berms.

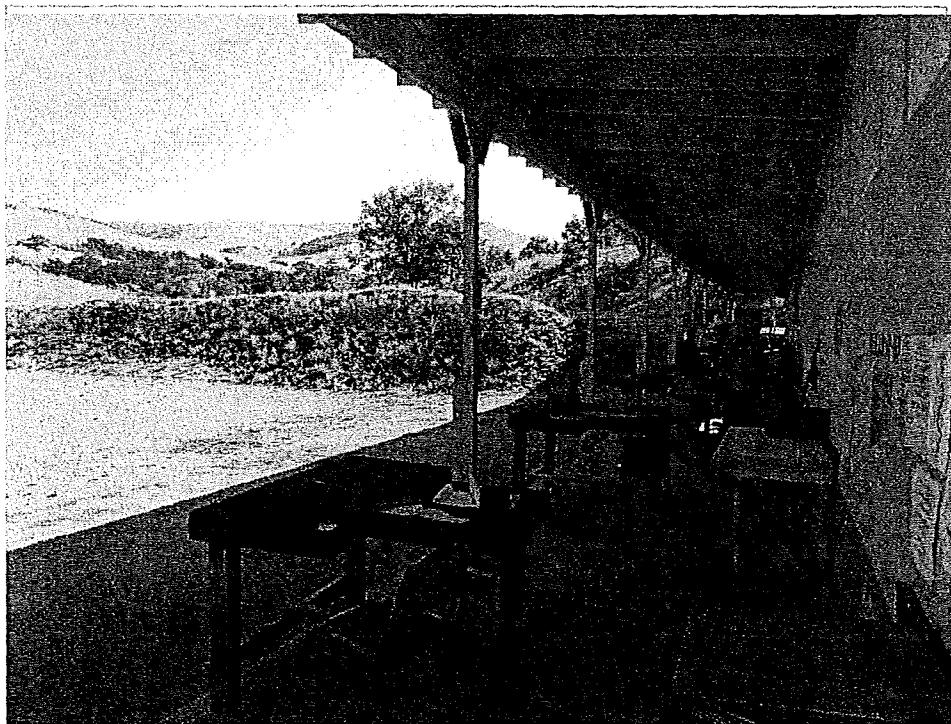
Photo 10

50 Yard Range firing positions. 50 Yard Range shares one firing line shed with the 100/200/300 Yard Range. Side berm in background separates the 50 Yard Range from the 100/200/300 Yard Range.

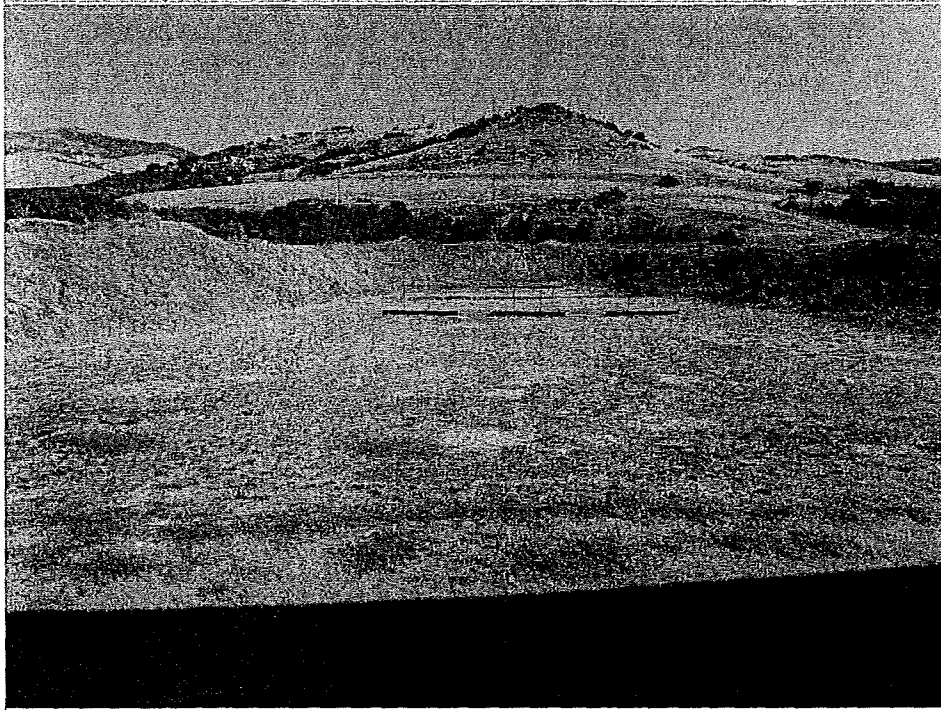
Photo 11

50 Yard Range bullet impact berm and side berms.

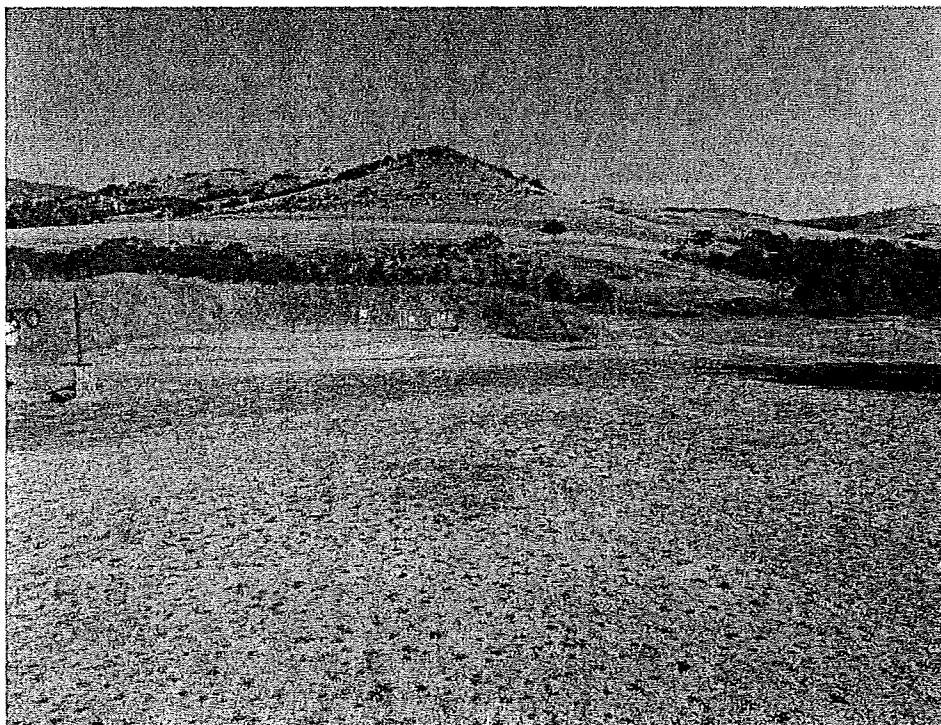
Photo 12

100/200/300 Yard Range targets at 100 and 200 yards target area with impact berms. The 300 and 600 yard impact berm is on the right side of the photo.

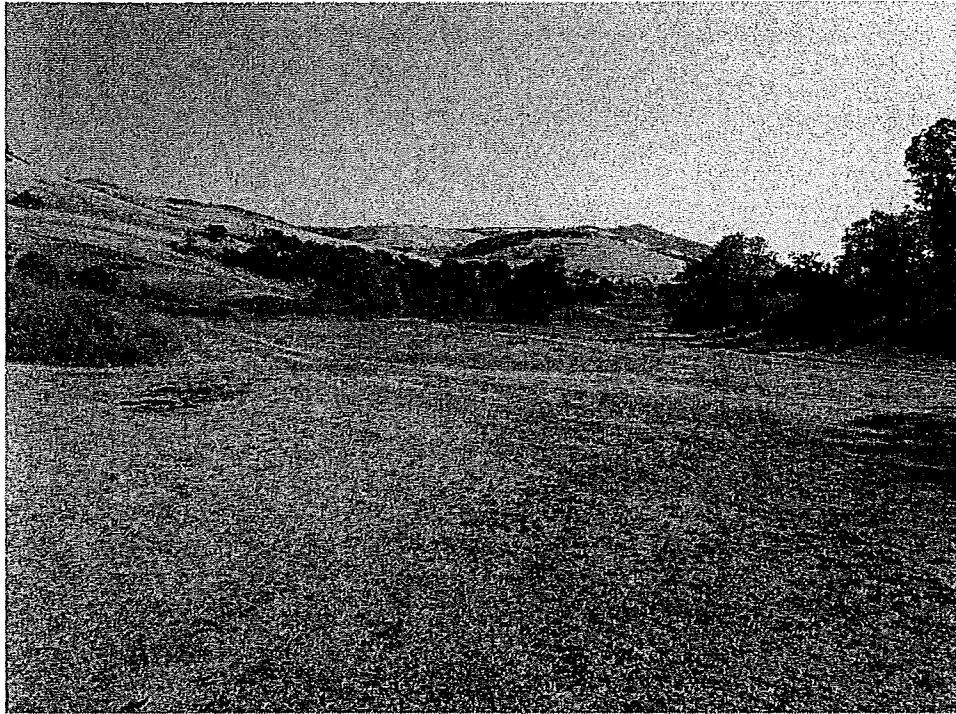
Photo 13

100/200/300 Yard Range vegetated range floor. The 300 and 600 yard target area with impact berm in the distance.

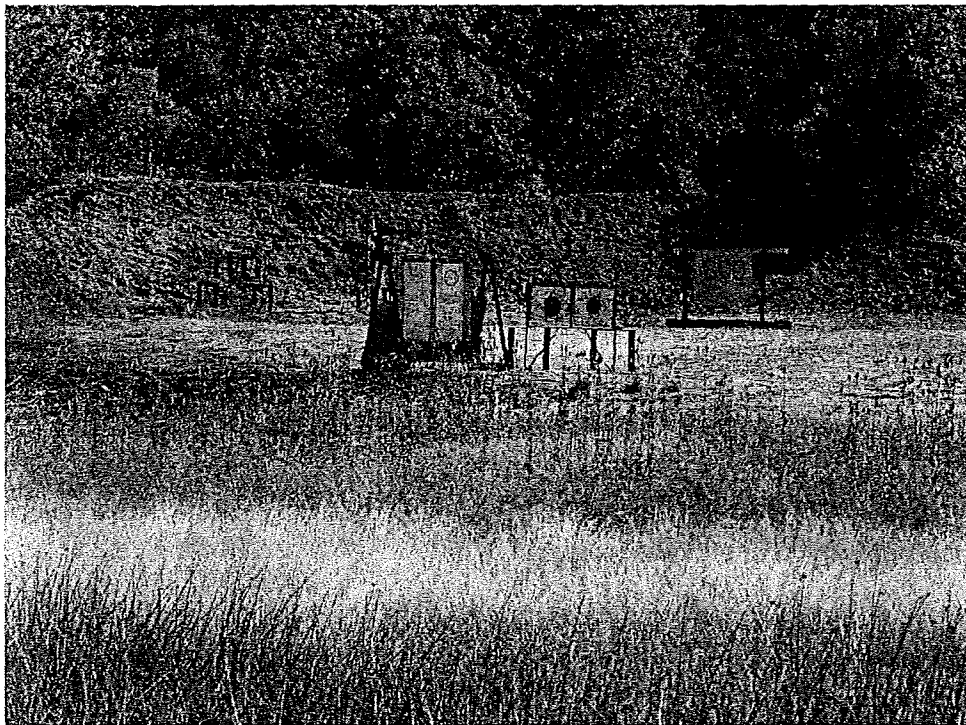
Photo 14

300 and 600 yard target area with bullet impact berm.

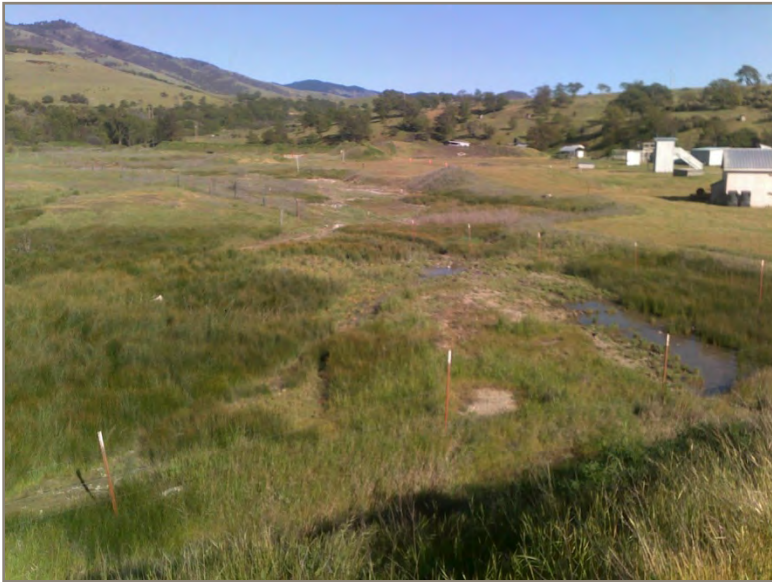
Photo 1: Filling, grading and berm construction seen for Gun Club purposes. Photo overlooking Wetland 3.

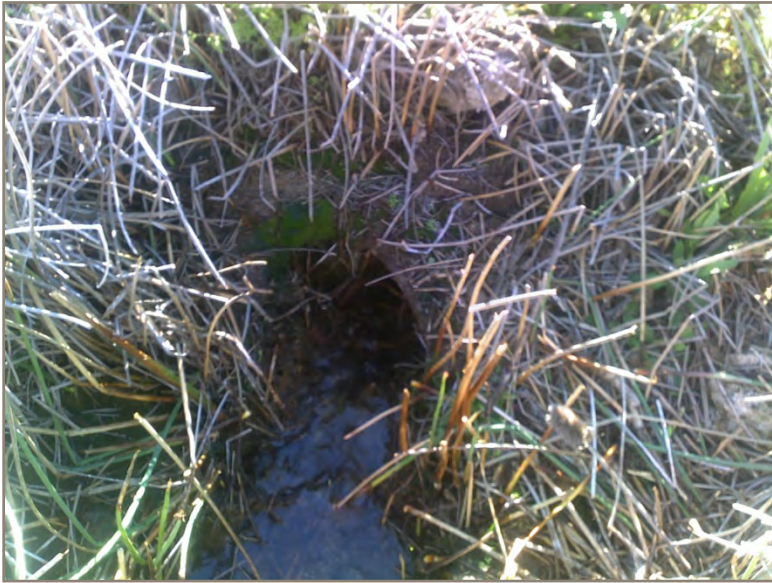
Photo 5: Culvert connecting Wetland 2 and Wetland 3.

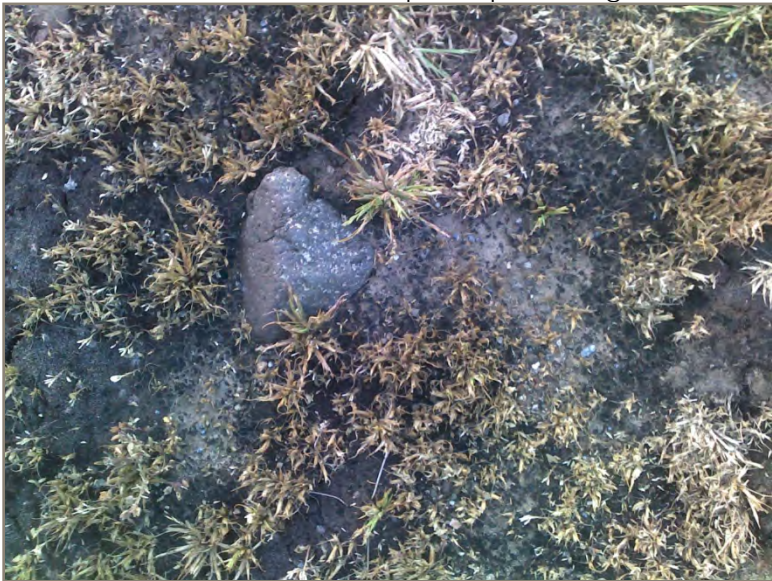
Photo 11: Lead shot scattered on ground in Wetland 3.

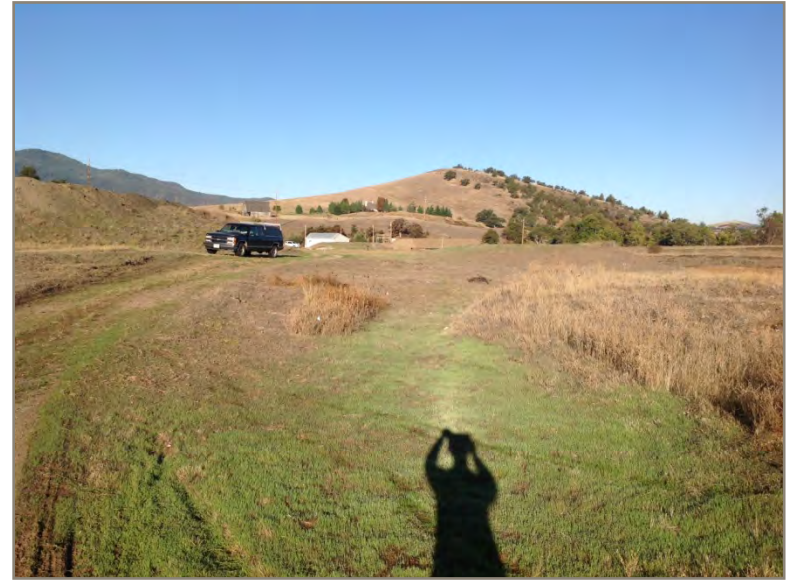
Photo 14: Drainage swale from former bath house is kept maintained.

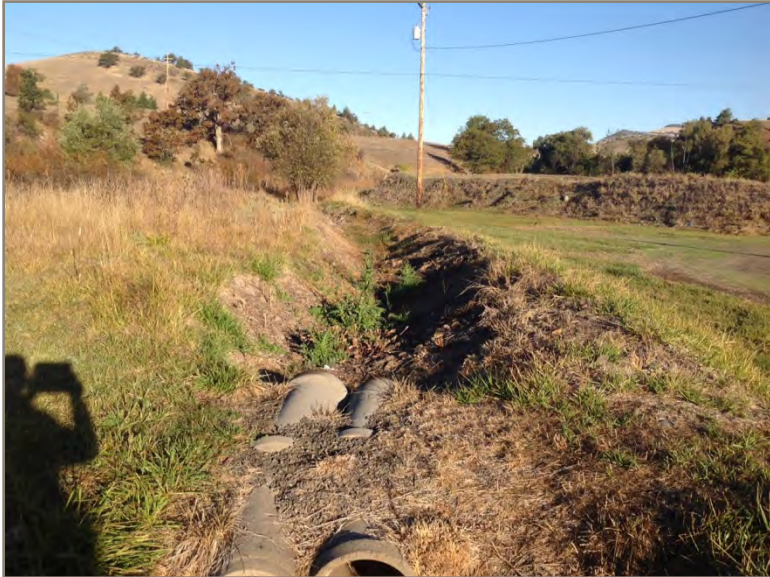
Photo 19: Looking west along the ditch between Wetland 1 and the road.

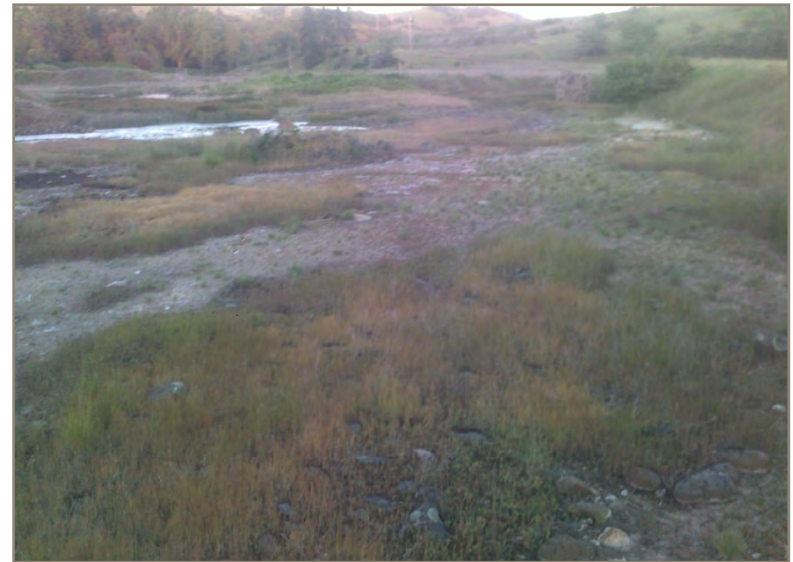
Photo 18: Wetland 6 is a mosaic of mineral-encrusted cobble beds and vegetated patches, with inundated areas threaded throughout.

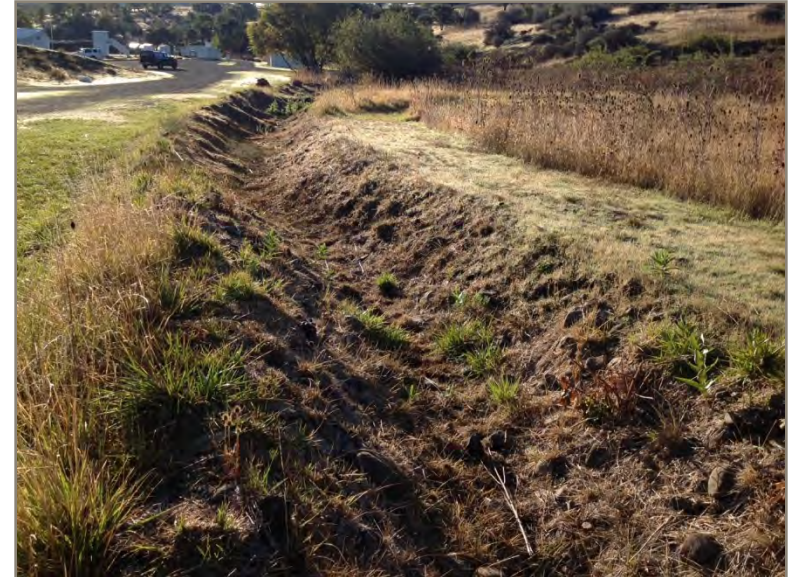
Photo 20: View of the east end of a ditch between Wetland 1 and a road, originating at the junction with the main access road.
