Council Study Session

Title: Water Treatment Plant Status Update
Item Type: Informational
Requested by Council? Yes
From: Paula C. Brown, PE Public Works Director
paula.brown@ashland.or.us

PLANT EVALUATION REPORT

City of Ashland Water Treatment Plant

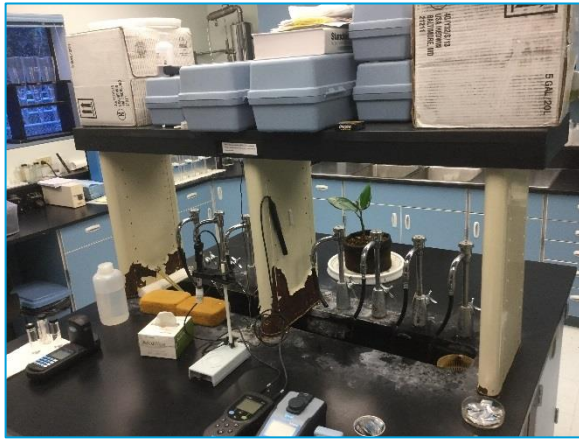
Photo 3-1 – Lab in Administration Building

The offices were in good condition, with no visible defects, or known issues brought up by the WTP staff. Within the lab, the sample sink needs to be replaced. The metal shelf stands have begun to

corrode, and the narrow sink might not effectively suit technicians' needs (Photo 3-1). It was brought up by the City that they would like the shower facilities to be updated in the locker room. Furthermore, the City voiced a desire to recoat the plant administration building.

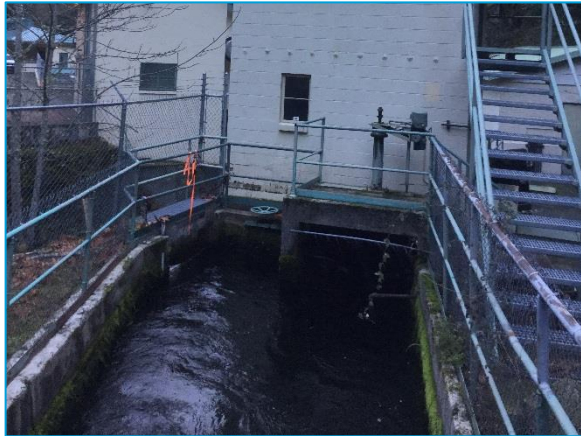
Photo 3-3 – Influent Weir

The WTP tailrace structure, influent weir, and influent line were all structurally in good condition. It was noted by the City that there is a desire to be able to actuate the influent weir electronically, instead of manually adjusting the weir height. Furthermore, the 36-inch butterfly valve on the plant influent line doesn't close completely or modulate effectively. This should be replaced. Lastly, the City would like the hydroelectric generator bypass to be redesigned to eliminate vibration issues

and improve flows. They are currently limited to 5 mgd with this bypass pipe. Photos of the influent weir and 36-inch butterfly valve are below (Photo 3-3 and Photo 3-4).

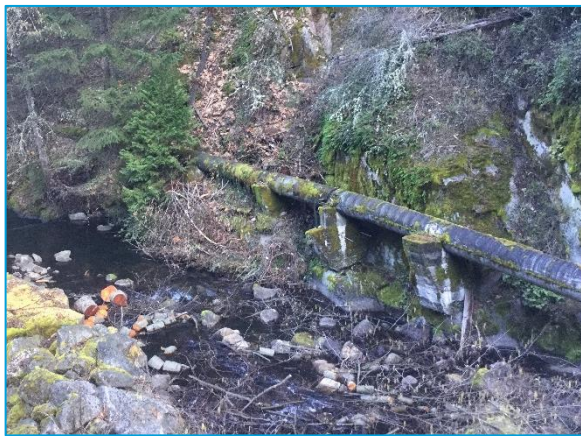
Photo 3-5 – Talent Irrigation District Influent Pipeline

Water from the Talent Irrigation District is used to supplement supply during periods of drought or low water years. A 24-inch steel water pipe feeds the WTP from the Terrace Street Pump Station. The pipe supports were not closely inspected; however, material under some of the supports appears to be washing away. Furthermore, when there are high-level flows, the pipe is submerged in the creek, subjecting it to damage from debris (Photo 3-5).

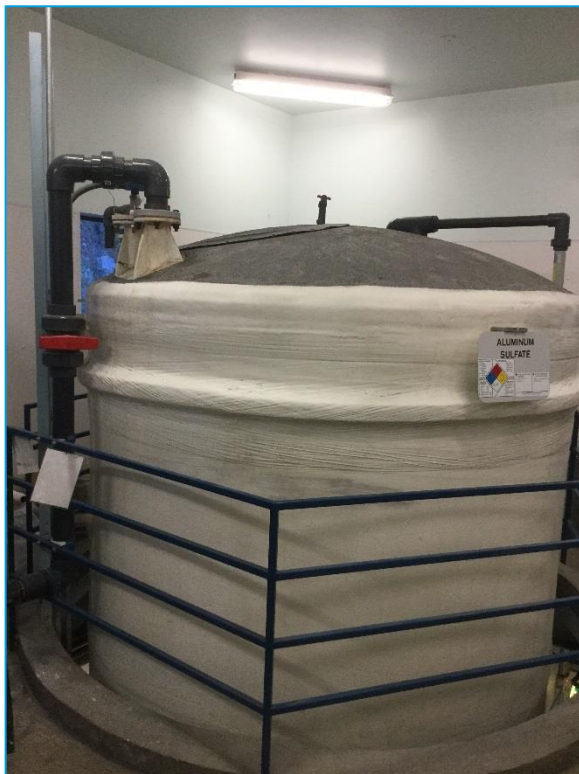
Photo 3-6 – Top of Alum Tank

The alum feed system consists of one alum tank, two alum feed pumps, and two alum feed motors. The new chemical building was built around the existing alum tank, with little regard given to tank replacement or maintenance (Photo 3-6). It was reported to Black & Veatch that the transducer located in the tank isn't functioning. However, to replace this transducer, the tank top would need to be removed, and there is limited space within the chemical building to perform this work. Additionally, if the tank were ever needed to be replaced, the building and second floor would likely have to be modified to accommodate this work.

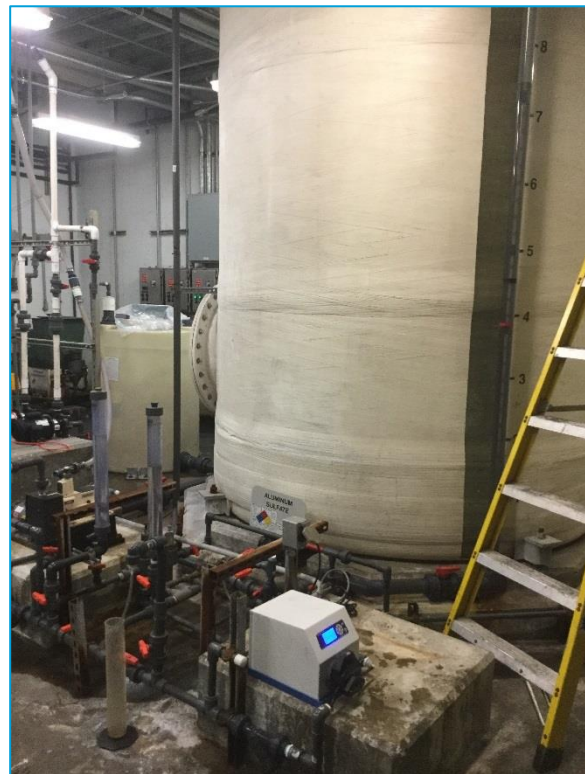
Photo 3-7 – Base and Pedestal of Alum Tank

The older auto diaphragm feeder pump was replaced with a peristaltic pump 2 years ago, and the City is very satisfied with the performance (Photo 3-7). However, the older pump can only be manually operated and replacement should be considered.

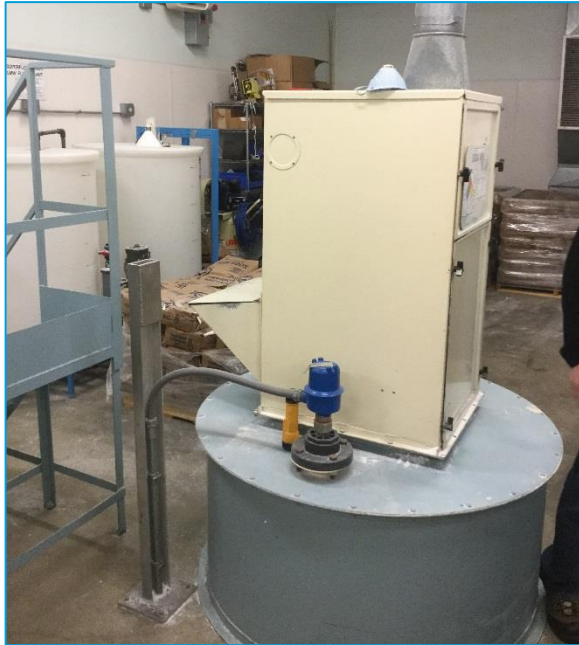
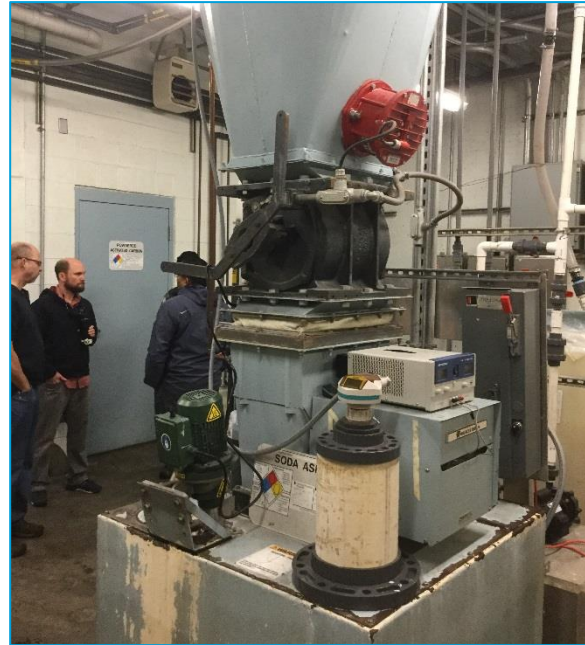
The solution tank, hopper, storage tanks, feed pumps, and feed motors are all part of the soda ash system. The soda ash is used to maintain or adjust pH for finished water, and the City has mentioned that they would like to develop an improved caustic soda feed system to replace the current one. The current system is functional, and there weren't any visible defects. However, the age and efficacy of the system should be taken into consideration, and B&V concurs with the City that the system should be replaced in the next 10 years. The current system will be unable to meet

any future higher pH requirements. Furthermore, the lower level of the chemical building is susceptible to flooding. Photos of the soda ash system are below (Photo 3-8 and Photo 3-9).

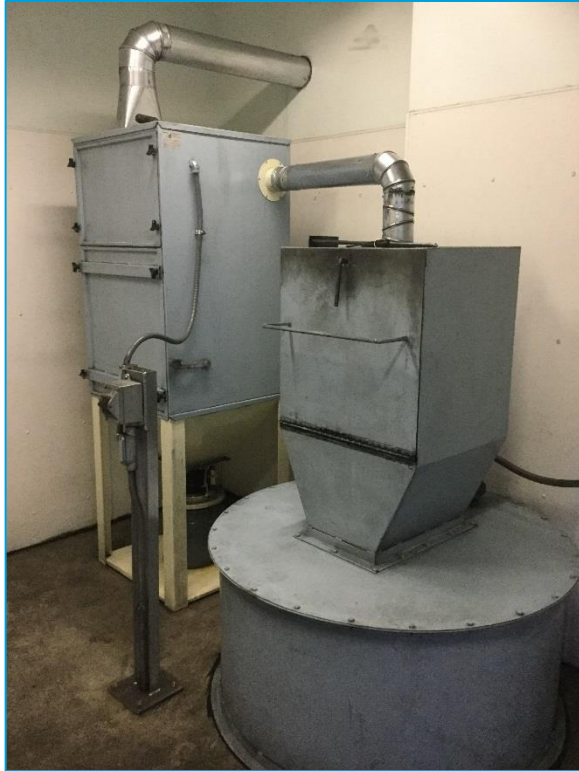
Photo 3-10 – Powdered Activated Carbon Hopper

The PAC hopper, auger feed and motor, and an educator make up the PAC feed system (Photo 3-10). Similar to the Soda Ash system, the PAC system is susceptible to flooding since part of the hopper is located on the lower level of the chemical building. There were no significant observable defects with the PAC system. However, the PAC system does not meet the desired level of service, and has not been effectively treating taste and odor during high Geosmin events. Furthermore, handling PAC can pose a health risk. The MSDS lists that the primary concerns for occupational exposure are skin contact and inhalation in the form of dust. The dust may cause eye irritation, slight skin irritation, and possible respiratory tract irritation. In confined spaces, it can adsorb oxygen, and asphyxiation may result. The dust from loading PAC can also lead to an explosive environment. It is recommended that this system be replaced in the 10- to 15-year timeframe.

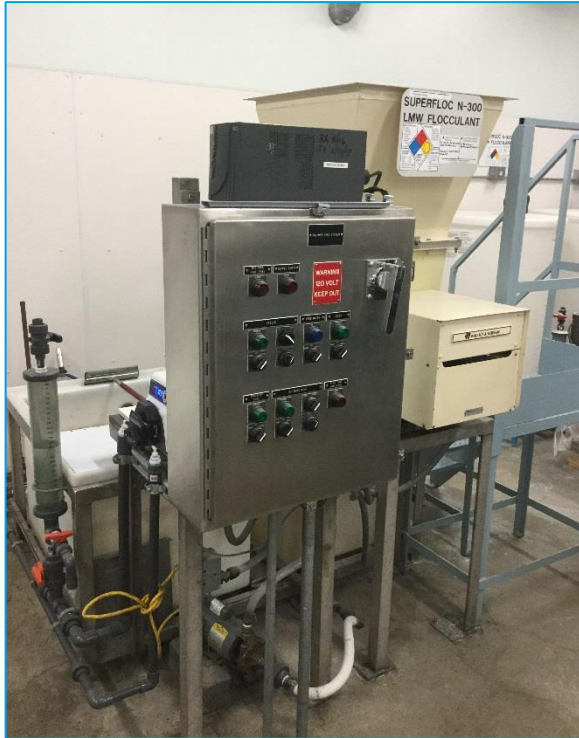
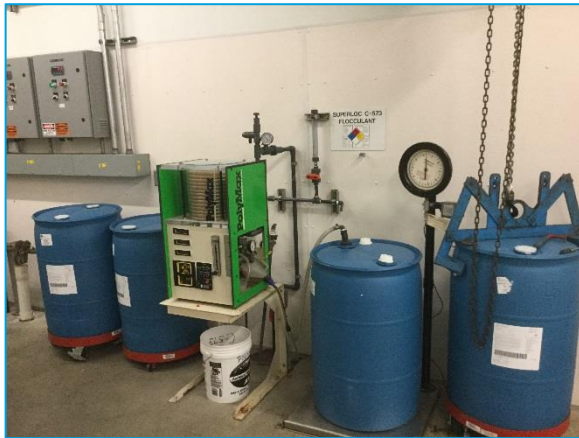
The polymer system is comprised of two tanks, filter polymer aid (Superfloc N-300) feed pumps and motors, and cationic polymer (Superfloc C-573) feed pumps. Overall there were no significant visible defects detected with the polymer feed system. There are no visible defects with the LMI Polymax feed system. However, the City is hoping to upgrade the current cationic polymer diaphragm feed pump with a peristaltic pump. At this time, they would also like to reevaluate alternate injection points other than mixer M015. Due to lifespan expectancy, it is recommended to replace this system in the next 10 years. The filter polymer aid system is functional, but obsolete. The City has also reported that it delivers polymer aid unevenly to the filter surfaces. It is recommended to replace this system in the next 10 years. The tanks for the polymer feed and mixing are functional and should be used until the end of their useful life. However, the City has stated that functionally only a third (approximately 33 gallons) of the working capacity of each tank are able to be used. In the 10- to 15-year timeframe, the current tanks should be replaced with

smaller, more adequately sized tanks. The City currently has planned replacements for both polymer systems budgeted. Photos of the polymer system are below.

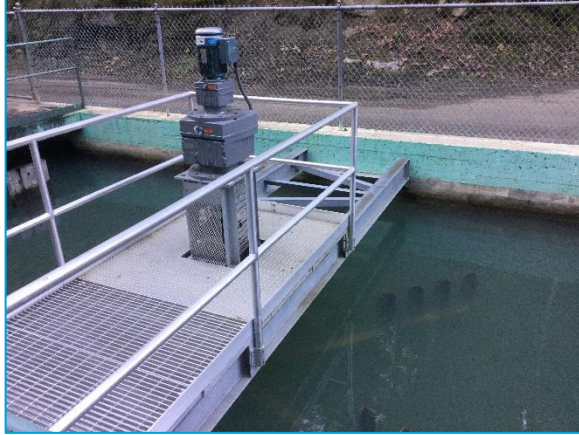
Photo 3-16 – Flocculation Basin and Paddle Mixer

The Pretreatment process is made up primarily of the Flocculation Basins. During the inspection, it was observed that the Flocculation Basin structures were in good condition. However, it is recommended that they be recoated within the next 10 years to preserve concrete integrity. The City has mentioned that they would like to upsize and relocate the drain, as it is currently not at the bottom of the basin. Upsizing and relocating the flocculation basin drain would trigger major structural modifications, and this recommendation should be considered optional. It was also reported by the City that there has been hydraulic short-circuiting in the Flocculation Basins. Black & Veatch would recommend rewiring the flocculation motors to spin in the opposite direction and disassembling and reversing the vertical paddle mixers to improve settlement (Photo 3-16). This should be done in the next 10 years.

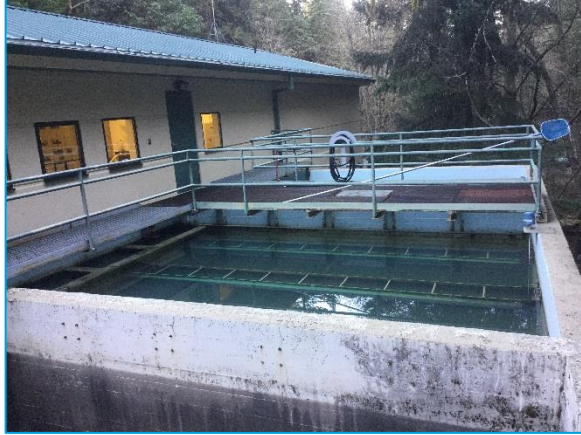
Photo 3-18 – Dual Media Filters

The Dual Media Filters were in fair condition (Photo 3-18). There is evidence of cracking within the filter structures, and possible leakage, visible from the efflorescence on the exterior of the filter concrete wall and from the leakage pattern staining around the air supply line on the exterior wall (Photo 3-20 and Photo 3-21). The coating is also failing in some areas. Concrete cracks should be repaired, and the filter basins should be recoated in the next 10 years. The City has mentioned that excessive debris falls into the basins during normal operation, affecting filter performance. Recent removal of overhanging trees has improved this situation. While not necessary for proper operation of the plant, a canopy structure over the Dual Media Filters would be considered an optional improvement to the plant to prevent the debris entering the filters. Filters 7 and 8 are currently not operational, and it is recommended to rehabilitate these filters in the 10- to 15-year timeframe to meet future treatment process demand (Photo 3-19). Rehabilitation would require concrete crack repair and surface restoration in addition to replacement of process mechanical equipment, launders and piping penetrations. In the same time frame, it is expected that existing filter media will reach the end of its useful life, and should be replaced. The filter influent pipe showed some signs of surface corrosion, and it should be recoated in the 10- to 15-year timeframe as well. When this effort is undertaken, it is recommended to perform a detailed condition assessment of the pipe.

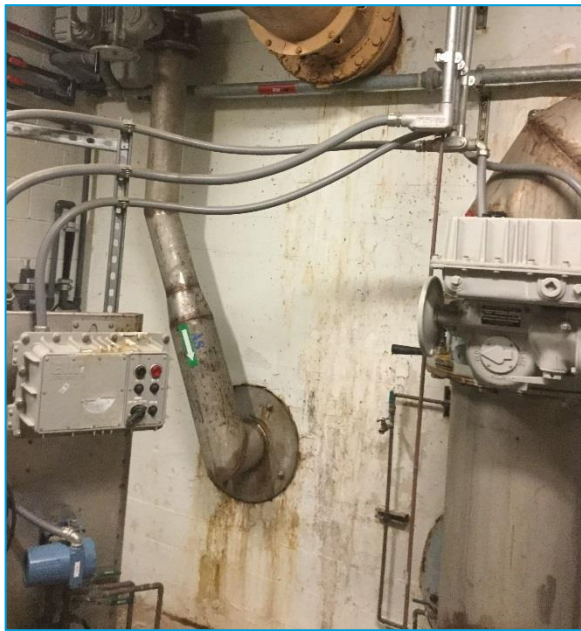
Photo 3-20 – Air Scour Air Supply (Evident Leakage)

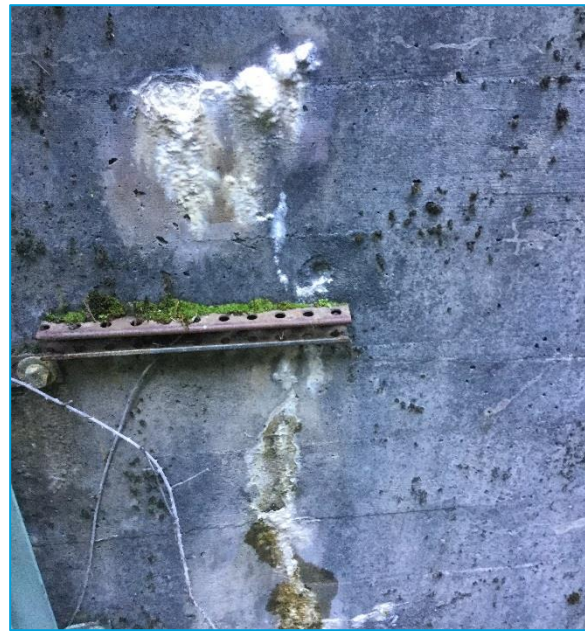
Photo 3-21 – Efflorescence on Exterior Dual Media Filter Wall

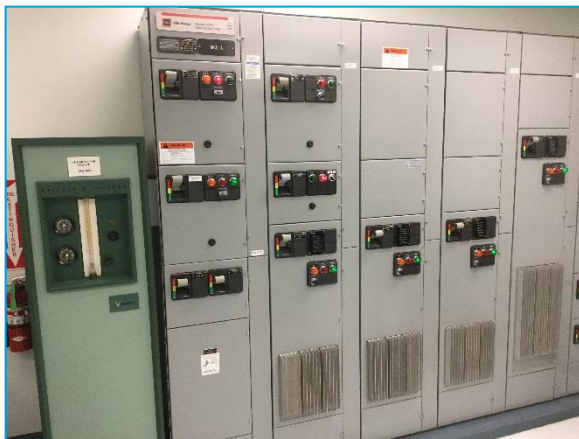
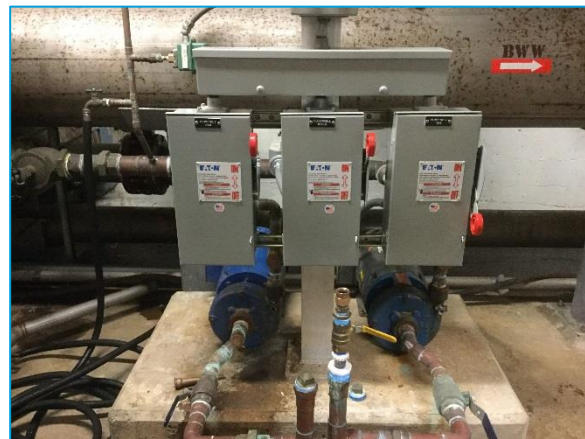
Electrical equipment was visually inspected while the plant was in operation; because of safety considerations, none of the cabinets were opened. Black & Veatch relied on information from the plant operators to make plant improvement recommendations. The plant generators are currently adequate, and no observable defects were detected. However, it is expected that the generators will require a major overhaul or need to be replaced during the next 20 years. Similarly, transformers, MCCs, breakers, cabling, and power lines were all in good condition, but will likely need to be replaced in the next 20 years. The building and yard lighting should also be replaced with LEDs as the existing lighting fixtures are considered to be economically obsolete. The photos of the electrical equipment shows arc-flash related labels/stickers which would indicate that at some point, an arc-flash analysis or study was conducted. NFPA 70-E guidelines stipulate that an arc-flash analysis be conducted every five years. Representative photos of electrical equipment are below.

In general, it was observed that some electrical equipment is not expected to last another 20 years and is recommended for replacement. Some of the electrical equipment that provides power to pump motors, valves, instruments, and other process related electrical loads is considered obsolete and is due for eventual replacement. The equipment includes:

Based on the evaluation, it was observed that the panelboards serving process-related loads had reached the end of their useful life, with parts becoming difficult, if not impossible, to find. Therefore, panelboards are assumed to be obsolete and are recommended for replacement.

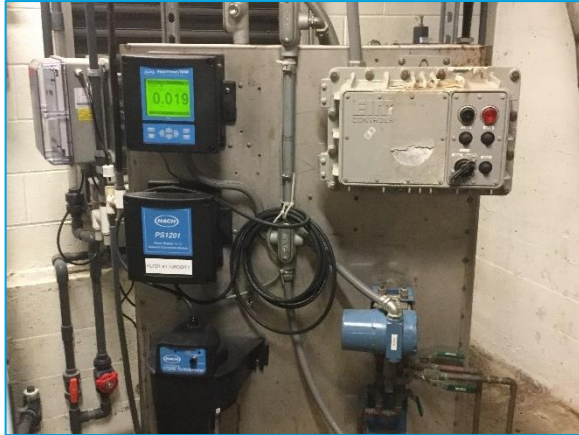
Representative photos of instruments are below.

- It is recommended to add a TOC in-line analyzer.
- Inflow meters should be replaced as they are nearing the end of their life expectancy.
- The WTP finished water effluent pipe empties as it flows to Crowson Tank during filter backwashes, resulting from inaccurate measurements. It is recommended to relocate the plant effluent flowmeter 1000-yards farther downstream to provide more accurate information.
- Upgrade Wonderware software on plant computers.
