CITY OF ASHLAND

Talent Irrigation District (TID) Pipeline Repurposing Evaluation

TECHNICAL MEMORANDUM

SUBJECT: Ashland Water Treatment Plant
Talent Irrigation District (TID) Pipeline Repurposing Evaluation

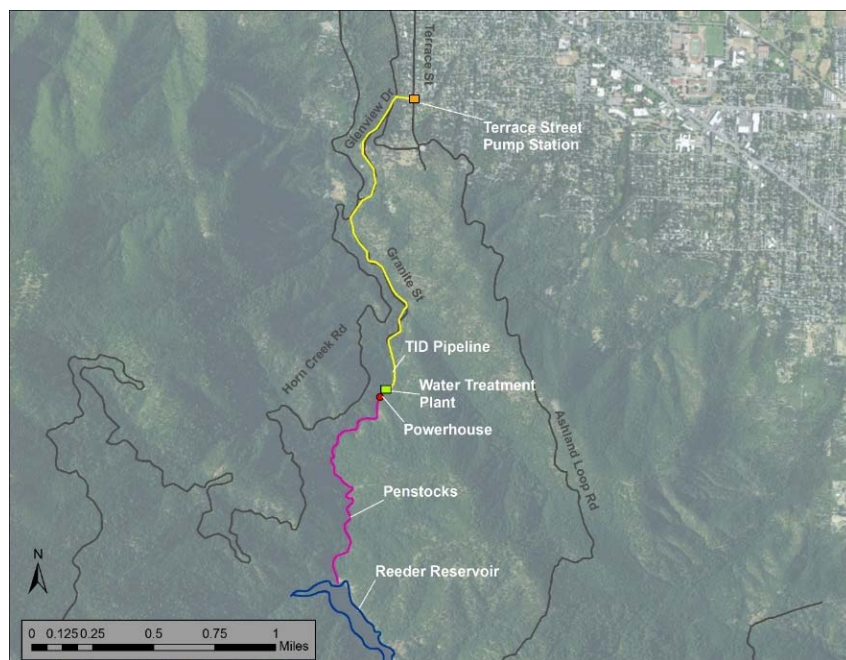
Figure 1: Existing WTP Location

The City of Ashland owns and operates a surface water treatment plant (WTP) located on Granite Street approximately 1.3 miles south of town (Figure 1). The WTP's primary source is the Reeder Reservoir on Ashland Creek. Water from the reservoir is conveyed via a 24-inch ductile iron pipe known as the Penstock. Prior to entering the plant, water in the Penstock passes through a power generation facility (powerhouse). The WTP also has the capability of accepting supplemental water from the City's Terrace Street Pump Station, which draws water from a Talent Irrigation District (TID) canal and pumps it to the plant (Figure 1). The waterline dedicated to this supplemental source is a 24-inch steel pipe referred to as the TID pipeline.

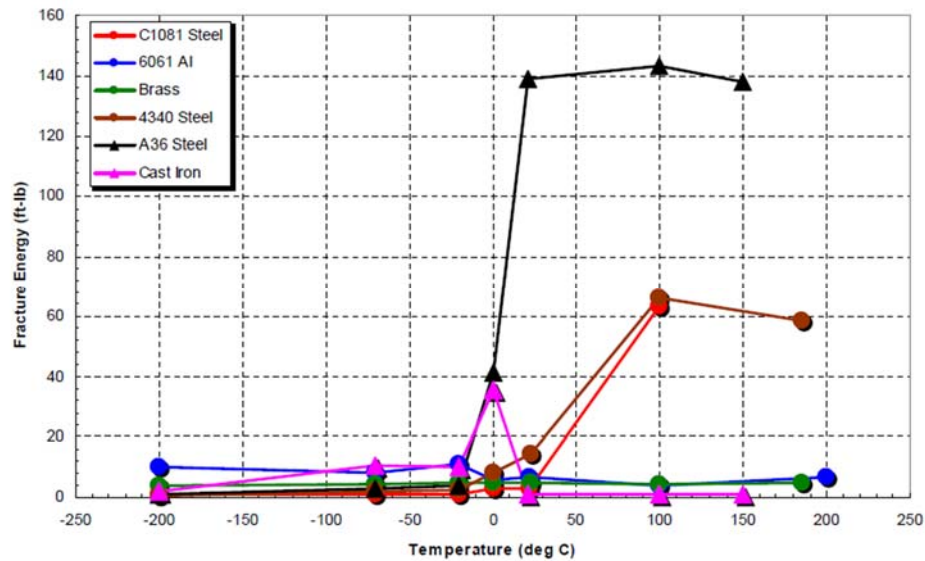
Figure 3: Typical Charpy Test Results

The Charpy Impact Test is used to measure the toughness of a material, or amount of energy required to fracture a v-notched specimen at a range of temperatures. The results show the temperature at which a metal transitions from a ductile material to a brittle material. The test is performed by placing a metal specimen, with a v-notch cut into its center, in the path of a pendulum of known mass and length. The pendulum is allowed to fall and break through the metal specimen. The height of the pendulum on the follow-through of the swing is then compared to the height of the follow-through without any resistance. The results of the test are reported in foot-pounds (ft. lbs.). Figure 3 below shows a series of typical Charpy test results for various materials including steel, brass, aluminum and iron.

Another useful result of the Charpy Test is the failure mode. Brittle materials fail in Charpy Tests with only part of the face being sheared and the remainder with a brittle failure. The test results on the pipeline material shows all the specimens had 100 percent shear faces after the being broken during the test. The significance of the 100 percent shear failure is the material failed in a ductile mode.

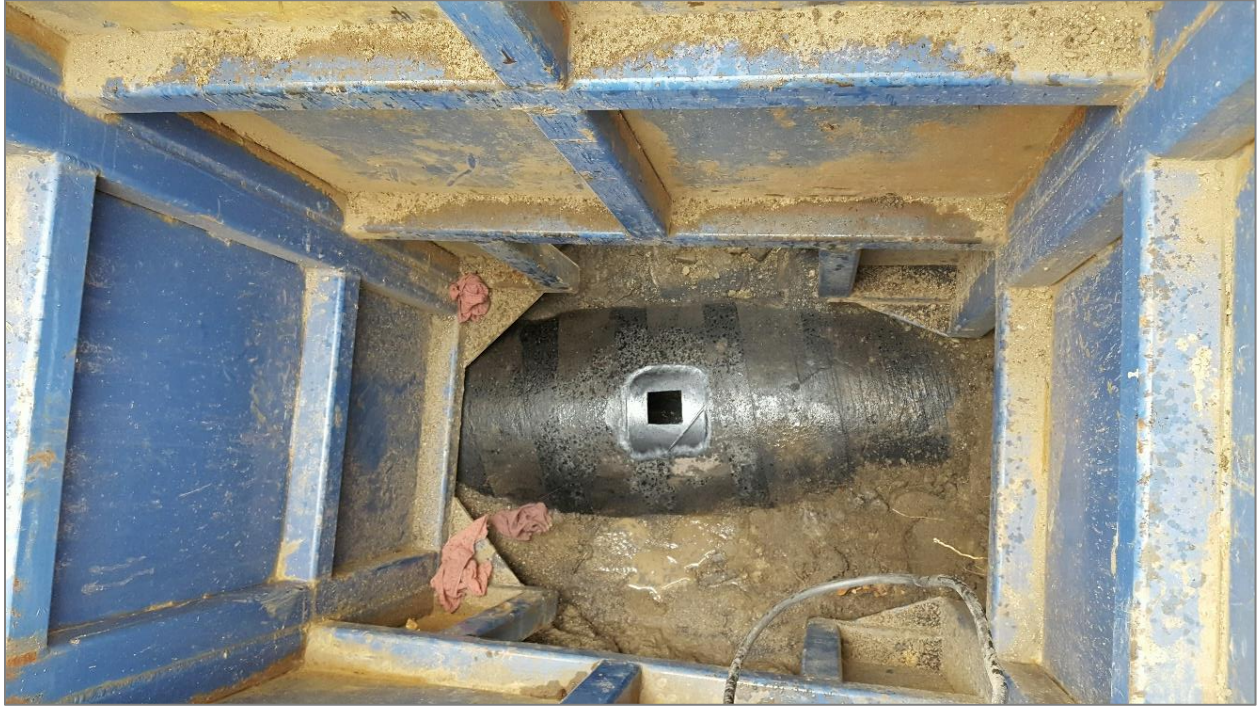
In addition to the ultrasonic in-place thickness measurements, the City collected two coupon samples from the pipeline; one near the WTP entrance gate on Granite Street, and one on Glenview Drive (near the access road to the Concrete Site). The thicknesses of the coupons were measured to be 0.144 inches (WTP Entrance Gate) and 0.135 inches (Glenview Drive). This further confirms that the pipe thickness matches what was called out on the record drawings, and that little to no corrosion has affected the pipe.

TID Pipeline Coupon Collected on Glenview Drive (Near Access Road to Concrete Pit Site)

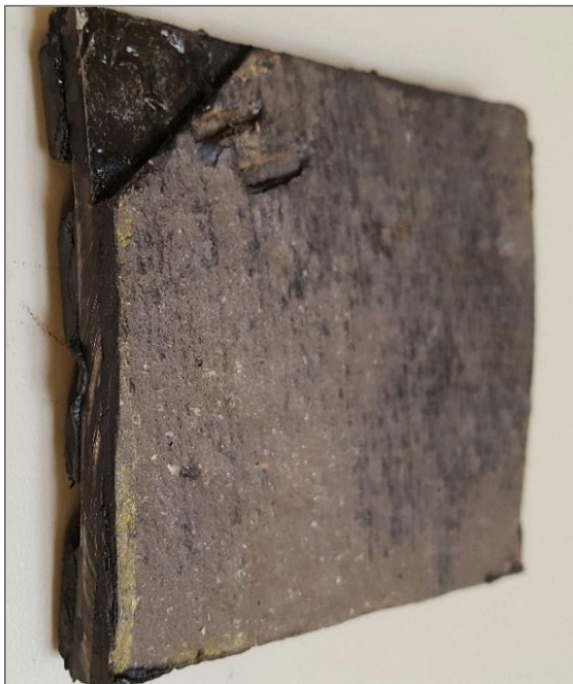
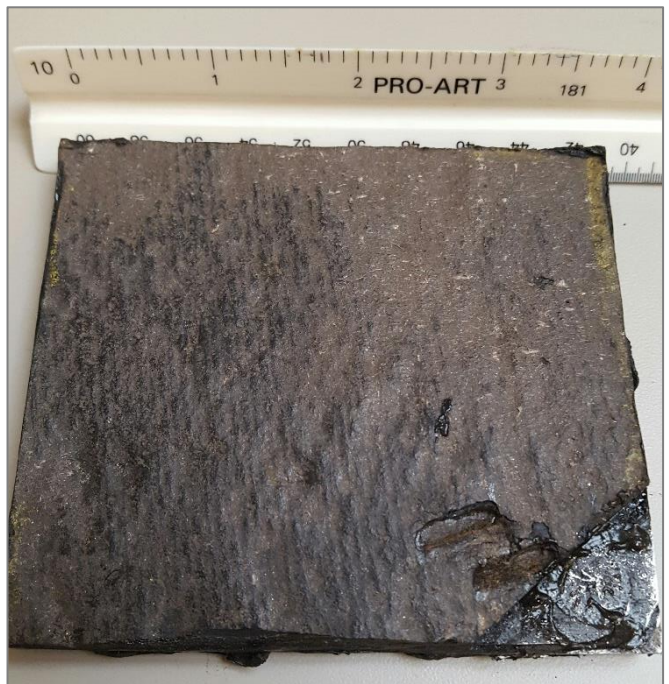
TID Pipeline Coupon Collected Near WTP Entrance Gate (Granite Street)

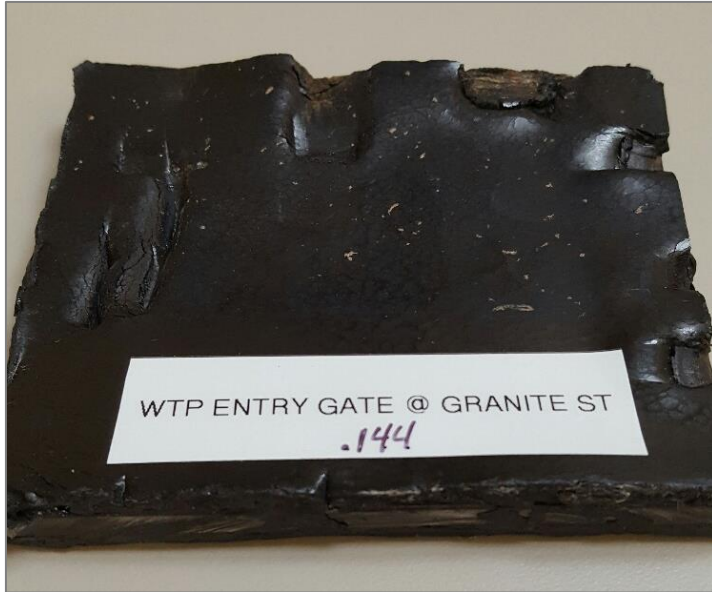
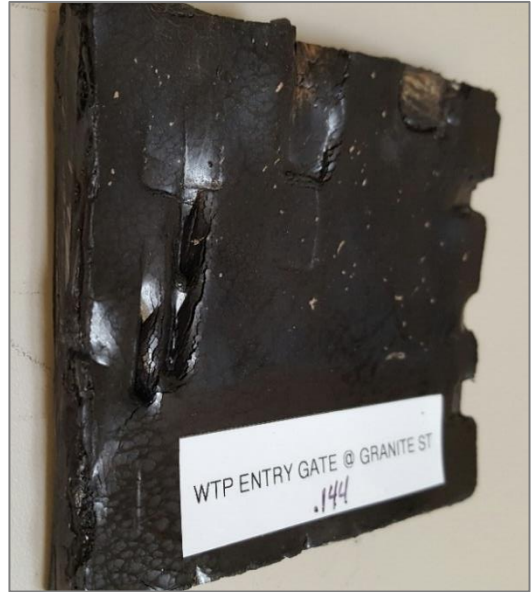
TID Pipeline Coupon Collected Near WTP Entrance Gate (Granite Street)

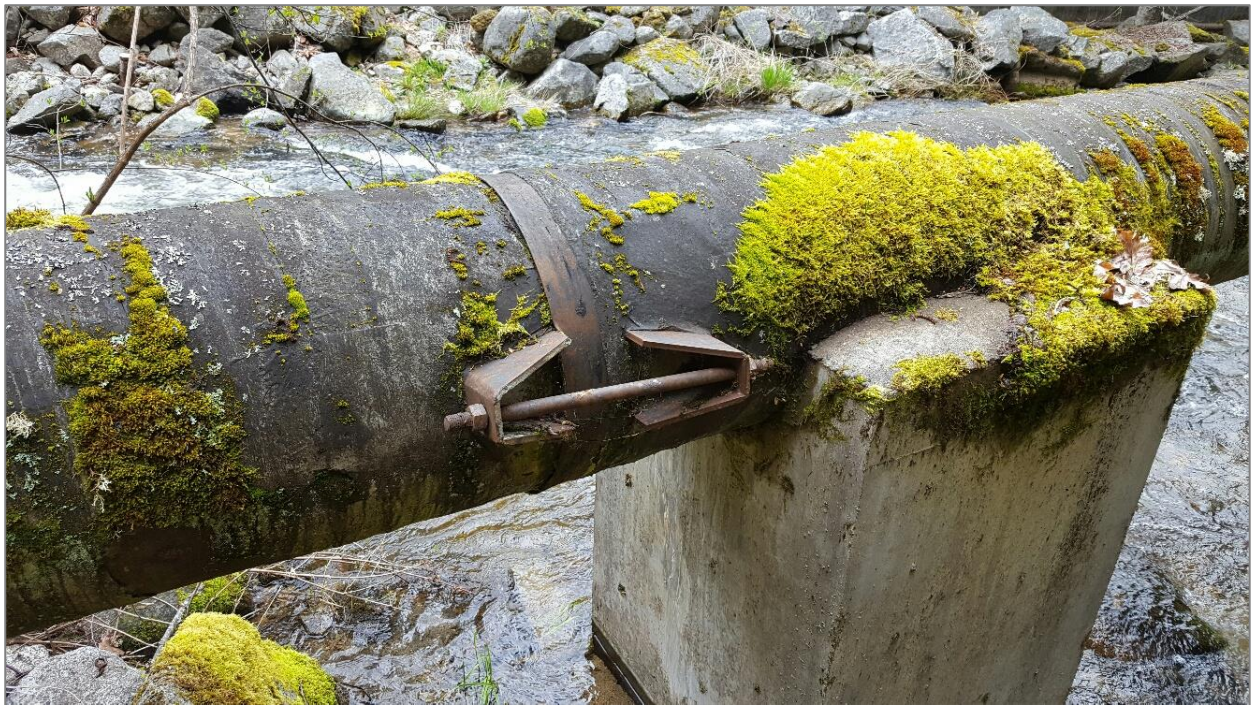
Visual observation of the pipeline was conducted by examining photos at locations where its thickness was tested, where it is exposed (near the WTP), and where the pipeline enters the Tailrace. Attachment B contains several photos of the pipeline that were taken at these locations. No major defects or corrosion were observed; considering the age of the pipe (installed about 40 years ago), it appeared to be in good condition overall.

Pipe Joint Near Existing WTP

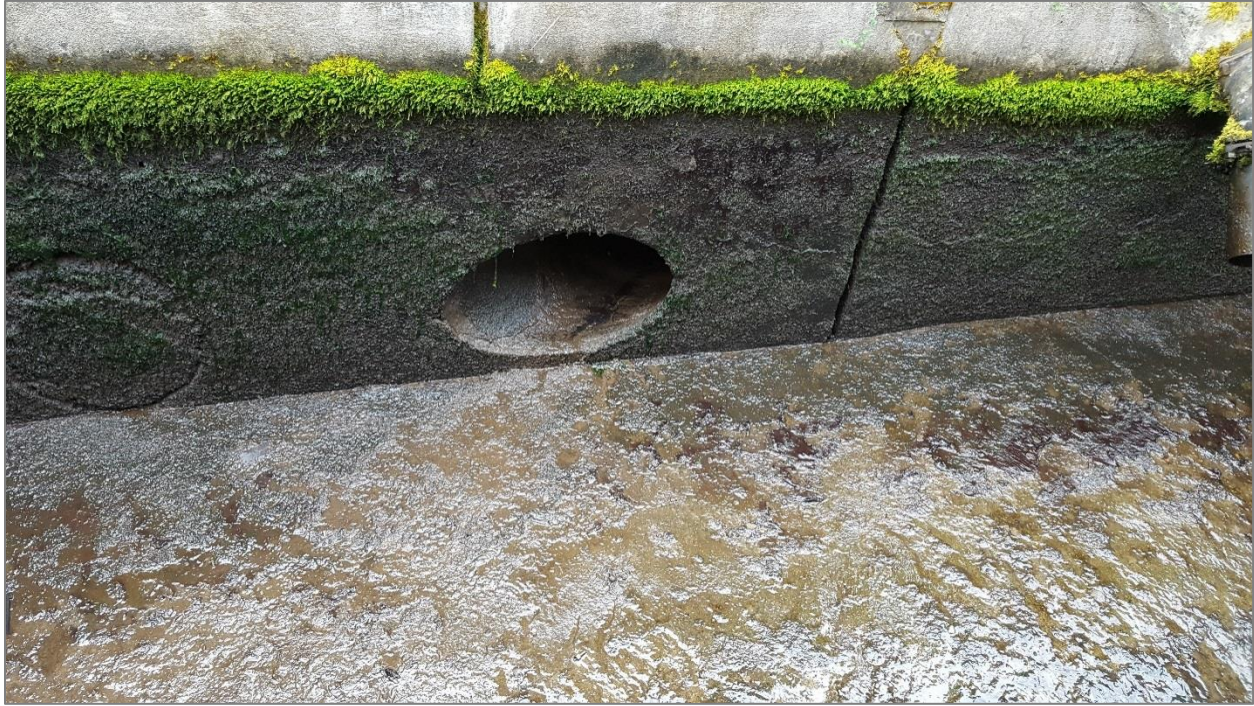
Tailrace Exit

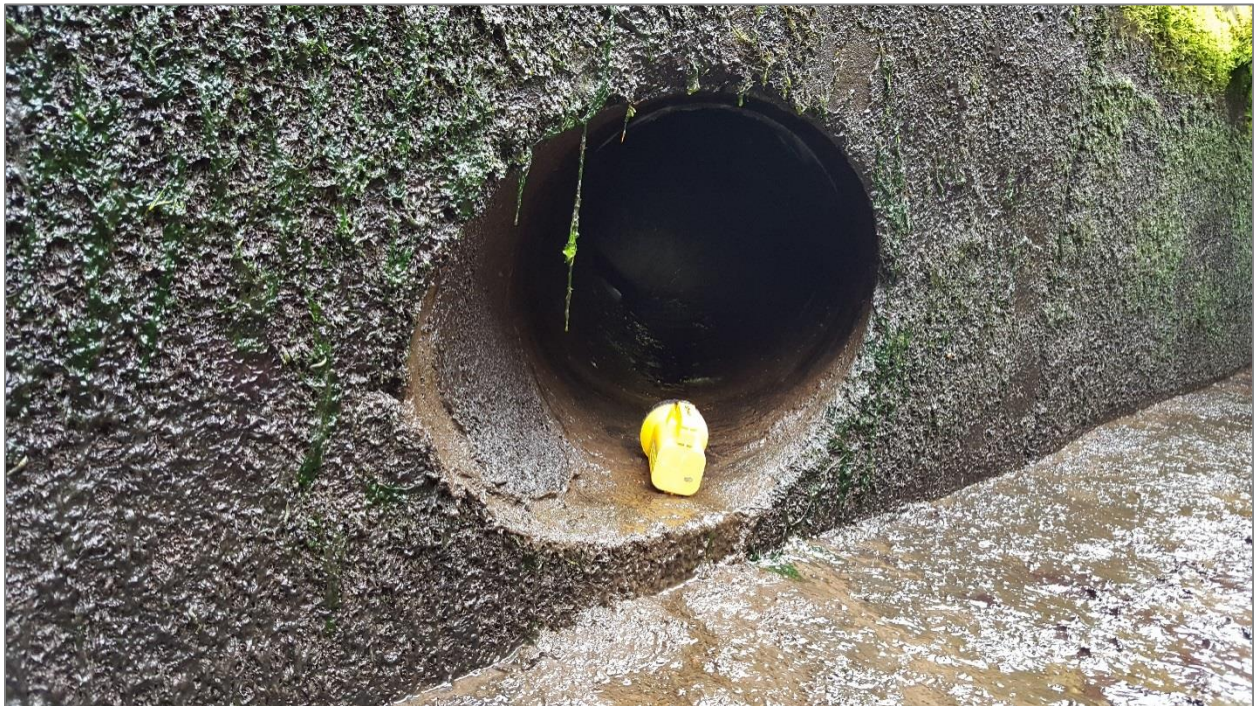
Tailrace Exit

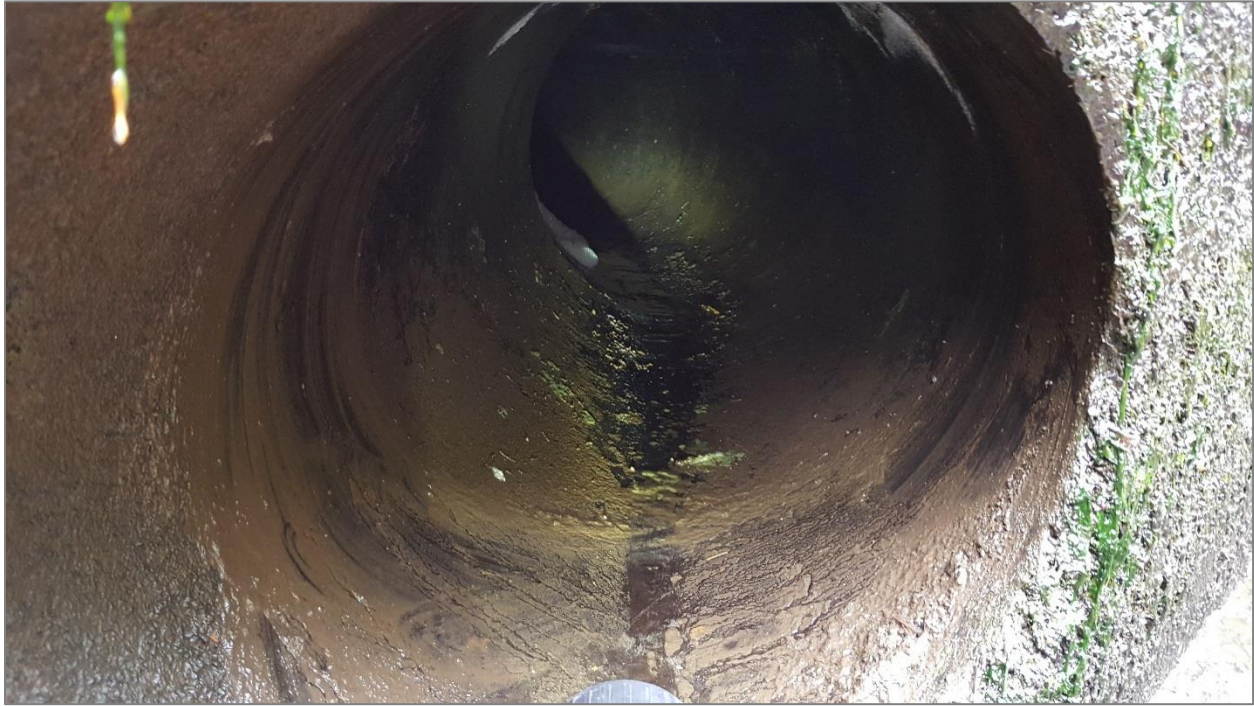
Tailrace Exit

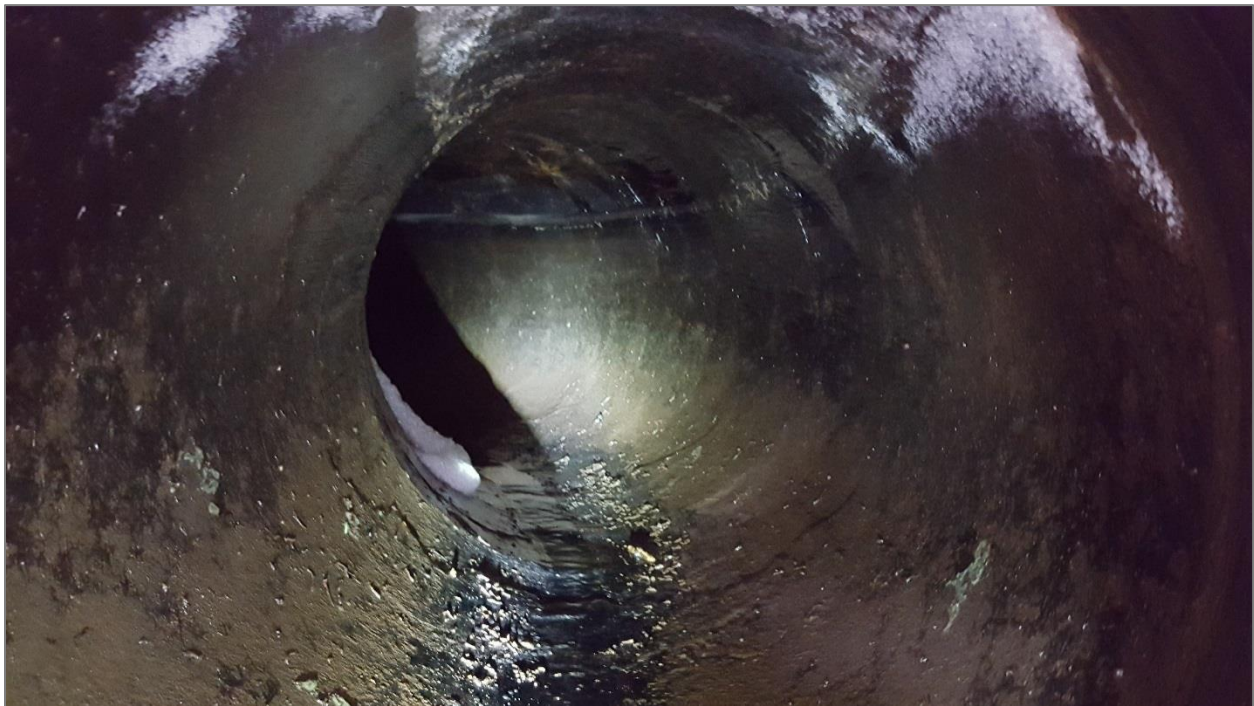
Tailrace Exit

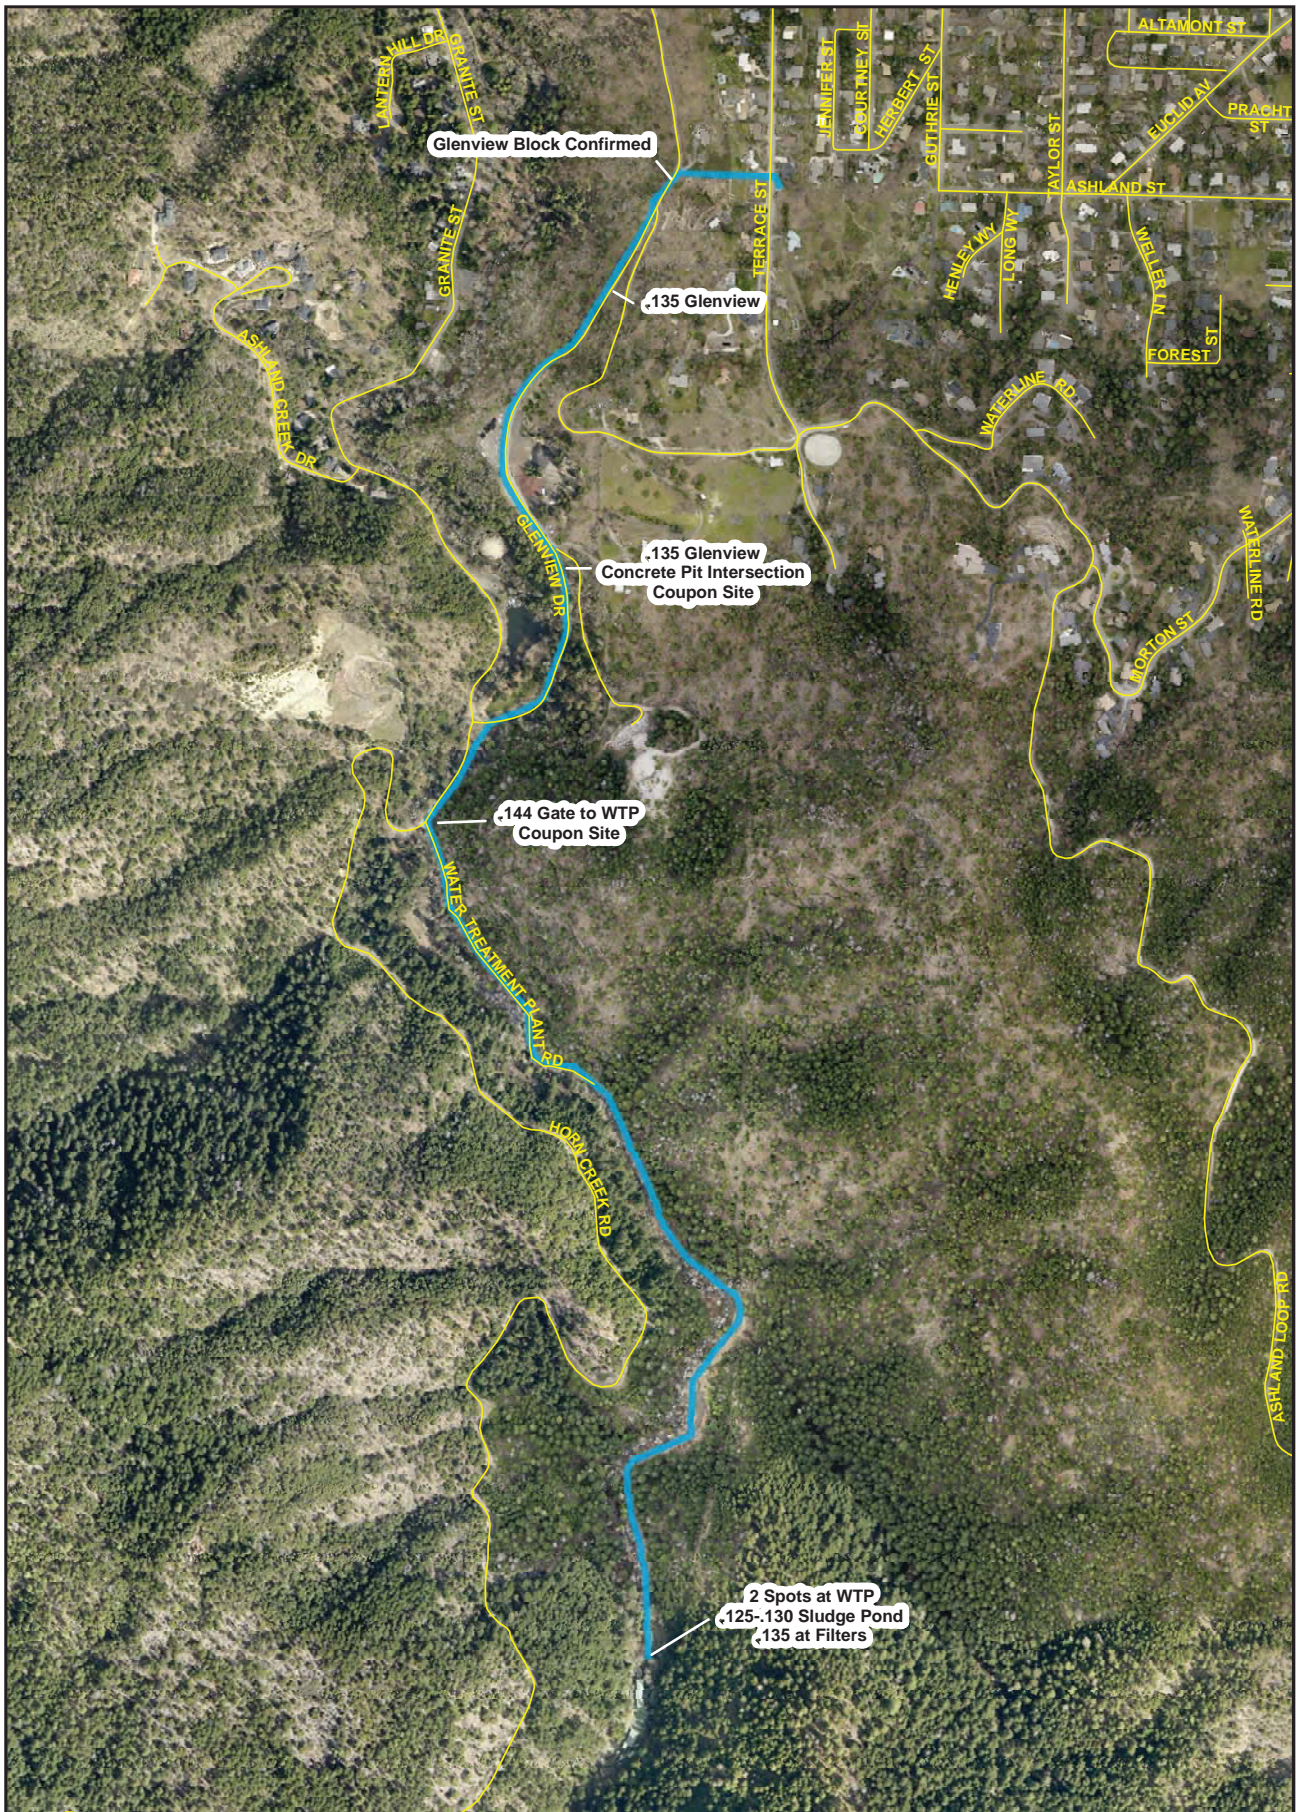
TID Pipeline Inspection Points

The City purchased an ultrasonic thickness gauge to take in-place measurements of the pipeline's thickness. This was completed for several reasons, including comparing the pipe's actual thickness to that shown on the record drawings, and to determine if a substantial amount of corrosion has occurred since the pipeline was constructed. Several locations along the pipeline were potholed, and the pipe's thickness was measured. A third-party testing agency (Professional Service Industries, Inc. [PSI]) was also onsite during a few of the potholes to measure the pipeline thickness and verify that the City's gauge was working and being used properly. A comparison of gauge measurements collected by the City and PSI, along with the pipe thickness indicated on record drawings, is provided in Table 1. Measurements made by the City and PSI vary slightly from one another; however, the overall averages only vary by a few thousandths of an inch. It appears that the pipe installed matches the thickness indicated on the record drawings, and that little to no corrosion has taken place.

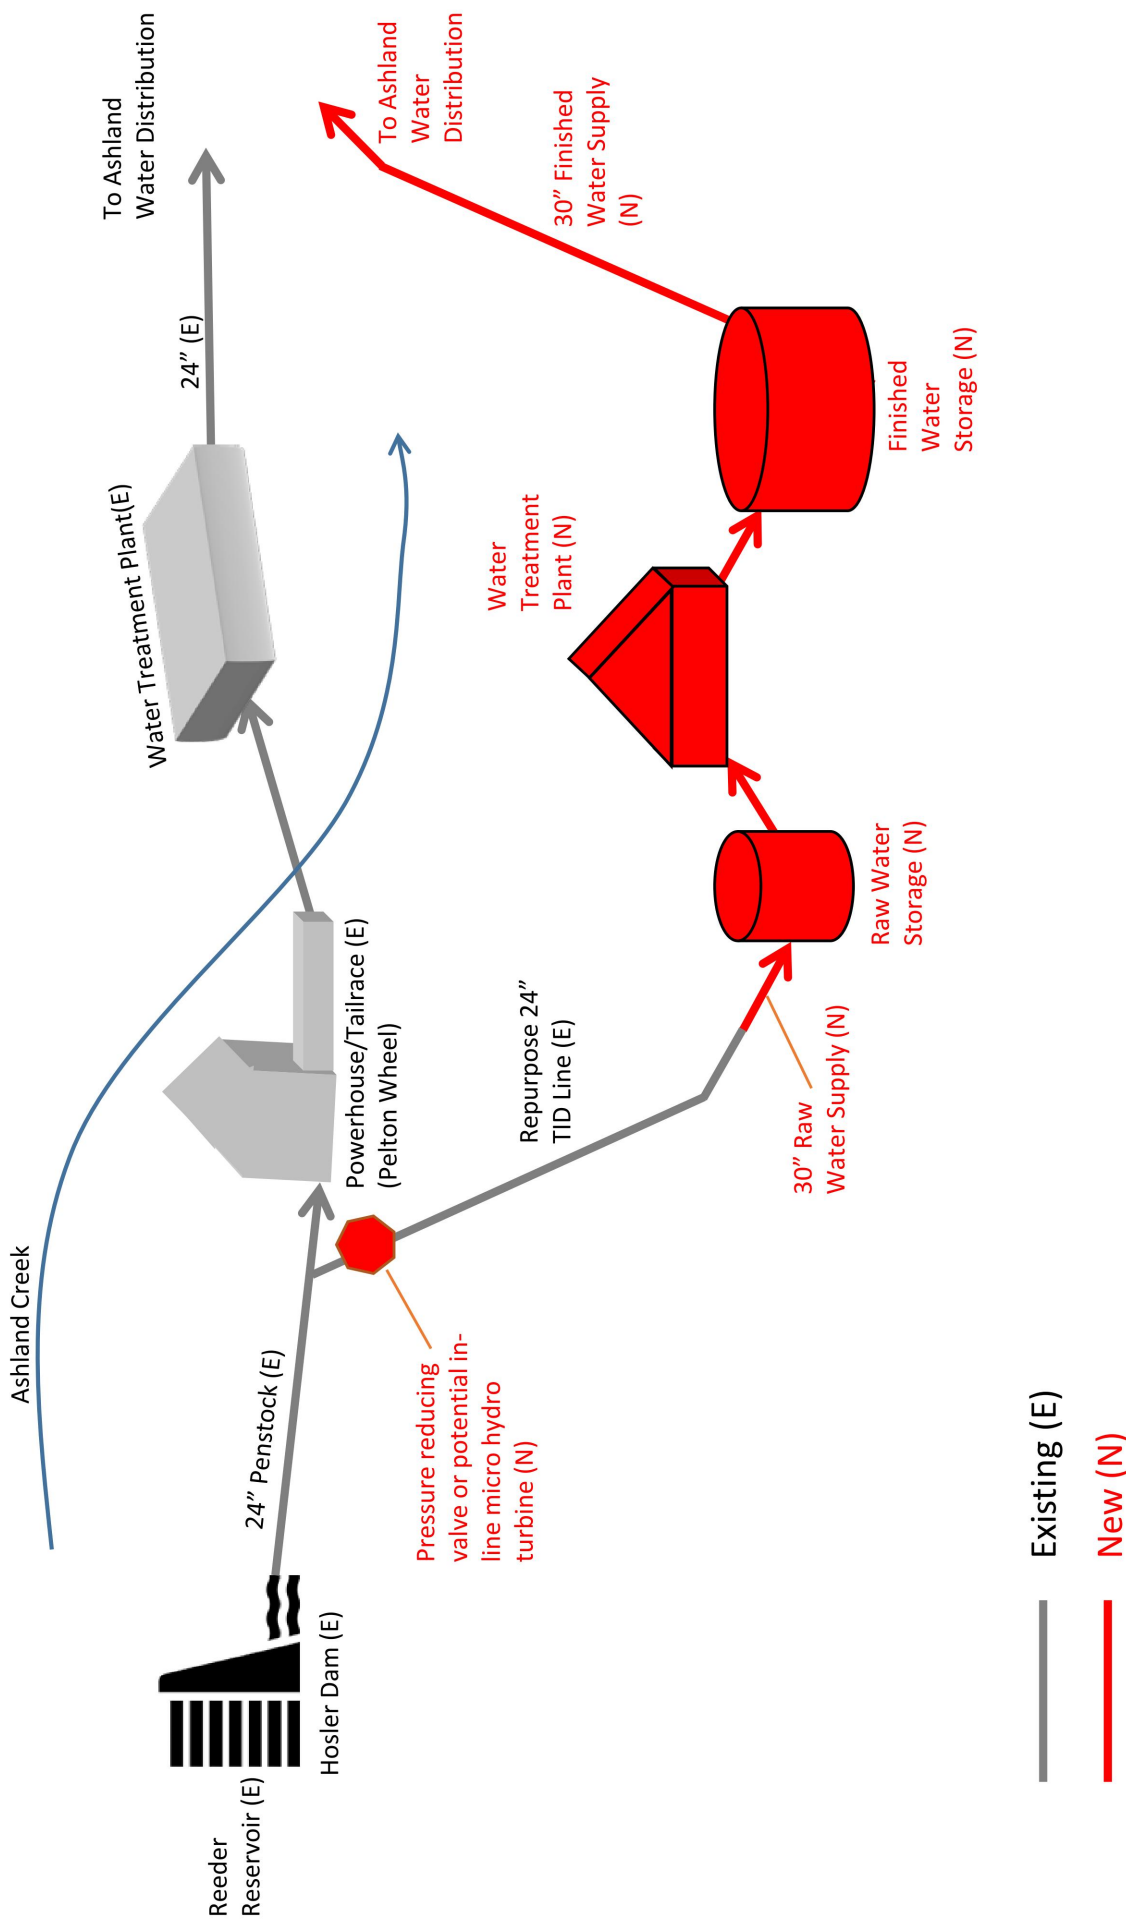
The existing water supply system is shown in **Figure 1**, along with potential new facilities. With this alternative, raw water would be obtained by connecting to the existing penstock upstream from the powerhouse. Connecting upstream from the powerhouse provides greater water pressure and may allow raw water to be supplied through the new WTP without additional pumping. This alternative also allows the City to repurpose the existing Talent Irrigation District (TID) raw water supply line, conveying water from the penstock upstream of the powerhouse to the new WTP. We can envision circumstances when both WTPs would be operational.
