CITY OF ASHLAND

HISTORIC COMMISSION MEETING

THE CARTER MEMORIAL FOUNTAIN, ASHLAND, OR HISTORY AND OPTIONS FOR REHABILITATION

Carter Memorial Fountain
PIONEER MIKE RESTORATION OPTIONS
City of Ashland, OR, April 2015

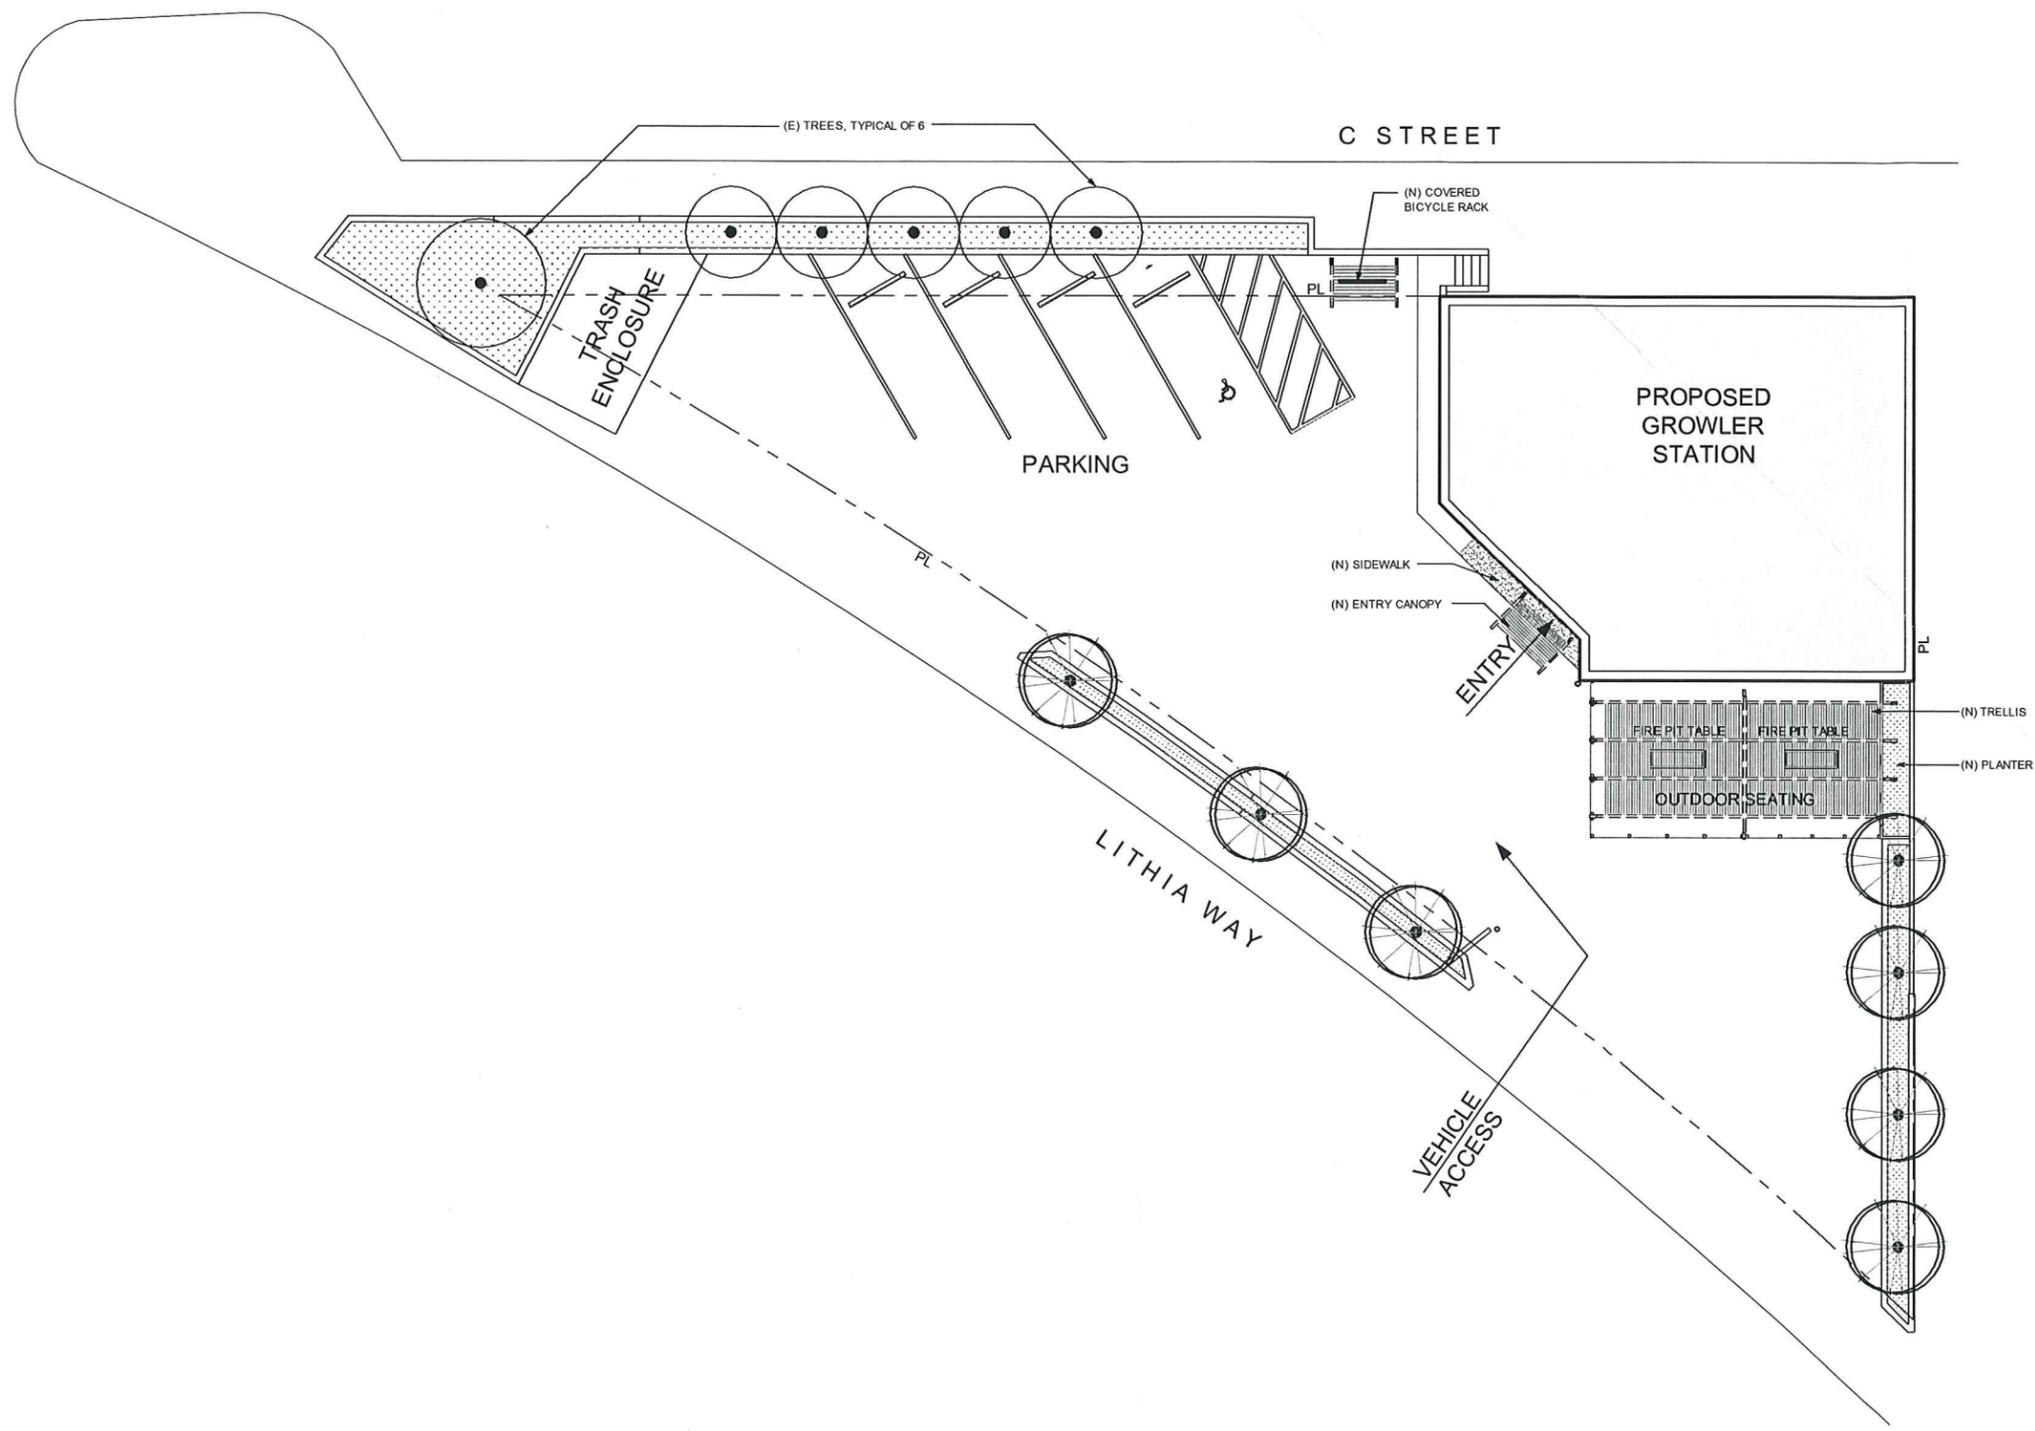
SITE PLAN
1" = 10'-0"

- ❖ an outdoor seating area consisting of a steel and wood trellis, concrete paver flooring, horizontal cedar railing and (2) gas fire tables/pits.
- ❖ replacement of the (2) overhead doors facing Lithia Way with new, all glazed, clear anodized aluminum framed overhead doors. These doors will remain operable and provide great access to the outdoor seating area.

- b. The original metal cornice and cmu will be retained and painted. Two of the existing overhead doors will be replaced with new fully glazed overhead doors - the opening sizes will remain the same.

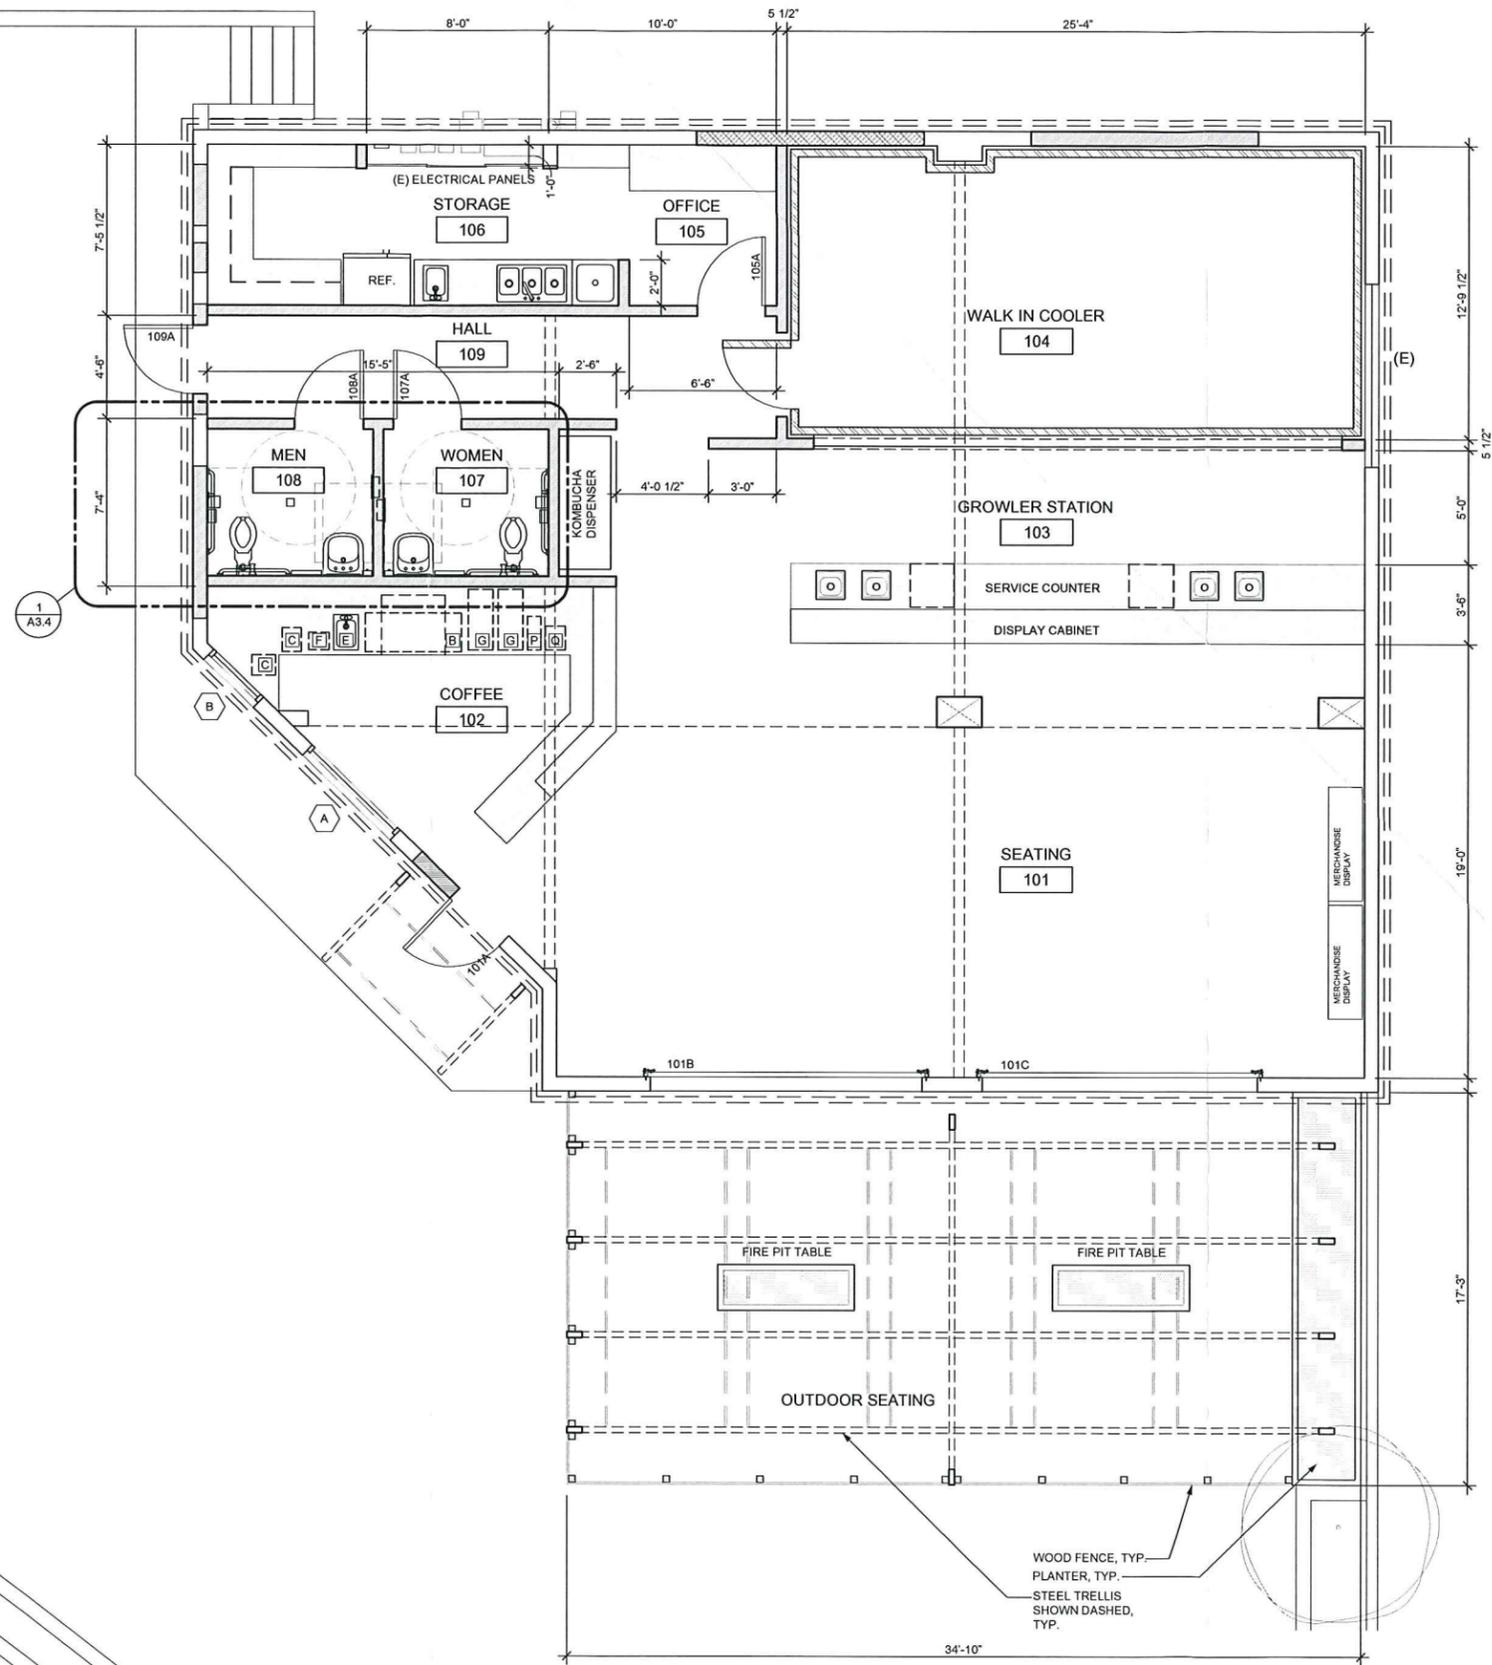
- [B] F.F.C.I. ESPRESSO MACHINE. SEE MECHANICAL DRAWINGS.
- [C] F.F.F.I. GRINDER- GEE- MANUAL, TIMER, AUTOMATIC, GROCERY
- [E] HAND SINK. SEE MECHANICAL DRAWINGS.
- [F] F.F.F.I. VITA- MIX. - VM0115E (VERIFY)
- [G] F.F.F.I. DUTCH FREEZE - TAYLOR 428 FROZEN BEVERAGE FREEZER
- [P] F.F.C.I. BUNN (5) GALLON WATER HEATER - MODEL H5E. SEE MECHANICAL DRAWINGS.
- [Q] F.F.C.I. UNDERCOUNTER REFRIGERATOR

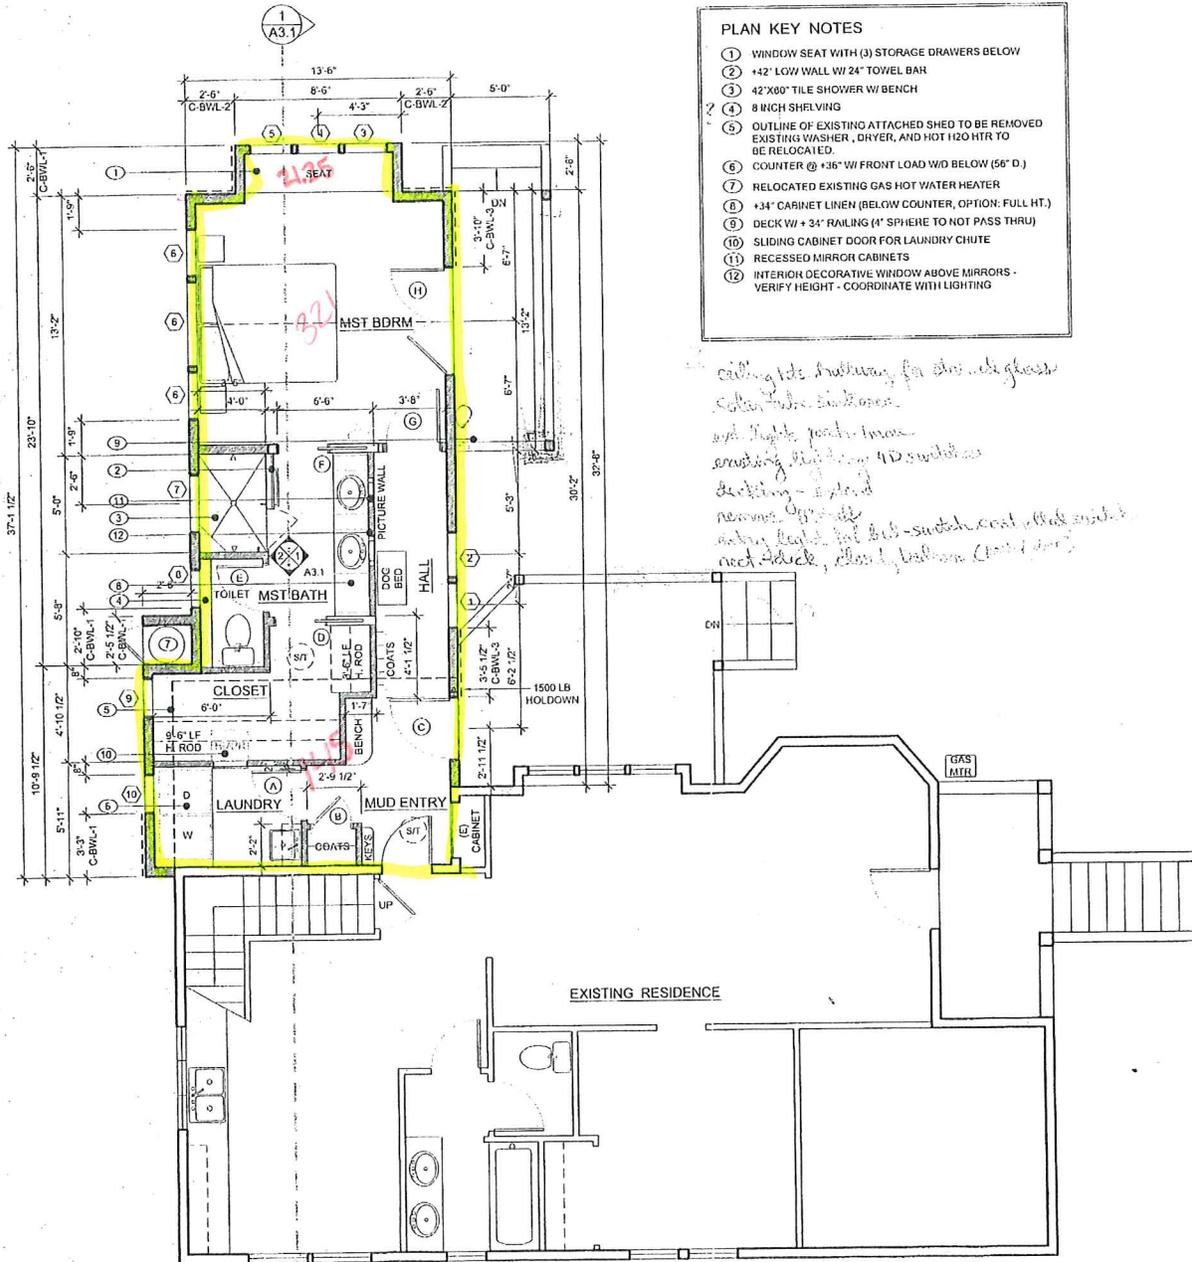
- PLAN KEY NOTES**
- ① WINDOW SEAT WITH (3) STORAGE DRAWERS BELOW
 - ② +42" LOW WALL W/ 24" TOWEL BAR
 - ③ 42" X80" TILE SHOWER W/ BENCH
 - ④ 8 INCH SHELVING
 - ⑤ OUTLINE OF EXISTING ATTACHED SHED TO BE REMOVED EXISTING WASHER, DRYER, AND HOT H2O HTR TO BE RELOCATED.
 - ⑥ COUNTER @ +36" W/ FRONT LOAD W/D BELOW (56" D.)
 - ⑦ RELOCATED EXISTING GAS HOT WATER HEATER
 - ⑧ +34" CABINET LINEN (BELOW COUNTER, OPTION: FULL HT.)
 - ⑨ DECK W/ +34" RAILING (1" SPHERE TO NOT PASS THRU)
 - ⑩ SLIDING CABINET DOOR FOR LAUNDRY CHUTE
 - ⑪ RECESSED MIRROR CABINETS
 - ⑫ INTERIOR DECORATIVE WINDOW ABOVE MIRRORS - VERIFY HEIGHT - COORDINATE WITH LIGHTING

I am requesting a conditional use permit for a travelers accommodation for the master bedroom in our house. This side of the house was beautifully remodeled with its own entrance, bathroom and closet and matches the 1898 décor of the rest of the house. This traveler's accommodation would be used during the Shakespeare season and would allow traveler's to stay in a historic home in downtown Ashland. No new construction is being proposed.

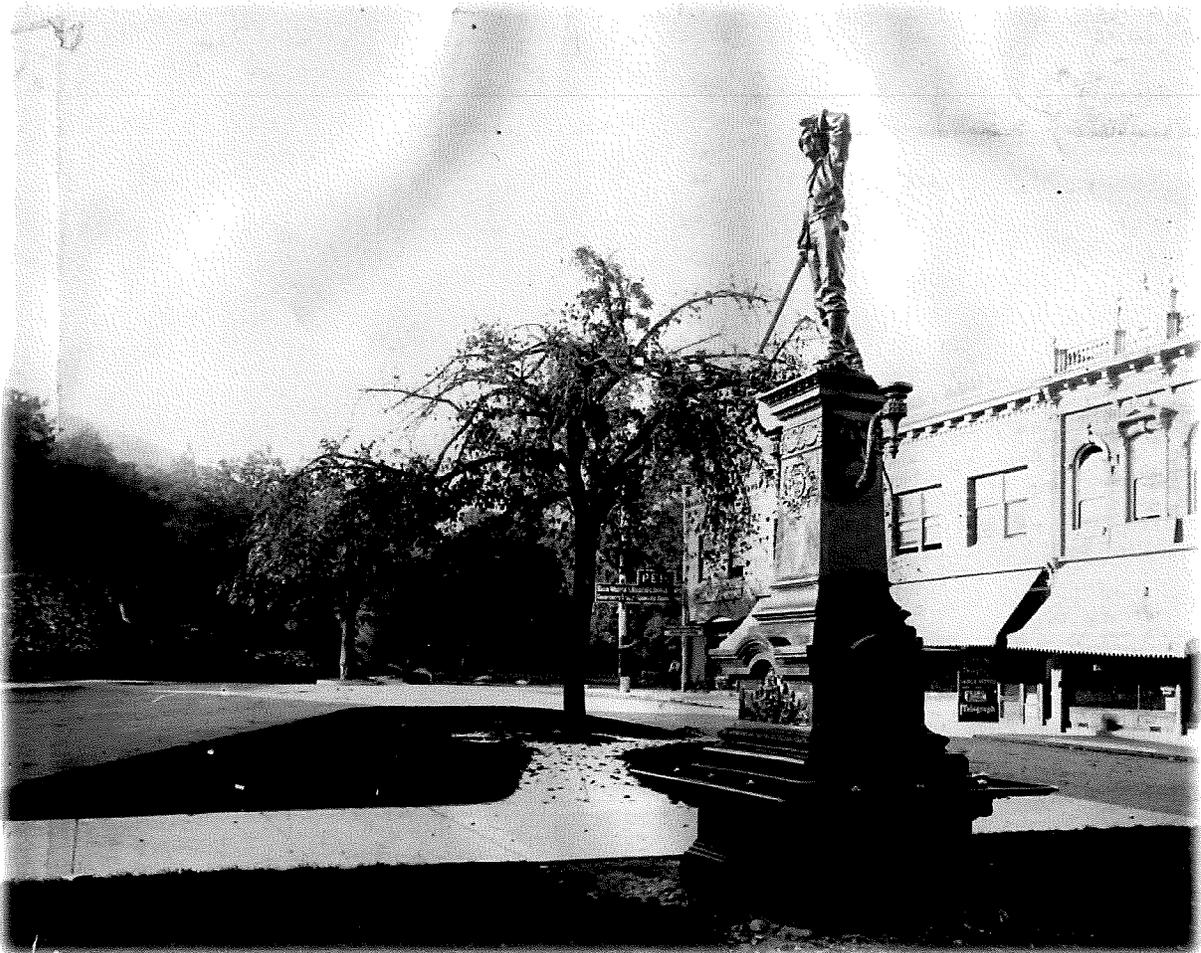
Carter Memorial Fountain, topped by Pioneer Mike, on the Ashland Plaza, 1910, shortly after dedication
SOHS Image #28294

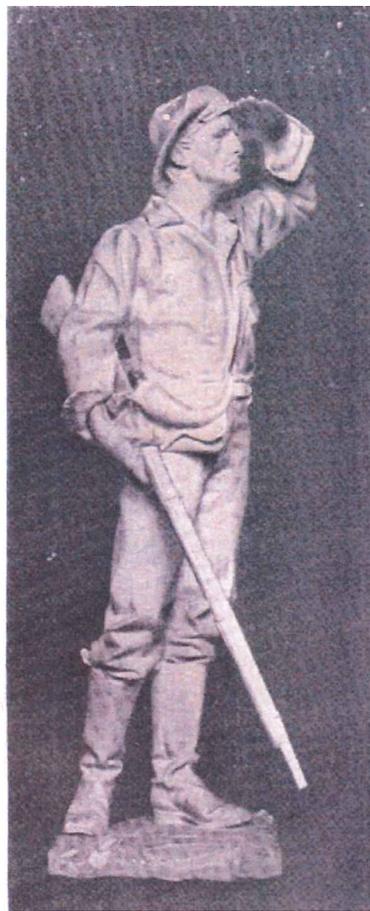
Figure 2. J. L. Mott, “Statue of Pioneer,” 1910 Catalog Cut

Plate 947-K
STATUE OF PIONEER.
Newman, Sculptor.
Height, 5 feet 6 inches.
Diameter of Base, 1 foot 5½ inches.
Price, painted, one coat.....\$200.
Price, bronzed\$215.

J. L. Mott continued to advertise the Newman “Pioneer” in its catalogs for at least a decade, between 1910 if not earlier and 1919.

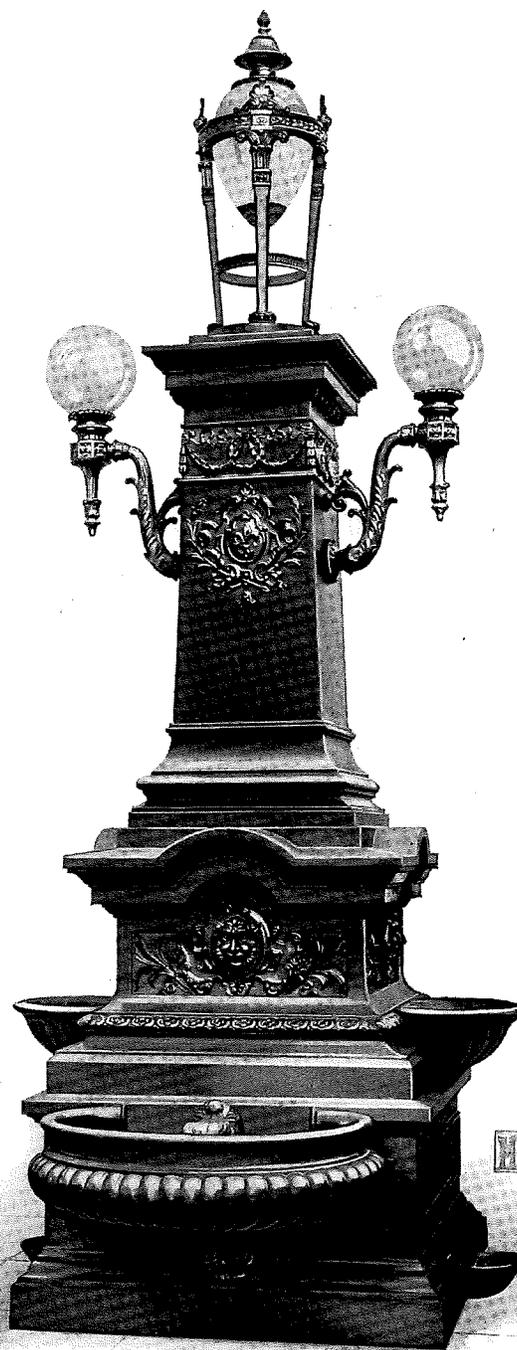
Plate 553-K

For Man, Horse and Dog.

The large fountain "base" of the Carter Memorial, also manufactured by J. L. Mott, appears to be a modification of Mott Model 553-L Fountain, for "Man, Horse and Dog." This cast-iron stacked tower, 14-feet tall to the stepped base, was slightly customized for installation in Ashland. The four projecting basins, two for horses, two, presumably, for people, of the standard design were removed and replaced with a four-sided projecting cantilevered

“tray” supported by a series of there cast iron arms (three per side). As originally designs, the fountain boasted twelve (12) individual bubblers, three on each side, that likely ran continuously, typical of the times. The dog basins, at the lowest level, were expanded from two to four, one on each of the fountain’s bottom level. The 553-K, which was “...arranged for Gas or Electric Lighting” came with two s-shaped projecting arms and torchiere bases, although Mott’s literature noted that the “Electric Light fixtures are not furnished by us.” (see Figure 3).

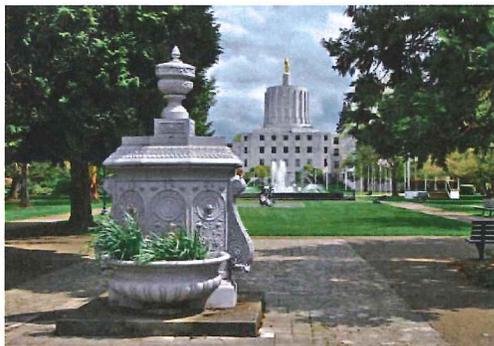
The City of Salem retained the cast iron base of the Breyman Fountain after the statue was damaged in 1917. Located on what are now the grounds of the Oregon State Capitol and under the management of the Oregon Parks and Recreation Department, the Breyman base remains as a rather odd remnant of the original design, without any water supply, obvious function, or interpretation.

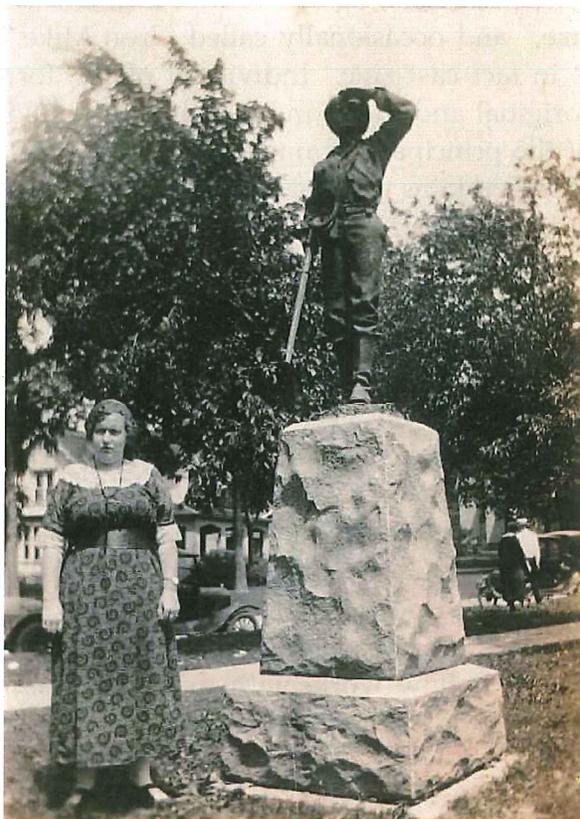
Pioneer Statue, Storm Lake, IA (1912, rebuilt 1973)

Located in Storm Lake, Iowa, the Pioneer Statue was presented to that city by "The Tuesday Club" and installed on November 15, 1912. It stands at the intersection of East Lakeside Drive and Lake Avenue, overlooking the lake, on a rough-hewn block of stone. By 1973 the statue had suffered damage from unknown causes, including a broken leg, and was removed. Recast in bronze by the Kennedy Galleries the replica was placed on the original stone base and remains on exterior display. The original zinc casting is at the Buena Vista Historical Museum (left, below). Both statues retain the original contrapposto posture.⁶

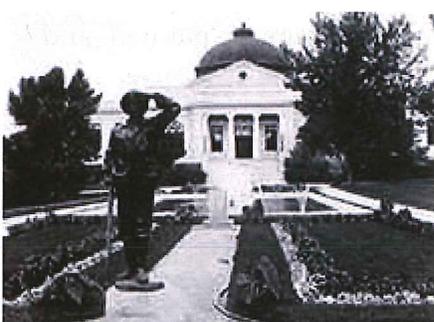
The "Minuteman," University of Northern Colorado, CO:

A gift of the class of 1911, the Minuteman stood on a rough cut stone base and was located at the edge of a garden and reflecting pool near Carter Hall on the UNC campus in Colorado Springs. According to the school's website, the Minuteman was something of a mascot and had a gossip column with "byline" in the weekly UNC paper, *The Mirror*. When an adjacent building was expanded and remodeled in 1938, the Minuteman "disappeared" and its fate is unknown.⁷

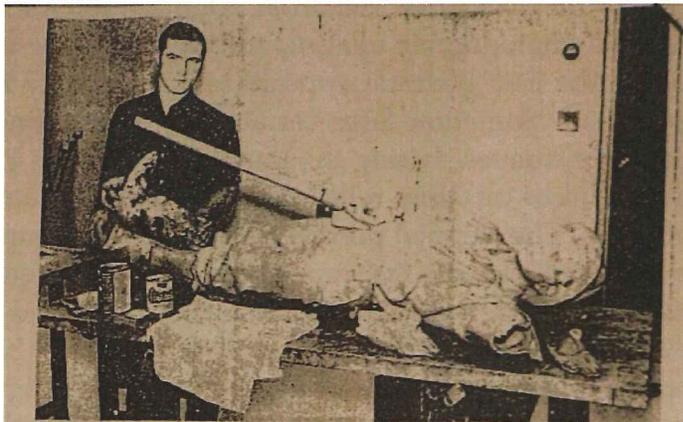
BACK BY SUMMER — The statue will be back on top of the fountain on Ashland's Plaza by summer, Ron Reinmiller, graduate student at Southern Oregon College who is working to restore it, said. (Bayley Photo)

Working with fiberglass and epoxy, Reinmiller is building a new boot and part of an arm, and repairing the rifle. The statue was made of pot metal, and it is difficult to strengthen and restore, he said.

Certainly, as shown in Figure 5, the statue was removed from the Plaza and the damage Smith reports is consistent with the repair work undertaken by Ron Reinmiller, a graduate student and "art lab assistant" at Southern Oregon College. "Working with fiberglass and epoxy (sic), Reinmiller is building a new boot and part of an arm and repairing the rifle" (*Ashland Tidings*, c1972). According to the article, Mike was to be reinstalled in June. It appears that rather than a "new" boot, Reinmiller simply modified and reinforced the original zinc while changing Mike's stance from *contrapposto*, with his left foot slightly behind and raised on toe, to the current flat footed design. Evidence of fiberglass over zinc remains.

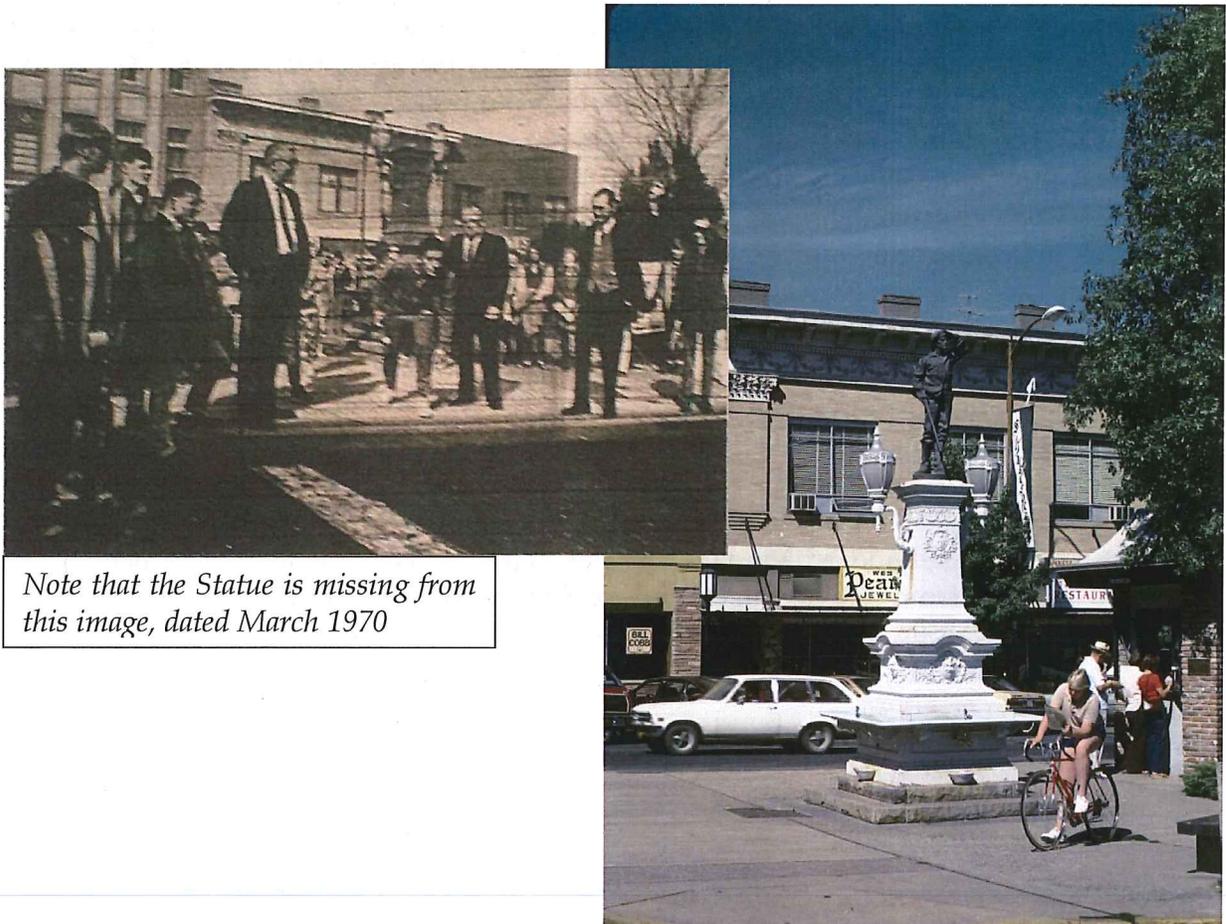
**Figure 6: Carter Memorial Fountain, 1970 (left) and as restored, c1975 (right)
(University of Oregon Image)**

Note that the Statue is missing from this image, dated March 1970

It appears that the c1972 work included the addition of support studs that allowed Mike to be physically bolted to the cast iron top of the fountain, since previously he simply sat on the fountain without any physical attachment points. Changes to Mike's rifle hand as part of the c1972 repairs are unknown, although it seems likely that at this time a bundle of copper tubing and epoxy were inserted into the rifle arm cavity in an effort to provide additional support.¹⁵ It is assumed that the reinstallation of the statue coincided with the decision to repaint the Carter Memorial Fountain base a glossy white, a major deviation from its historic scheme.¹⁶ At some point during this period, likely related to changes to the Plaza, the entire lowest plinth layer was embedded into the surrounding concrete surface, leaving only two layers of the granite exposed.

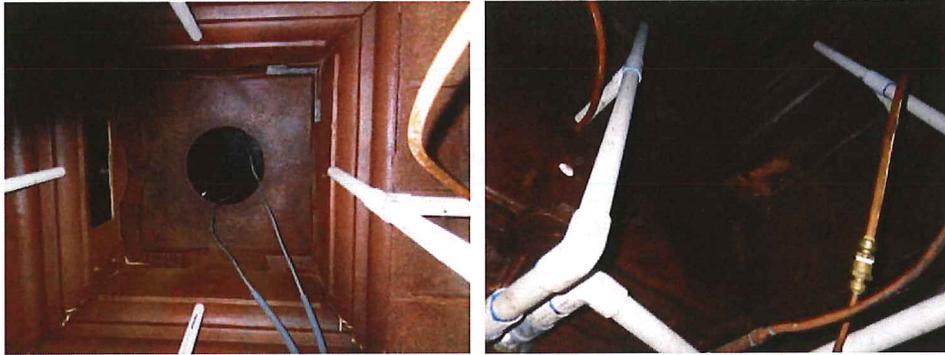
Figure 7: Carter Memorial Fountain, Interior Views, 2015 (note rusted surfaces)

The mechanical aspects of the fountain, being the water supply and drainage, electrical supply for the lighting, and a sump pump below grade, with four supply points on the fountain, has been continually rebuilt over the years and are presently in fair condition. Copper supply lines provide water to the four spigots, while PVC provides drainage. The copper was damaged during an electrical incident and have splice connectors that represent potential weak points. The dog bowls, non-operational, are vented with overflow points to the interior and there an automatic sump pump to reduce standing water. The interior of the fountain itself, subject to high humidity and standing water, exhibits a nearly complete rusted surface that should be addressed. The hollow interior of the fountain, formed by cast-iron pieces that are held together with metal screws, appears to be largely as originally installed.

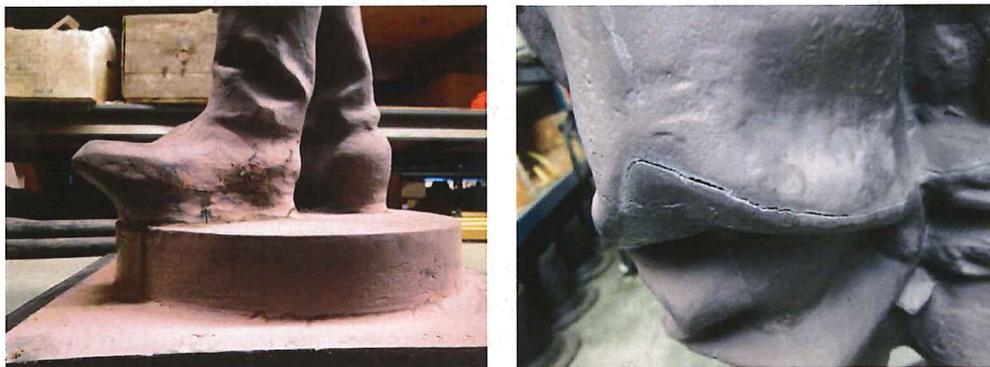
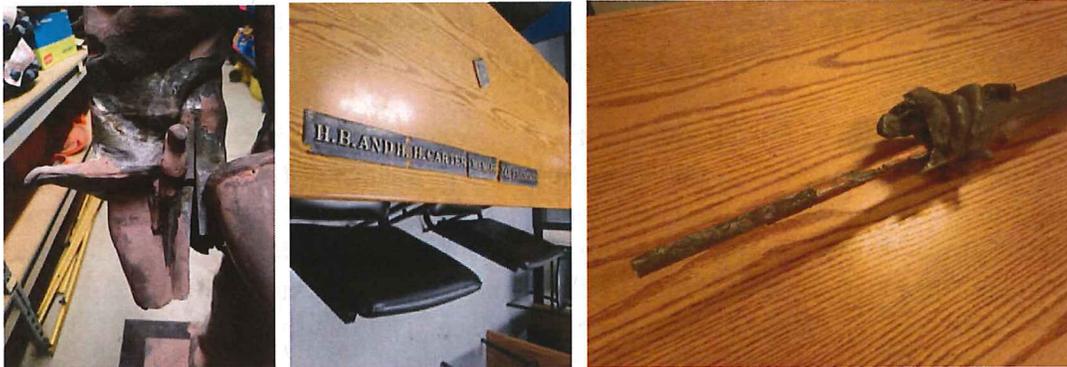
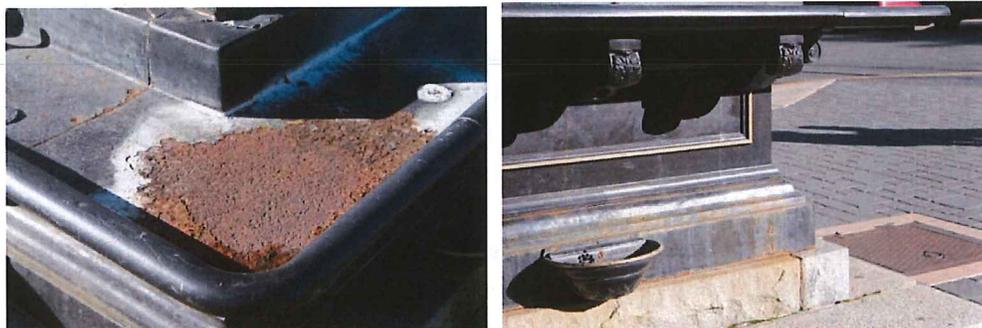
Figure 8: Carter Memorial Fountain, Current Conditions

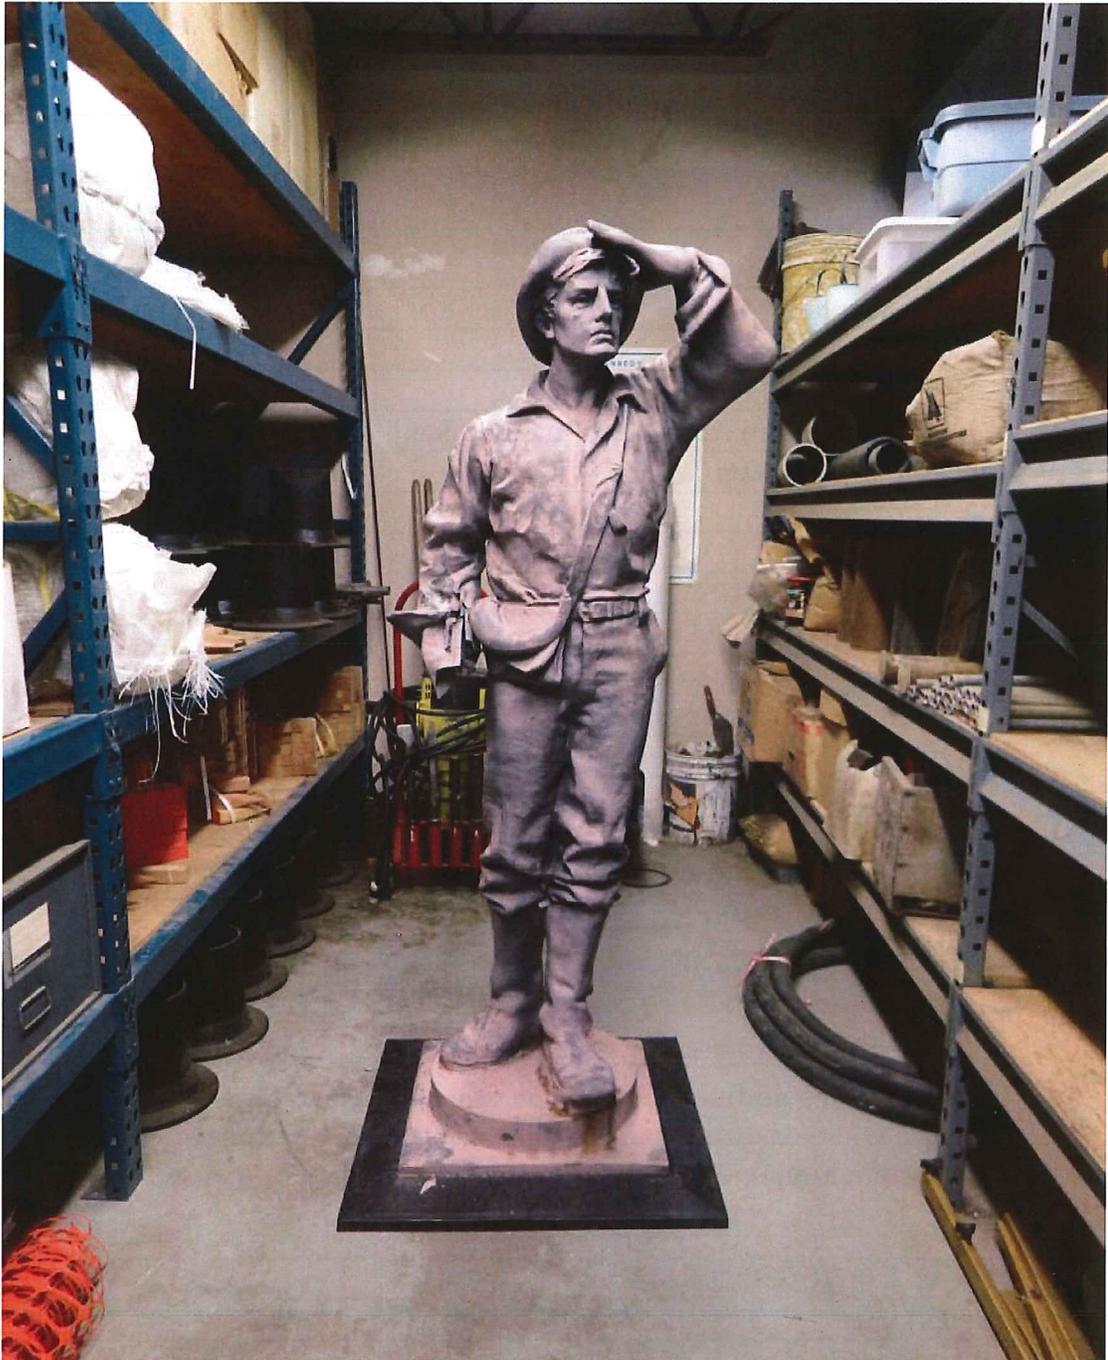
Figure 9: Pioneer Mike, at City Public Works Warehouse, February 2015

Made of cast-zinc, Pioneer Mike is a fragile work of art due to the inherent character of the material, exacerbated by more than a century of exposure and prior damage. As previous efforts of repair have demonstrated, the statue is increasingly difficult to repair; previously damaged areas create weak points that continue to "re-break" under even moderate stress.

Despite being frequently described as “Bronze,” and occasionally called “Iron Mike,” the statue atop the Carter Memorial Fountain is in fact cast-zinc. Individual plates, forming portions of the whole, were molded off the original and then sand-cast and then soldered together to form the hollow statue.⁸ “One of the principal advantages of zinc statues was that they were easily manufactured. “Since soldered joins were hidden by surface coatings, mold making could be simplified by casting in many pieces, which provided versatility” (Grissom, 2009:13). Zinc also save money over similar work in bronze or iron and, as a result, became a popular material for fountain and statuary manufactures beginning in the early 19th century and continuing through World War I. Zinc was especially popular during the period after 1870, as towns across the country matured and many expressed their civic pride through the installation of public works of art, often with monuments to Civil War heroes or, in the West, civic leaders. Zinc’s advantages, in addition to its easy workability and lower costs, were its resistance to short-term water damage. A non-ferrous material, zinc does not rust as does iron. Still, zinc was often challenged as an ‘imitation’ material, one that was frequently coated to appear as what it was not. Cognizant of that, some fabricators, including J. L. Mott, often marketed their zinc works, or alloys of zinc, copper and tin, as “White Bronze” (Grissom, 2009:18). Zinc is a particularly brittle metal and, with exposure to the elements, becomes more so. As hollow work, with thin shell, cast-zinc statuary has limited resistance to force and can break or shatters easily on impact.

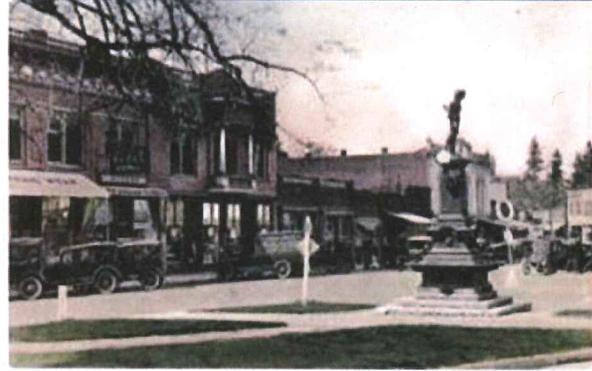
CARTER MEMORIAL FOUNTAIN, PHOTOGRAPHIC TIMELINE, 1910-1936

November 1910	Circa 1915	Circa 1926 (Prior to Lithia Fountain installation)	Circa 1932	Circa 1936s
Taken shortly after installation, this card is dated Nov 12, 1910. Note lack of three-step granite plinth at base, twelve bubblers, round light globes (G. Kramer Collection).	Granite plinth installed Repainted 1913 AT, 10-July-1913 Repainted with "gold trimmings," AT 1-July-1915	Note change in Plaza grade, partial encapsulation of granite plinth.	Note change to lamps, this image is assumed to show the fountain post-truck damage of October 1931. See AT 28-Dec-1931, 26-Feb-1932. Repainted 5/1937, Council considered moving the CMF in 7/1938 but did not.	Note change to four bubblers, down from twelve (one per side, not three), changes to Plaza included more concrete (Neon sign will be installed in 1937)
