# Fall Chinook Spawning Survey @ North Mountain Park

November 2, 2012

Conducted by: E. Wier, The Freshwater Trust, eugene@thefreshwatertrust.org (541)-227-9858

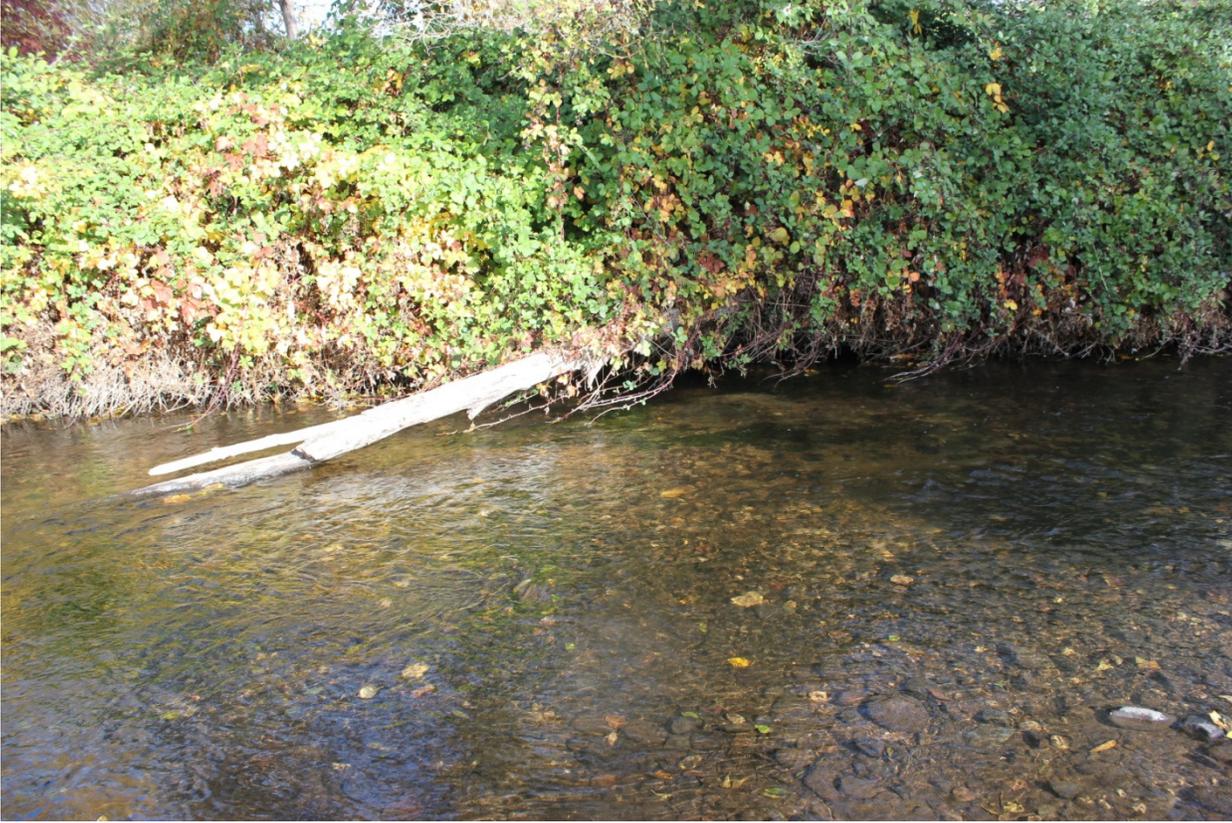
**3 redds and 0 live fish were observed.** This reach has limited spawning habitat, due to the substrate being dominated by bedrock. The redds that were observed centered on the same location where spawning was observed last

year, where a small log extends into the creek from the right bank about half way through this reach. **0 carcasses'** were seen.

Figure 2. 3 redds but no live fish were observed in 2012, however it is worth noting that this was the only place spawning was observed in this reach in 2011 and 2012. This log is the only piece of wood over 6" diameter in the reach.

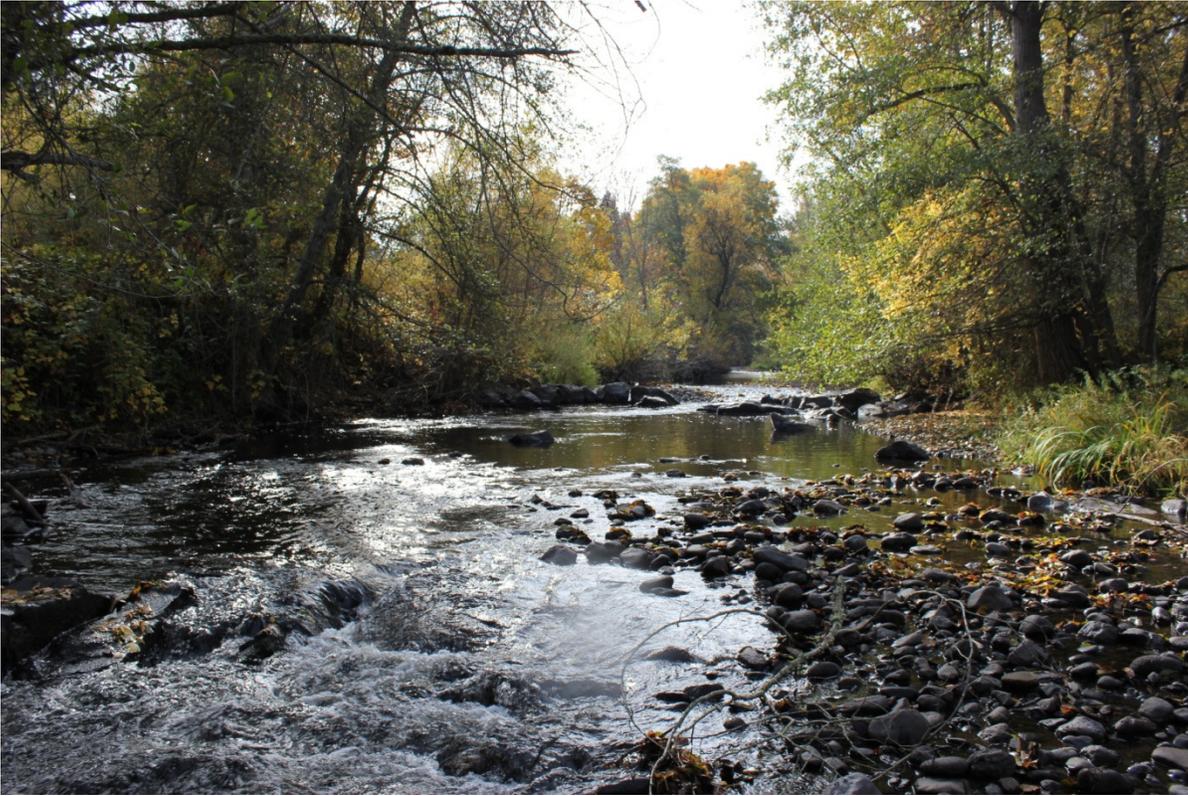
**2 live fish** were observed, and **1 active redd. 3 additional redds** were observed within the reach. 1 dead fish scavenged by raccoons was seen on the waters edge. Raccoon tracks and otter tracks were seen along the banks, primarily in the upper 1/3 of the reach (figure 3). The highest amount of activity was in the lower 200' of this reach and then activity dropped off until between the two upper most weir structures, where a couple more Redds were observed. No trout were observed this season despite relatively low flows and turbidity.

Figure 3. Upper 1/3 of NM Park survey reach.

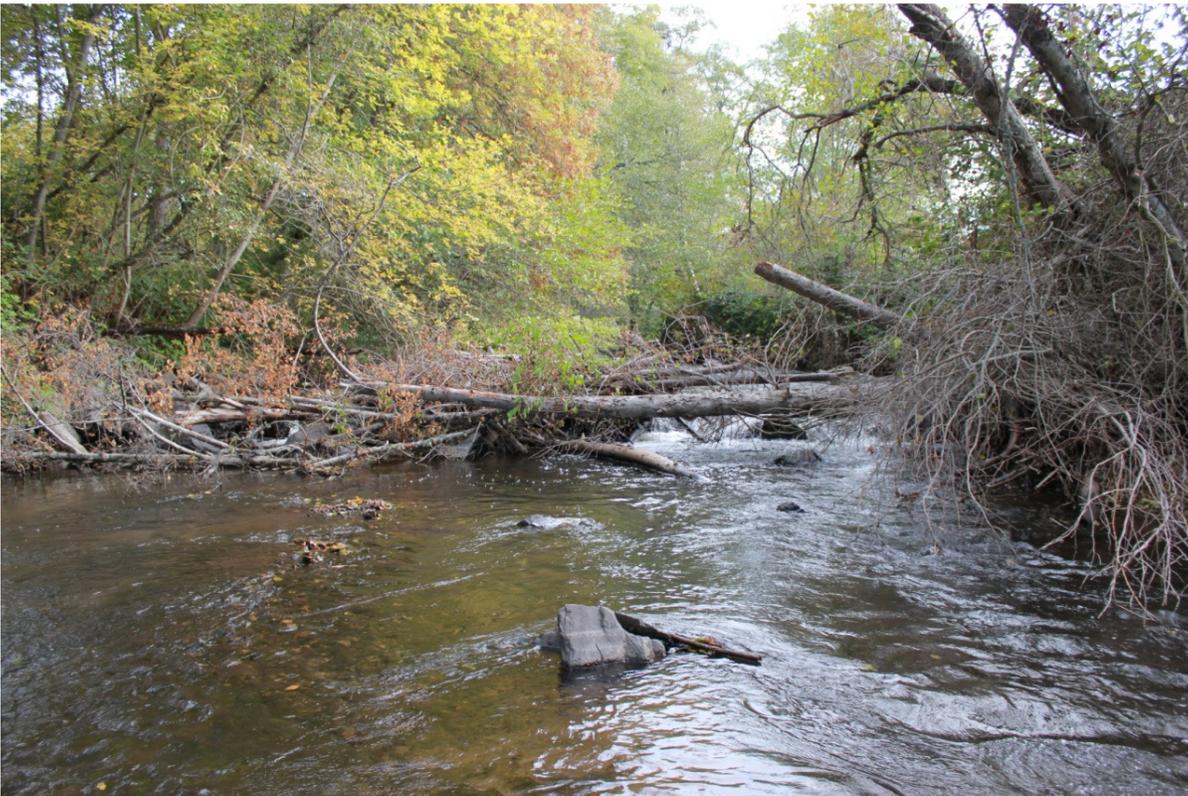
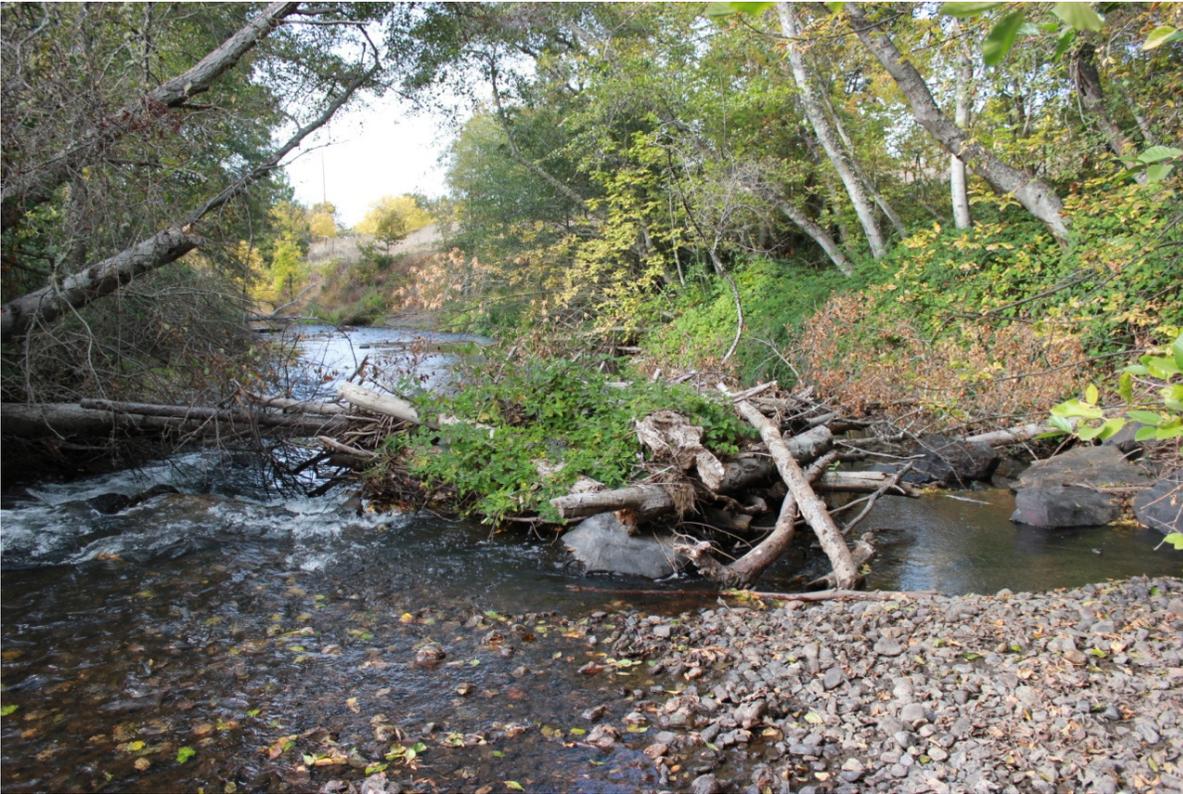
Figure 4.

Figure 4-5. Boulder weirs have trapped wood and improved pool habitat, as well as sorting spawning gravel. The weirs retained wood in a similar fashion in 2012 as seen in these 2011 photos.

In the years following the installation of the boulder weirs at N. M. Park I was asked by my supervisor (Su Mayo, USFS) to conduct spawning surveys throughout the areas detailed in this survey. As I recall the results of those surveys were similar to what was observed on this visit. The weirs appear to alter the channel conditions in a way that salmon prefer to the up and down stream surrounding habitat.

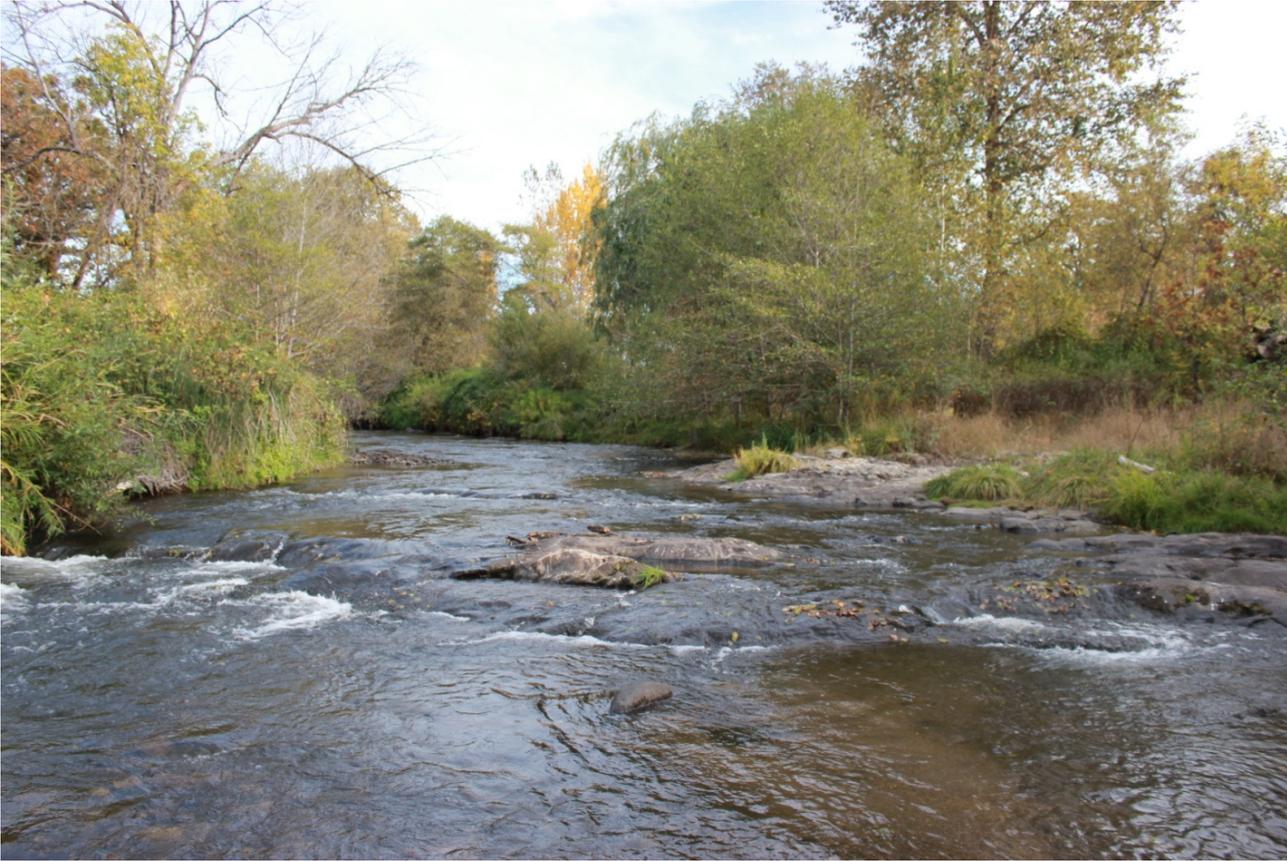
From the upper end of N.M. Park up to Willow Wind schools property I observed **0 live fish** and **0 redds**. The habitat in this reach is a mix of bed rock and shallow gravelly runs broken by lateral pools that are generally deeper than those observed in the lower two reaches. Although there seems to be more gravel in this reach than the other two, it is highly embedded and fish seem to reject it, as evidenced by lack of redds. This reach would benefit from instream structures that helped sort gravel and create drops in the gradient the help scour out fines.

Figure 8. The beginning of Willow wind reach looks much like sections of River Walk reach, where bedrock dominates.
