Fall Chinook Spawning Survey @ North Mountain Park

October 20, 2011

Conducted by: E. Wier, RVCOG ewier@rvco.org (541)-423-1368

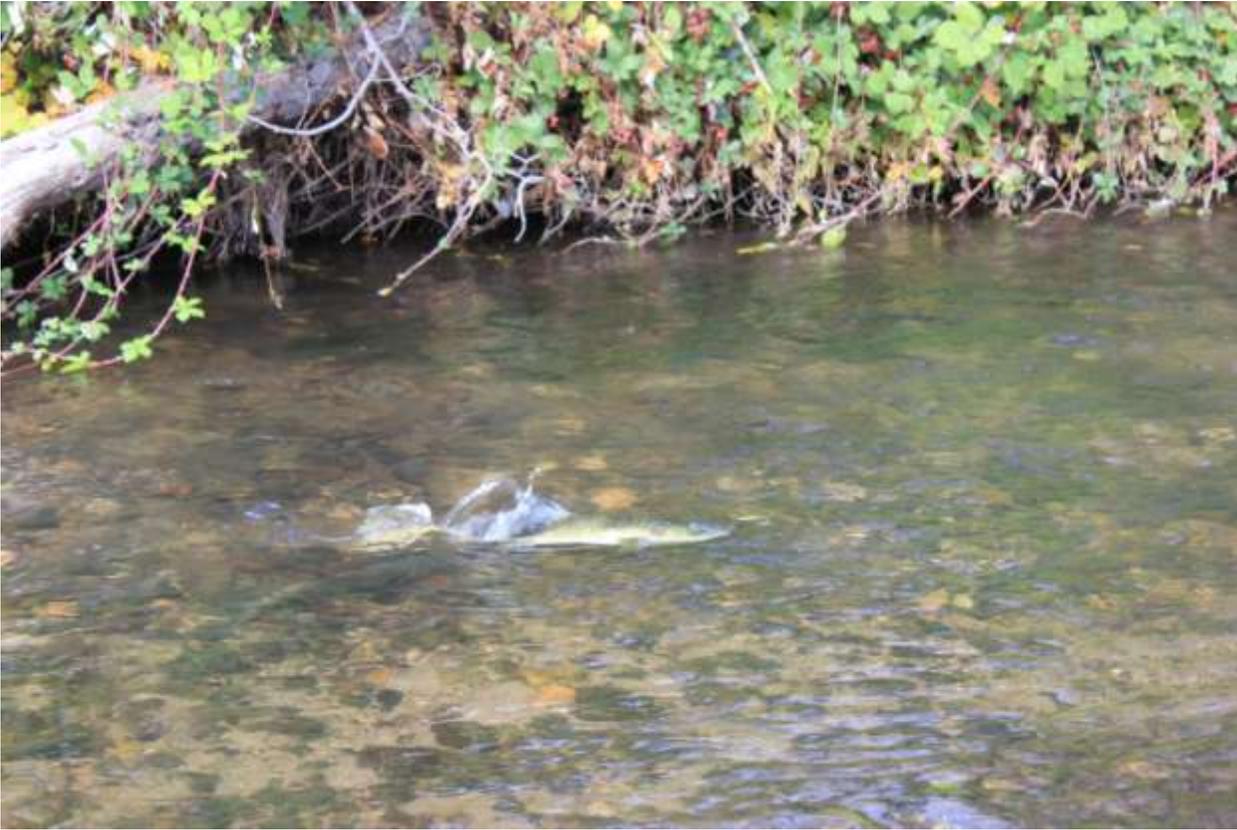
3 live fish were observed and **1 active redd**. One of the fish was decaying and was seen resting in a slow pool. The other two salmon were on a redd at a location where some wood protruded from the bank. This reach has limited spawning habitat, due to the substrate being dominated by bedrock.

Figure 2. A pair of spawning Chinook in the River Walk reach.

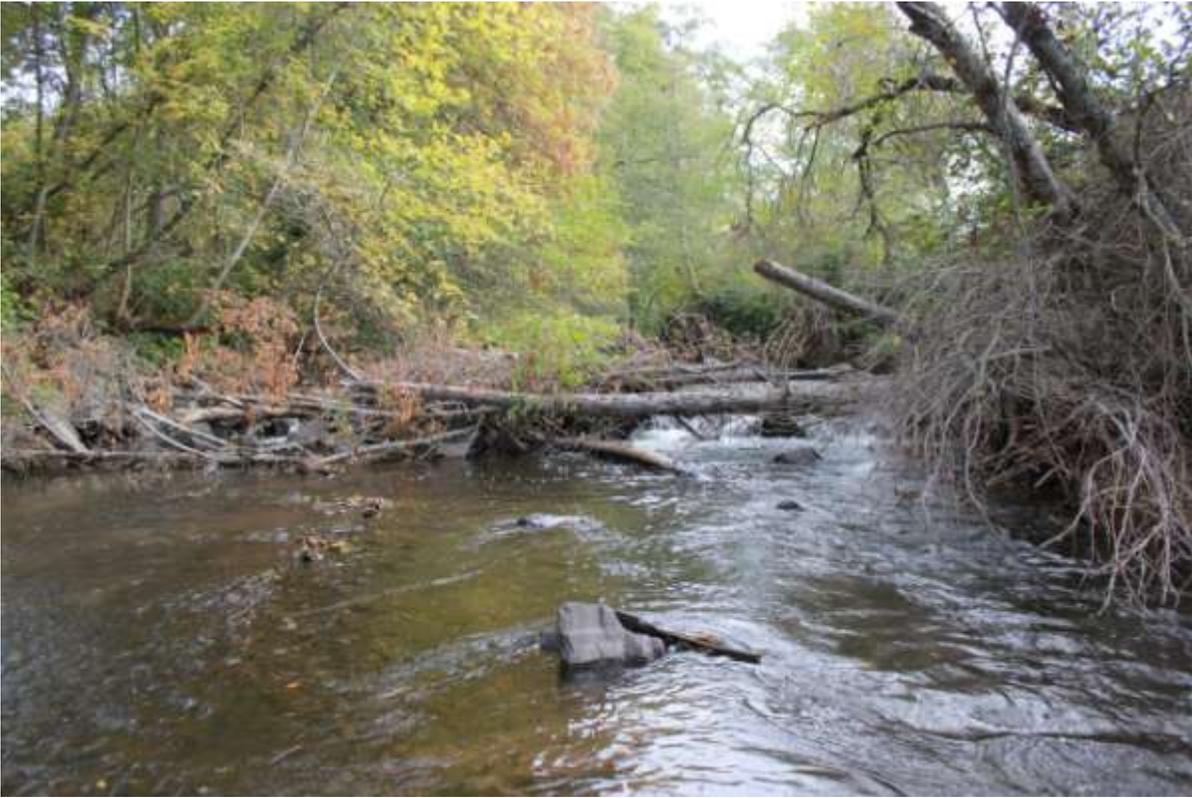
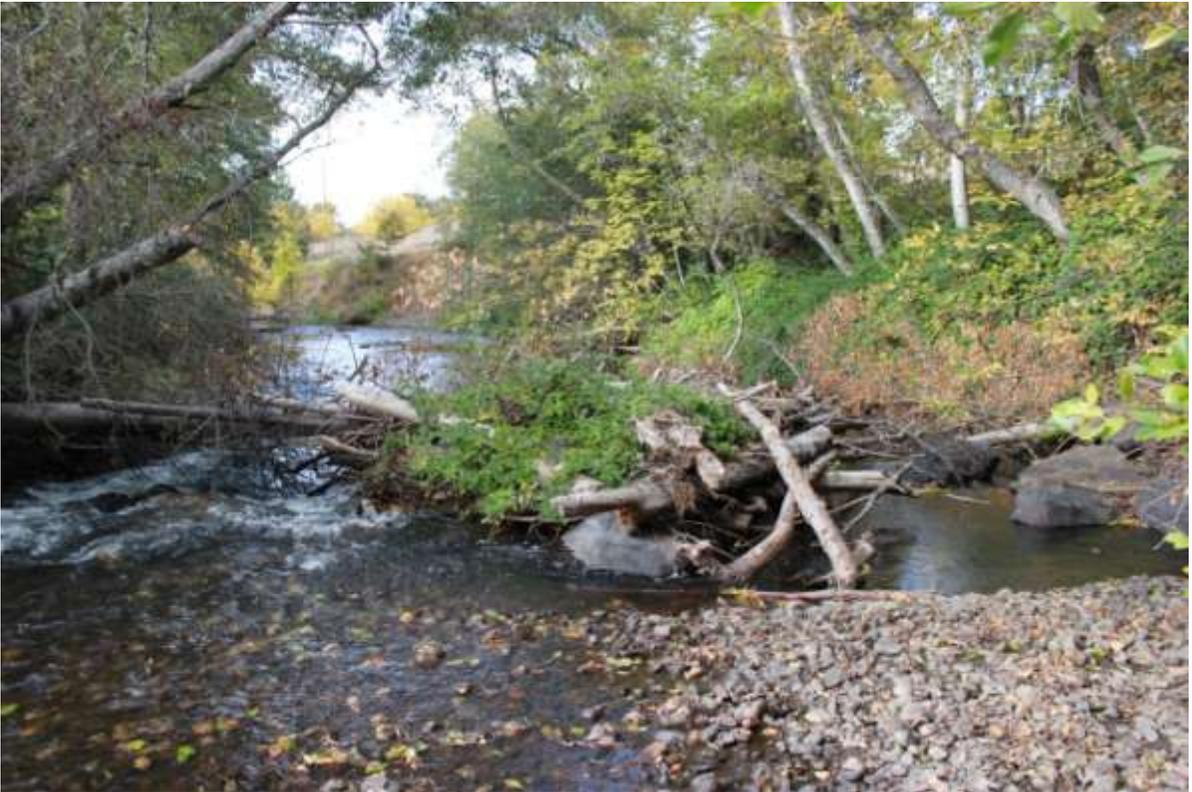
Figure 4-5. Boulder weirs have trapped wood and improved pool habitat, as well as sorting spawning gravel.

In the years following the installation of the boulder weirs at N. M. Park I was asked by my supervisor (Su Mayo, USFS) to conduct spawning surveys throughout the areas detailed in this survey. As I recall the results of those surveys were similar to what was observed on this visit. The weirs appear to alter the channel conditions in a way that salmon prefer to the up and down stream surrounding habitat.

I recommend that we resurvey this reach for fall Chinook on an annual or bi annual basis so that we can continue to document the presence of this species and continue to evaluate the effectiveness of the boulder weirs and future habitat improvement projects.

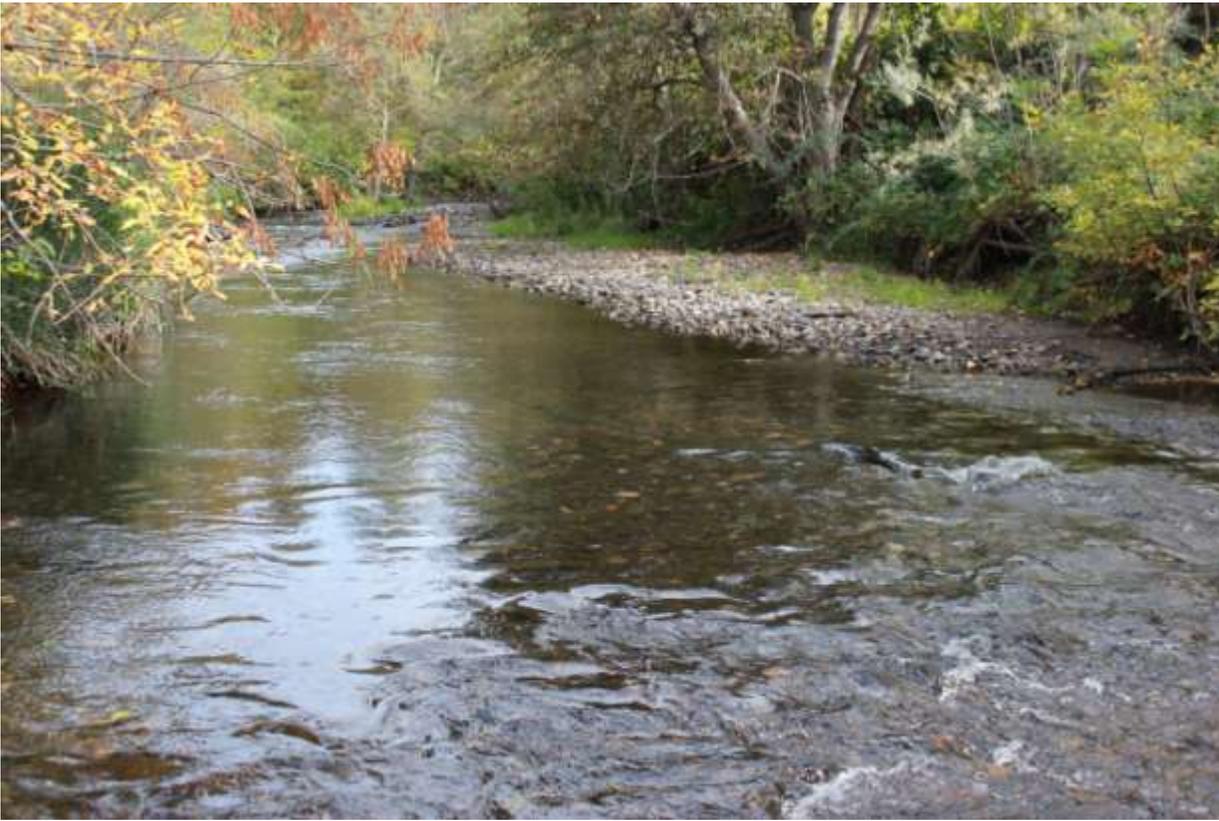
Figure 6. Large Chinook with back out of water while defending a redd.

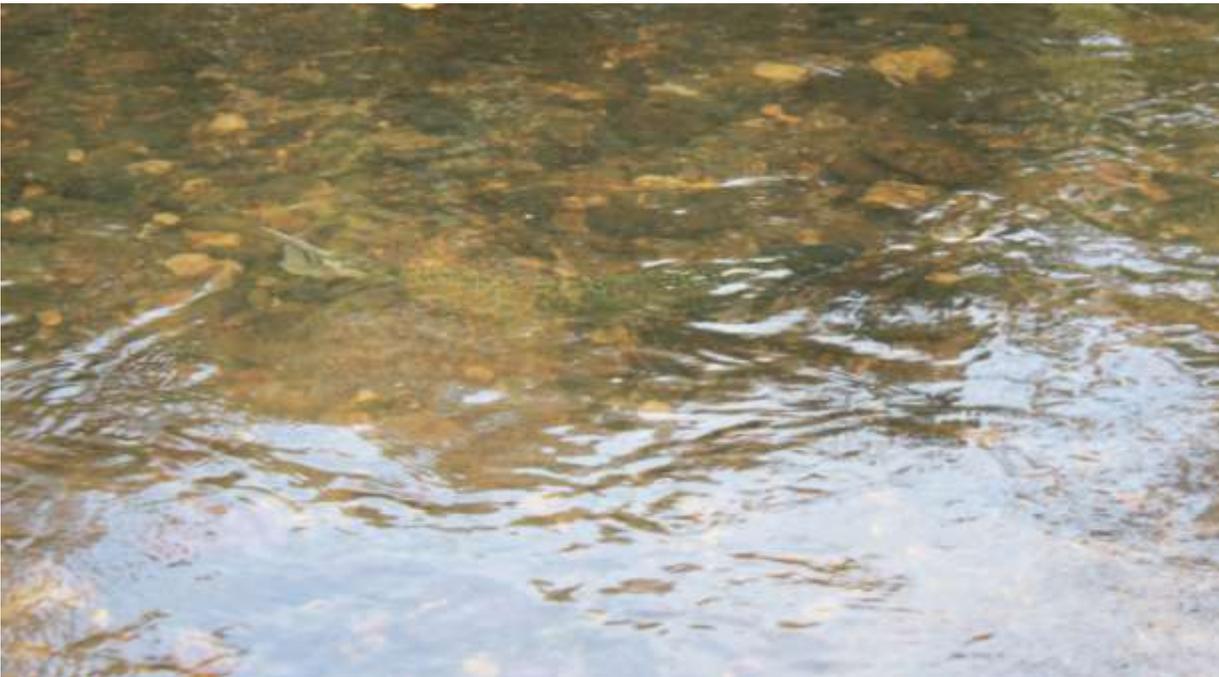
Figure 7. Bright Chinook on a redd.

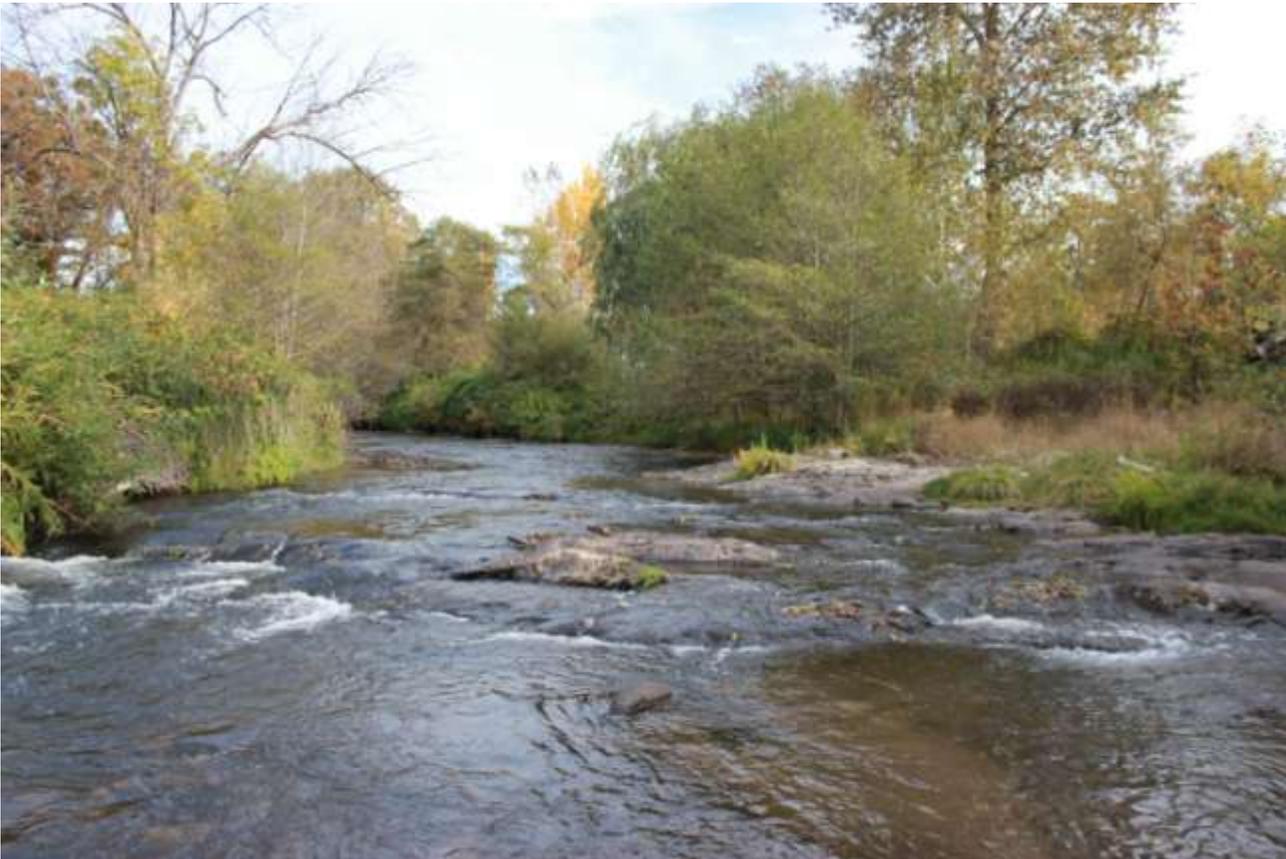
From the upper end of N.M. Park up to Willow Wind schools property I observed **2 live fish** and **no redds**. The habitat in this reach is a mix of bed rock and shallow gravely runs broken by lateral pools that are generally deeper than those observed in the lower two reaches. The live fish I observed were resting in pools. Although there seems to be more gravel in this reach than the other two, it is highly embedded and fish seem to reject it, as evidenced by lack of redds.

Figure 8. The beginning of Willow wind reach looks much like sections of River Walk reach, where bedrock dominates.

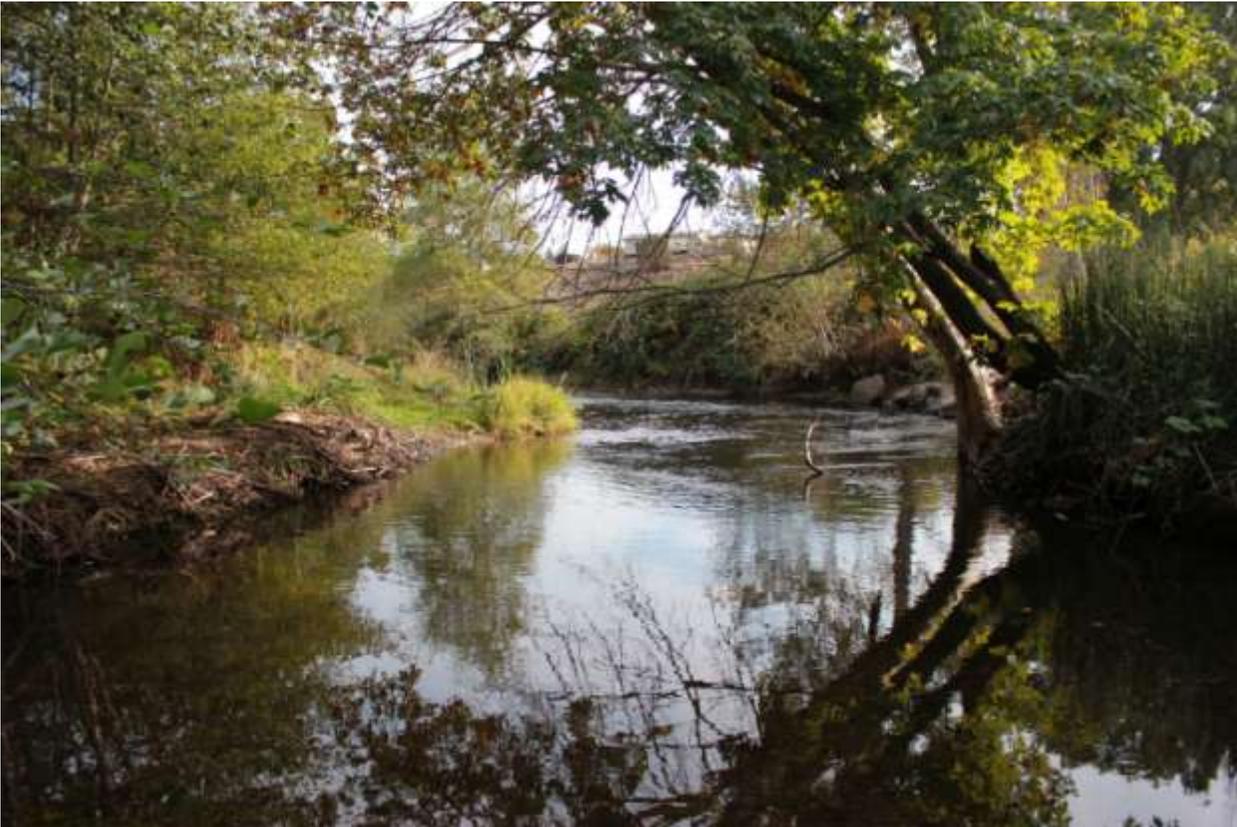
Figure 9. Deep slow pools in Willow Wind reach looked good but the tail outs did not have spawners like expected. Notice the accumulation of beaver chewed sticks on the left bank.

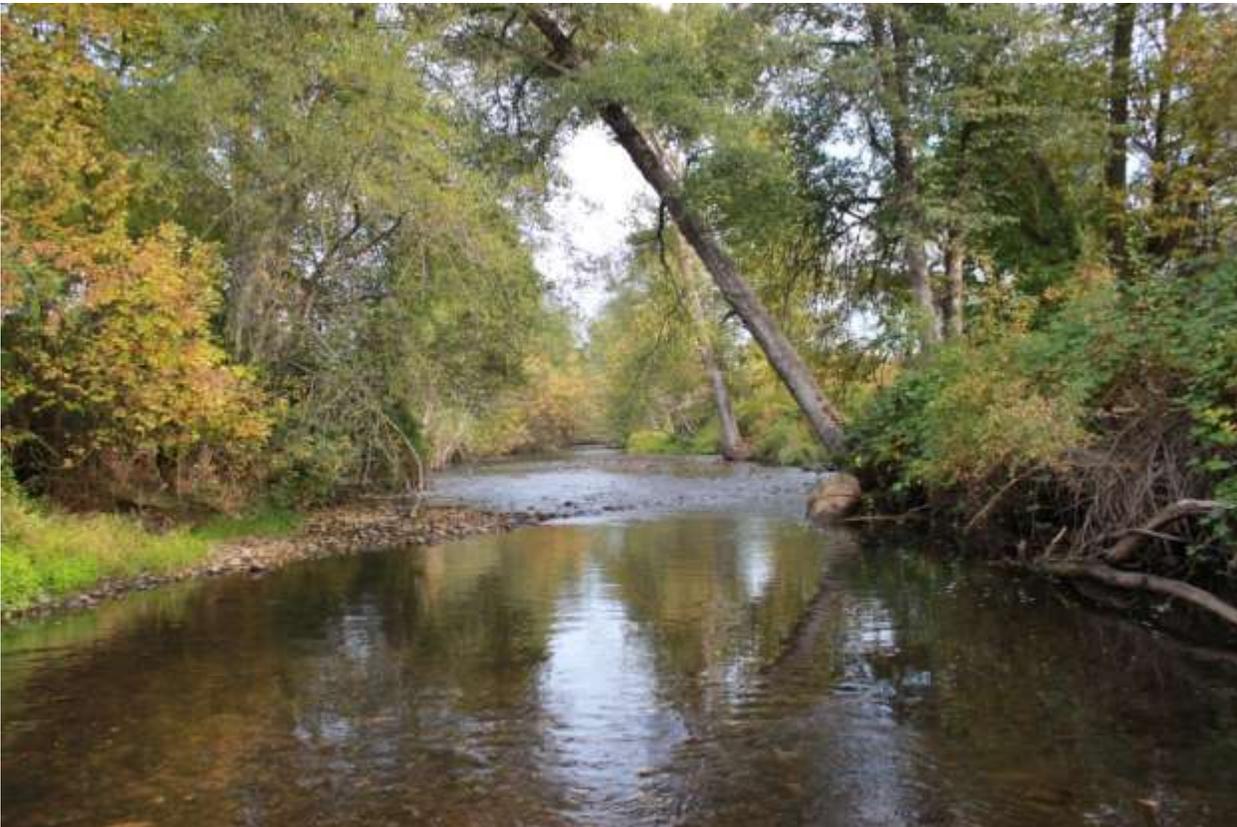
Figure 10. Nice riparian habitat in willow Wind reach, but it lacked spawning fish.
