Council Business Meeting

| Agenda Item | 10x20 RFP Review | |

City staff has refined, based on Council direction from the study session of September 17, the Request for Proposals (RFP) for a large scale (10-13 MW) solar generation project to be located on the City owned Imperatrice Property. The intent of the RFP is to solicit and receive current, market-based proposals to assist in determining the cost to the City for the generated electricity as well as a realistic timeline for completion of the proposed project. Staff is requesting direction from Council for any additional edits that Council sees fit and for authorization to release the RFP.

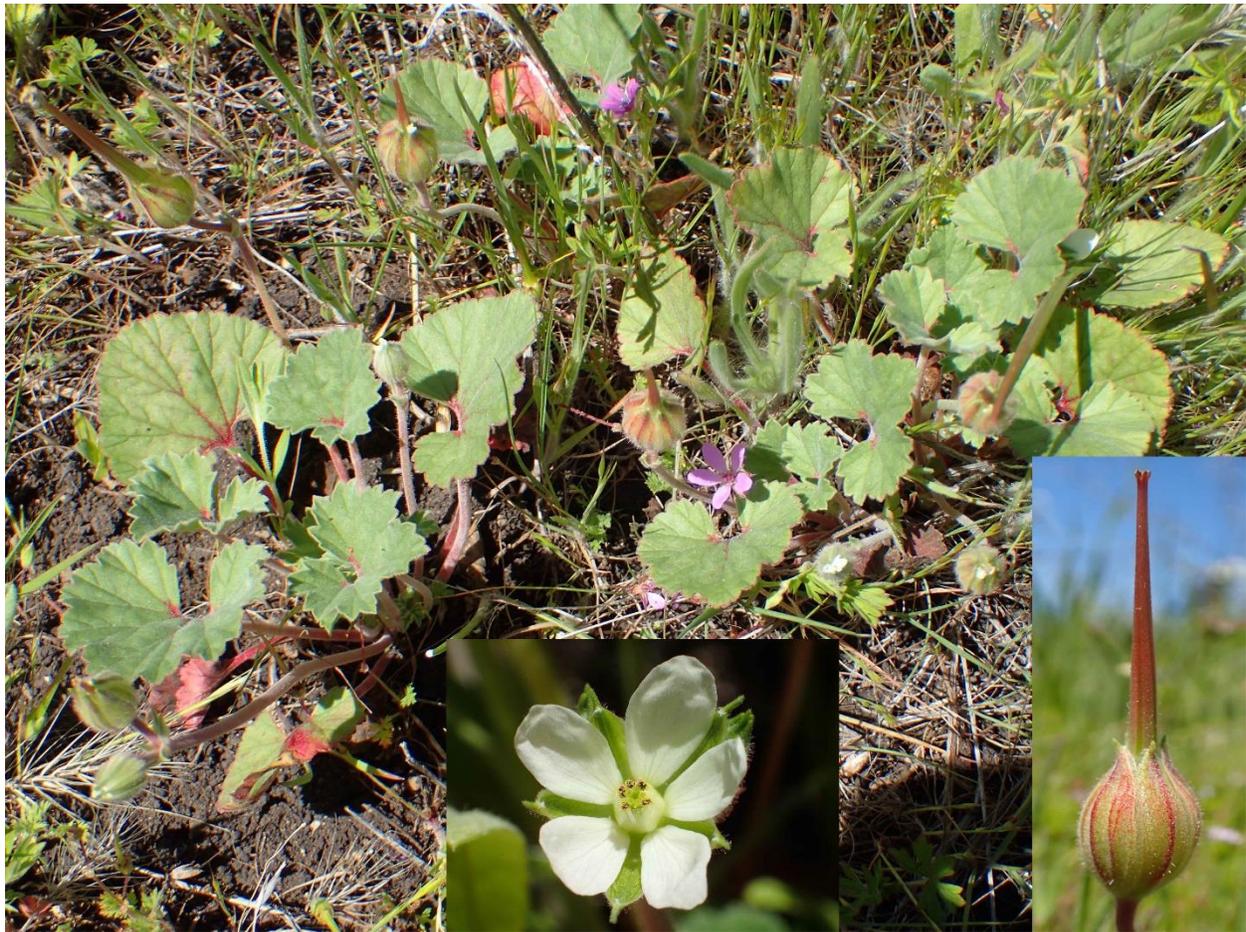
Figure 4: *California macrophylla* specimens

Plants, with fruit (lower right inset) and flower (bottom center inset)

Fourteen populations (Figure 3) of *California macrophylla*, (Figure 4) totaling approximately 8.0 acres, were found in the Study Area. This species was originally documented in Oregon by Thomas Howell in 1887, with the associated herbarium collection noting “hills near Ashland”. It is possible that his original collection was made at one of the Study Area populations. ORBIC previously listed this species with an “EX” status (assumed to be extirpated in Oregon) until Pacific Crest personnel discovered a new location near the city of Eagle Point, Oregon. Since then, five populations were found in the Study Area by Kristi Mergenthaler and ODA personnel (personal communication, Kristi Mergenthaler, Southern Oregon Land Conservancy, 4/25/17). *California macrophylla* is currently listed by ORBIC (2016) with a “1” status (threatened or endangered throughout its range), the highest list status that ORBIC can assign. This species may soon receive additional listing through the State of Oregon. The Oregon sites represent the northern-most known extent of this species; it is also known from California and Baja California. The California Native Plant Society (2017) lists *California macrophylla* as a 1B.2 (rare, threatened, or endangered in CA and elsewhere).

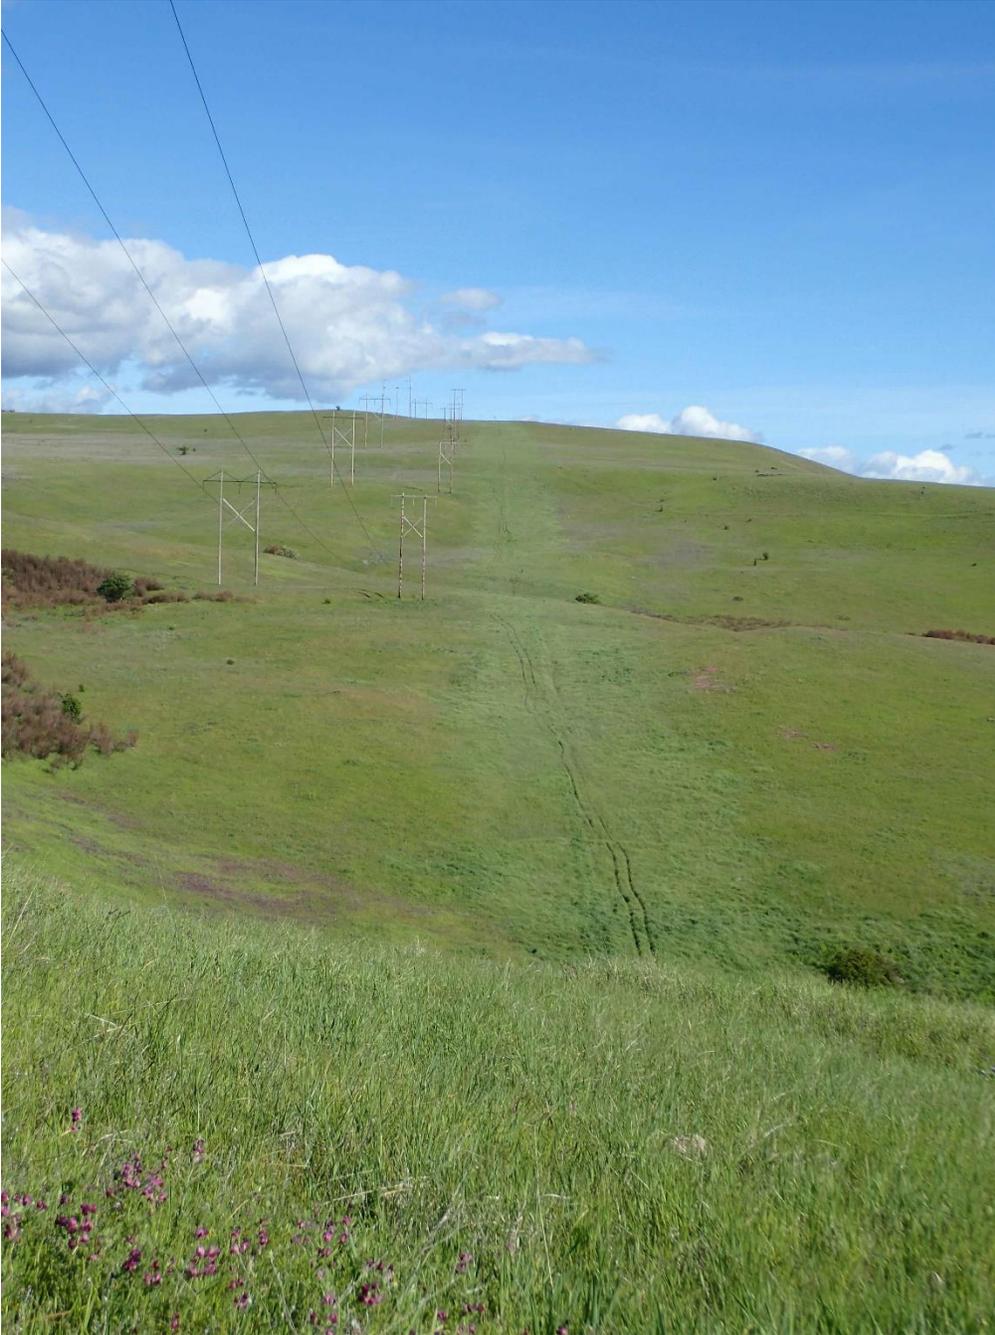
View of powerline and gas pipeline corridors on the Property; the pale strip from top to bottom, just left of center, with OHV tracks, is a *Thinopyrum ponticum* monoculture atop the buried gas pipeline (see 3.3 Noxious Weeds)

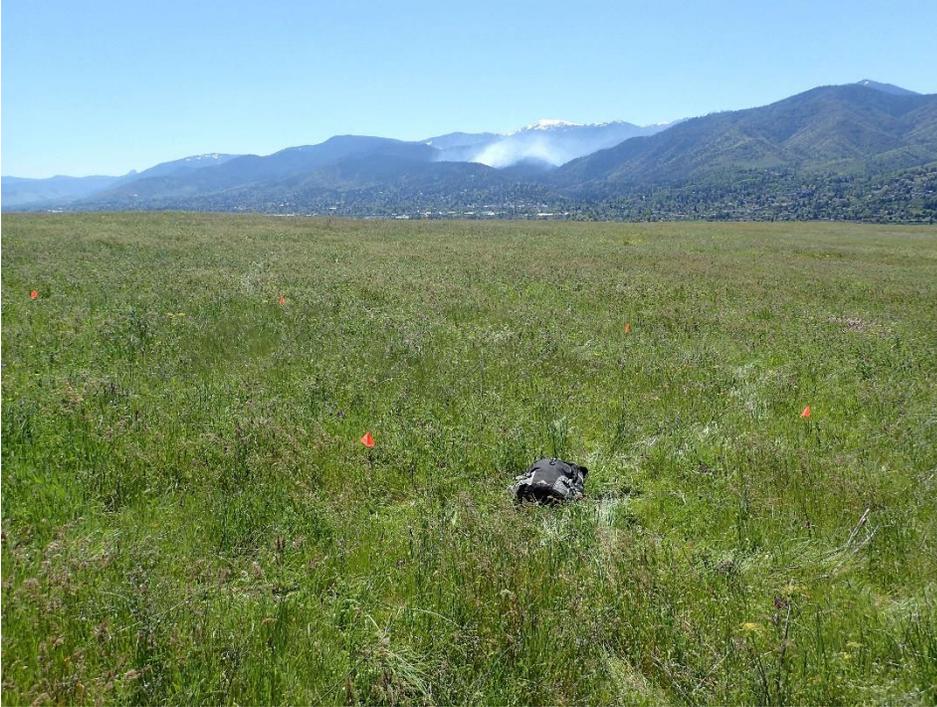
Pin flags delineating a *California macrophylla* population; background: controlled burning (smoke) from the Ashland Forest Resiliency project within the Ashland Watershed

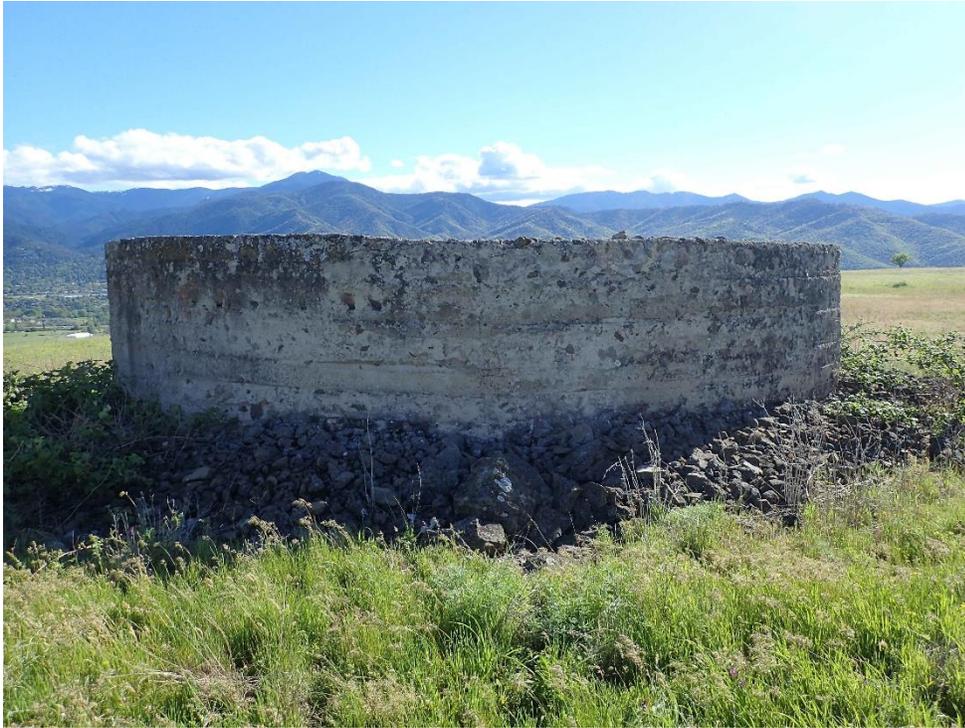
Cement “cistern” on broad ridgeline
