# Council Business Meeting

<b>Agenda Item</b>	Community Center and Pioneer Hall Ad-Hoc Committee Recommendations	
<b>From</b>	Scott Fleury PE Kaylea Kathol Rachel Dials George Kramer	Public Works Director Senior Project Manager Recreation Superintendent Historic Preservationist
<b>Contact</b>	<a href="mailto:Scott.fleury@ashland.or.us">Scott.fleury@ashland.or.us</a> <a href="mailto:Kaylea.kathol@ashland.or.us">Kaylea.kathol@ashland.or.us</a> <a href="mailto:Rachel.dials@ashland.or.us">Rachel.dials@ashland.or.us</a>	541-552-2412 541-552-2419 541-552-2260

## **Winburn Way Community Center/Pioneer Log Cabin**

**REPORT TO THE ASHLAND CITY COUNCIL**  
**21-September-2021**

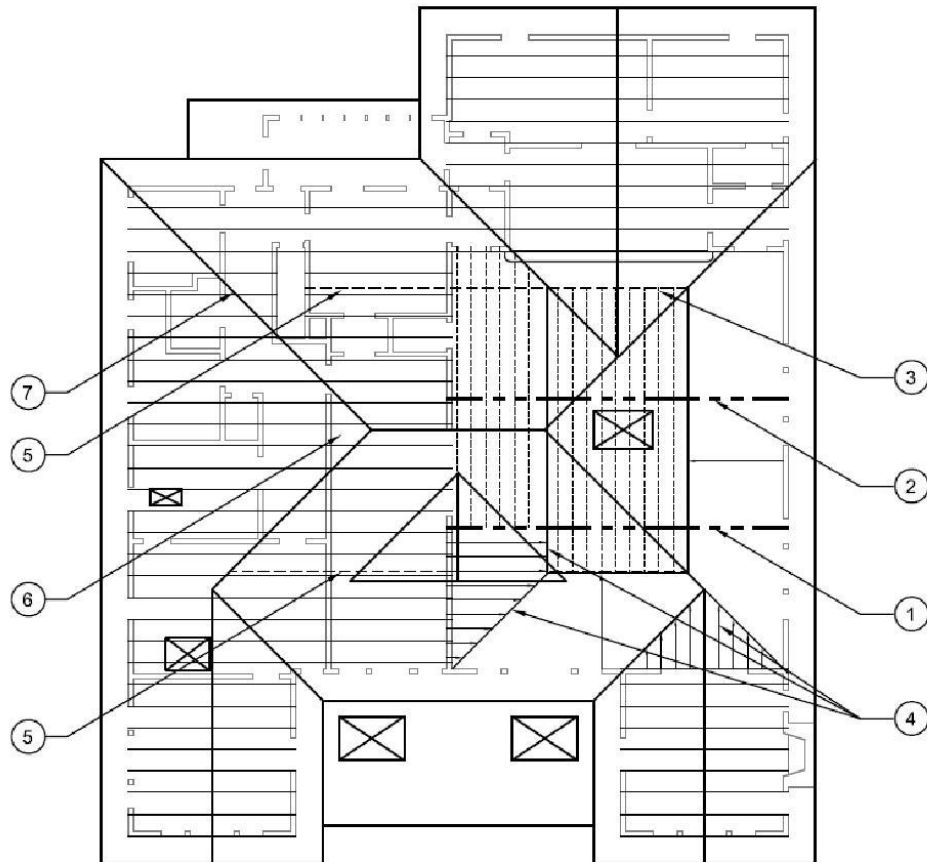
Please refer to this sketch showing the approximate As-Built ceiling framing of the Ashland Community Center.  
Keynote comments are listed on page 4.

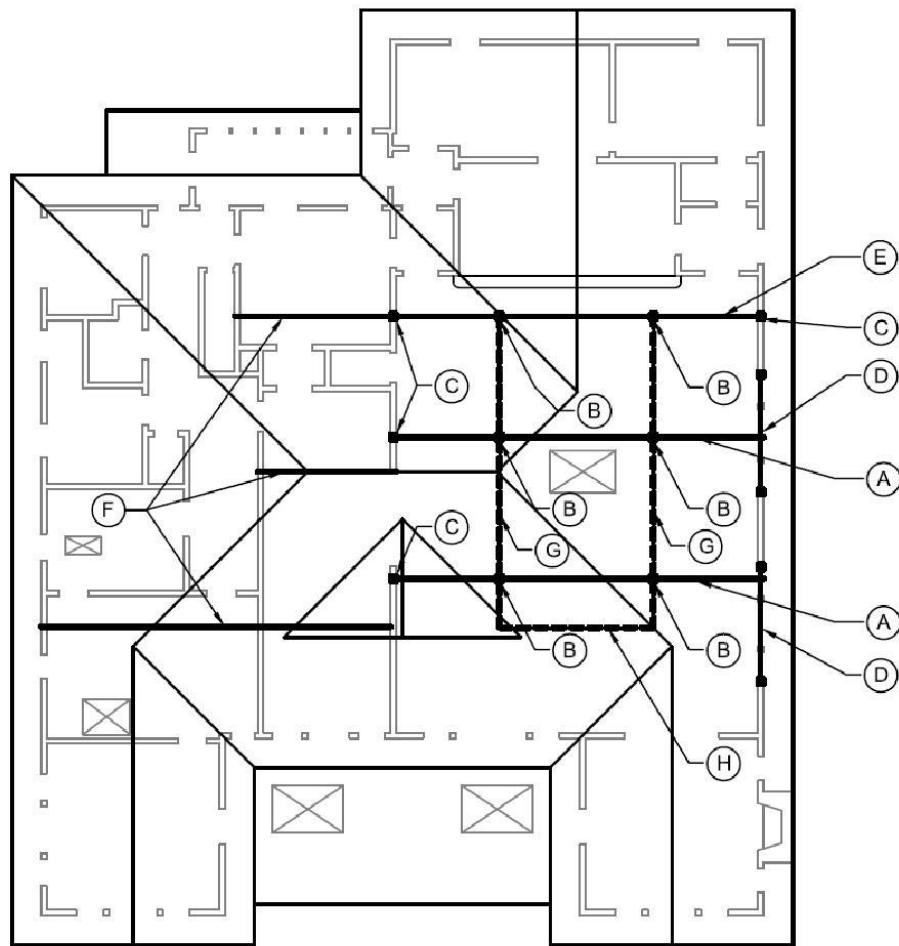
Please refer to this sketch for all references made in the Keynote recommendations:

(D) should be installed plumb on the interior, and extend through the existing floor to new pier pads below.

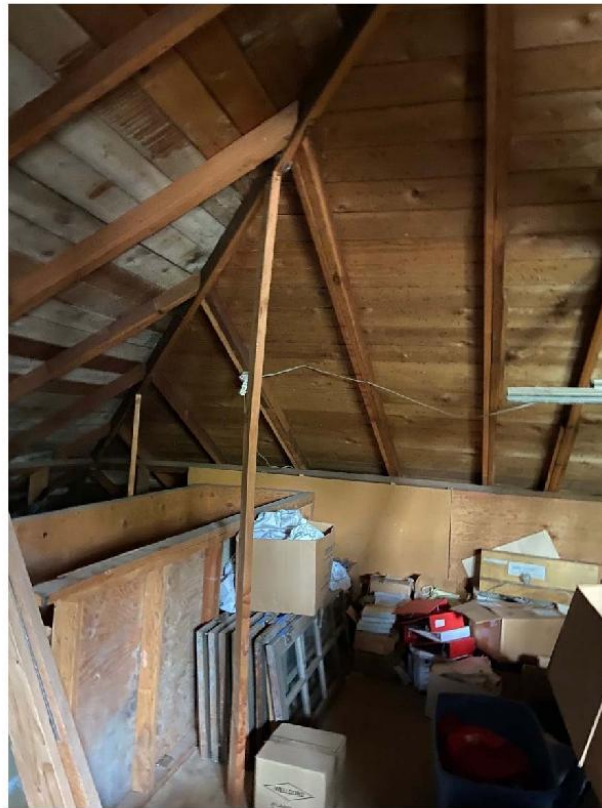
Analysis:

Existing supports for hips are insufficient.
