# Public Arts Advisory Committee Agenda

PUBLIC ARTS COMMISSION  
REGULAR MEETING  
November 18, 2022  
*DRAFT* Minutes

CONDITION ASSESSMENT AND RECOMMENDATIONS

Ashland Parks Foundation | July 26, 2022, Rev. 01 October 05 2022

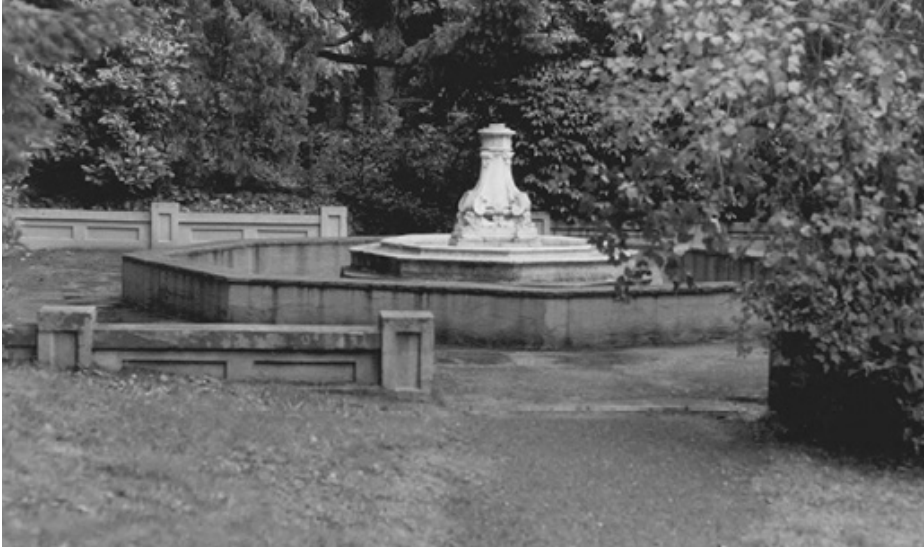
*Butler-Perozzi Fountain, circa 1981 before restoration. Note the missing light posts and fountain bowls.*

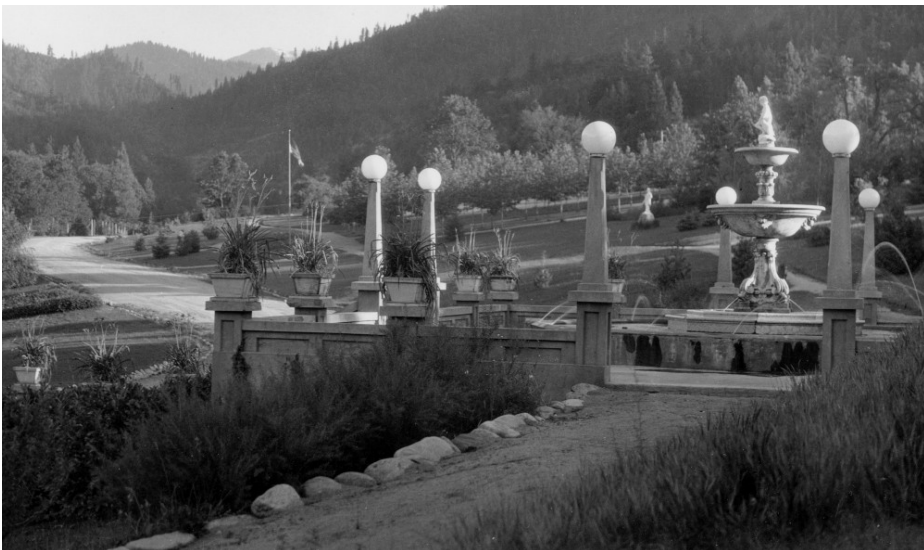
*Butler-Perrozi Fountain, undated. Note the water feature that spouts water from the outer rim of the fountain pool, toward the lower bowl. No sign of this feature is currently visible.*

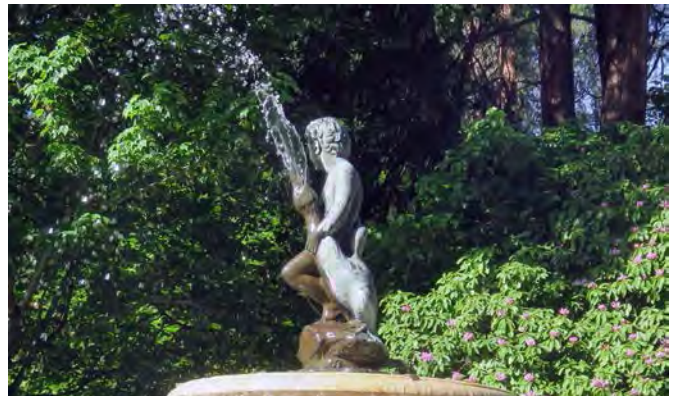
- The bronze statue at the top of the fountain is a replica of the original marble statue and was installed in the 1987 restoration. The bronze is in fair condition and is showing signs of cupric oxidation; it is turning green in some areas whereas the rest of the statue has a typical brown patina. The bronze should be cleaned and given a waterproof protective coating to prevent oxidation.

*Bronze discoloration at the fountain's statue.*

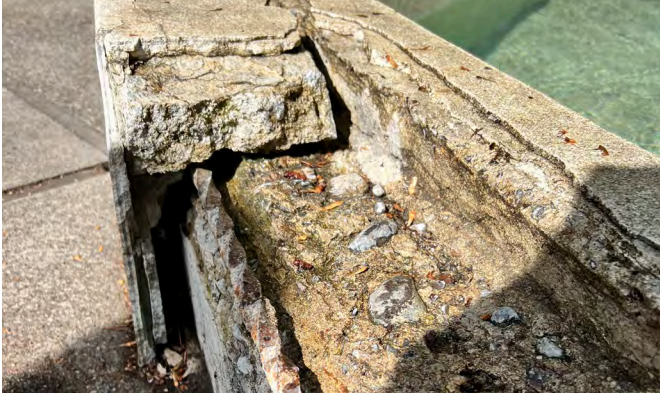
- At the fountain pool outer edge, perimeter terrace walls, and light posts, spalled concrete has revealed embedded ferrous reinforcement. In some areas the exposed reinforcement is corroding and causing further deterioration.

*Concrete cracking, spalls, and soiling at outer rim of fountain pool.*

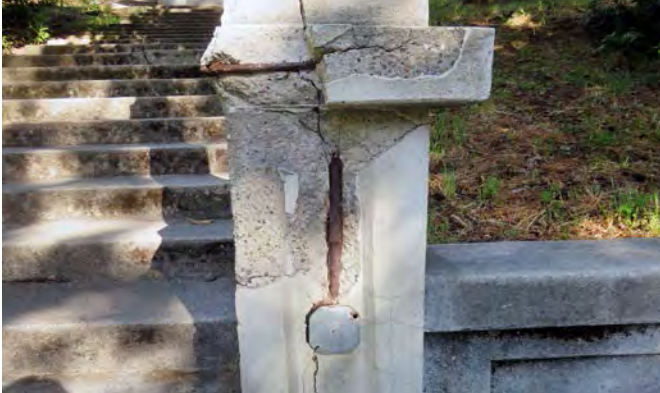
*Concrete cracking and spalls at light post.*

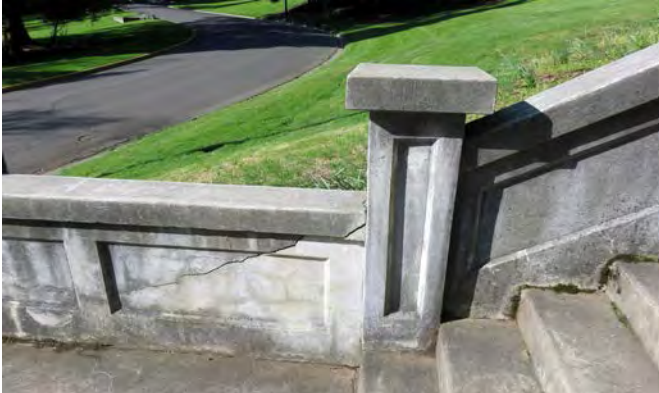
- There are cracks, spalls, and failed previous repairs at several stairs at the top and bottom of the main stair.
- There are cracks in the surface finish on the north and south cheek walls of the main stair.

*Cracks in the cheek wall. This crack is also visible at the exterior face.*

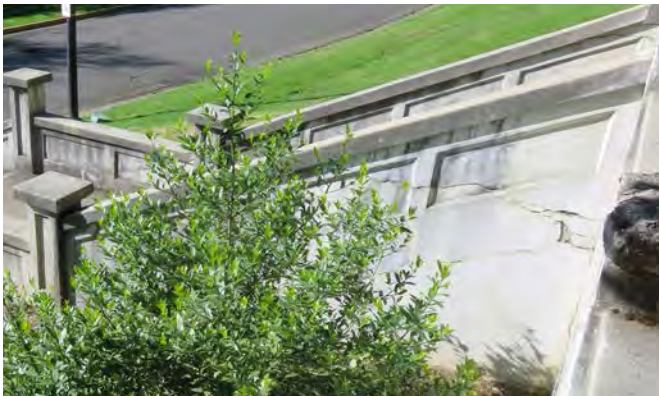
*Cracks in the outer face of the staircase. This crack is also visible at the interior face.*

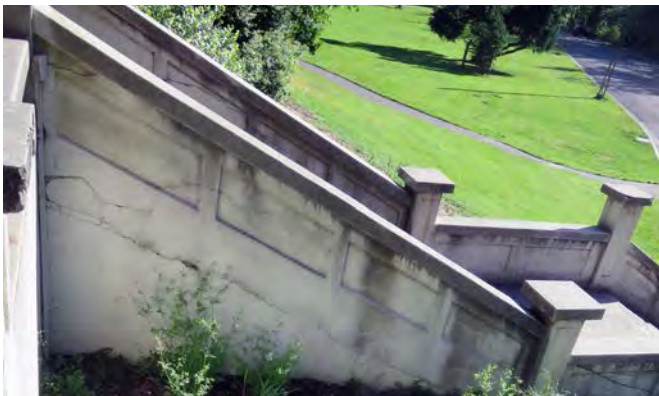
*Cracks in the outer face of the staircase.*
