# Public Arts Advisory Committee Agenda

# Butler-Perozzi Fountain: Request for recommendation

**Butler Perozzi Fountain Assessment and Recommendations**

#### CONDITION ASSESSMENT AND RECOMMENDATIONS

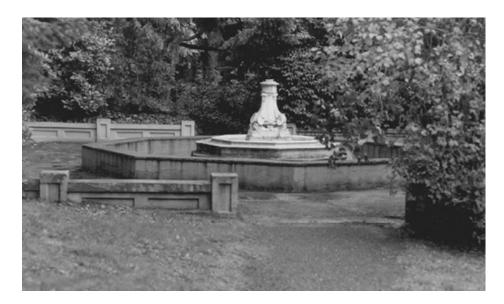
Butler-Perozzi Fountain, circa 1981 before restoration. Note the missing light posts and fountain bowls.

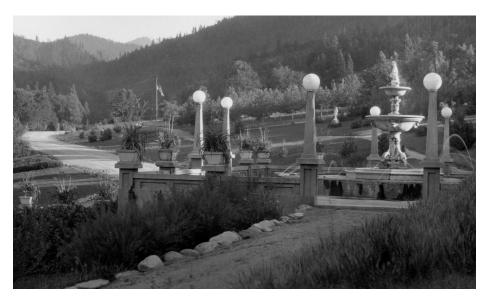
Butler-Perrozi Fountain, undated. Note the water feature that spouts water from the outer rim of the fountain pool, toward the lower bowl. No sign of this feature is currently visible.
