APPENDICES

Appendix A: Ashland Canal Tenth Mile Segment Profile Summaries

Ashland Canal Piping Project Segment #1 Summary

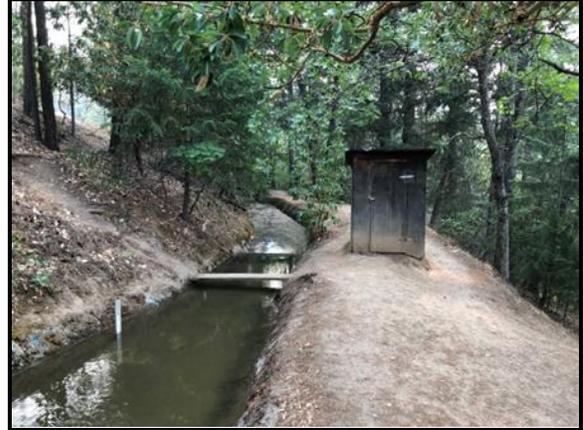
Segment #1 Start (mile 0.0), looking SW

Areas of Concern (AOC) 1.1: The cutbank associated with the private driveway downslope of the canal creates conditions that accelerate drying of the hillside above it by exposing lower slope strata that would normally be protected by layers of soil. If the

large conifers on this slope experience moisture stress following piping, the loss of summer water by the lower cutbank will increase this stress. Many of the larger conifers, particularly the Douglas firs, **are at risk of dying** following piping. The large ponderosa pines have a better chance of tolerating this change, as do all the hardwood species. The madrone dominant portion of the segment through the center and west ends appears stable and poses little concern through canal piping process.

Recommendations. AOC#1.1: Add 3"-4" of wood chip mulch covering the slope surrounding the specimen trees to delay soil drying. Thin out encroaching younger trees and shrubs to reduce competition. Monitor this site and remove trees that develop serious signs of decline or disease. Where feasible, avoid damage, disturbance and/or removal of large pines and oaks during excavation and construction. **Noxious Weeds. 1.** Remove Himalayan blackberry and Scotch broom prior to construction/excavation to reduce spread of infestation.

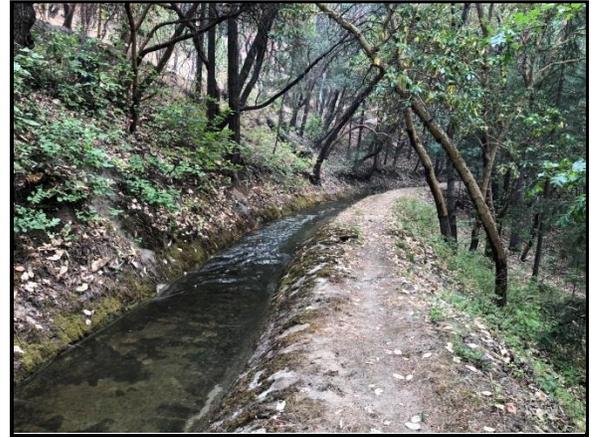
Segment #2 Start (mile 0.1), looking West
Upslope is mixed madrone and black oak with younger Douglas firs seeding in beneath them.

Areas of Concern (AOC) 2.1: If the large conifers (noted above) are receiving augmented summer water from portions of a leaking canal, they will experience water stress impacts following its piping and may die.

Recommendations. AOC 2.1: It is important to include this area in follow up monitoring to assess tree/forest health changes following piping. There are potential steps that can be taken to reduce moisture stress on specimen trees that include: mulching, thinning, and in very special circumstance, deep watering can happen over subsequent seasons following piping to help older trees adjust to changes in the water regime. **AOC 2.2:** Select hardwoods to keep and thin encroaching Douglas fir seedlings in stand to reduce competition and make the stand healthier. Leave scattered healthy Douglas fir where appropriate for site. Also consider multi-trunked hardwoods to 1-2 trunks where appropriate. **Noxious Weeds. 1.** Remove English ivy and hawthorne tree prior to construction/excavation to reduce spread of infestation. Ensure the ivy is removed from the specimen oak to prevent its eventual damage.

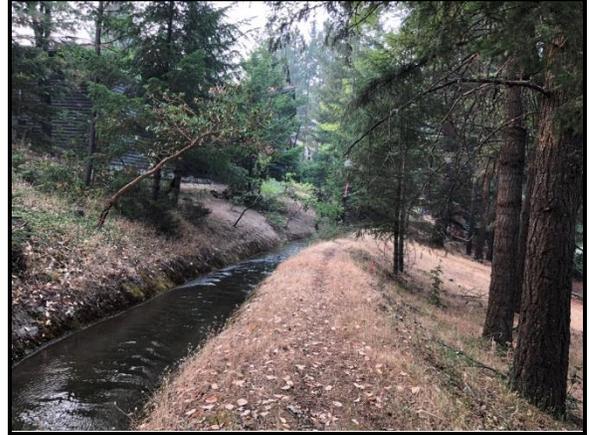
Segment #3 Start (mile 0.2), looking North at Large Douglas-fir and small conifers within 10 feet of canal.

encroaching Douglas firs which creates competition for resources and ultimately water. **AOC 3.2:** Very large Douglas fir on edge of trail below canal and other large conifers near canal have roots surrounding canal liner and will likely die from construction damages to roots and following piping changes to the water table.

Recommendations. **AOC 3.1:** Thin out encroaching Douglas firs from healthy, black oaks and Douglas fir specimen trees leaving enough room to minimize competition between trees. **AOC 3.2:** Have construction steward, forester, or consulting arborist evaluate large conifers near canal to decide which to remove due to construction hazards and likelihood of dying because of moisture stress and inappropriate siting.

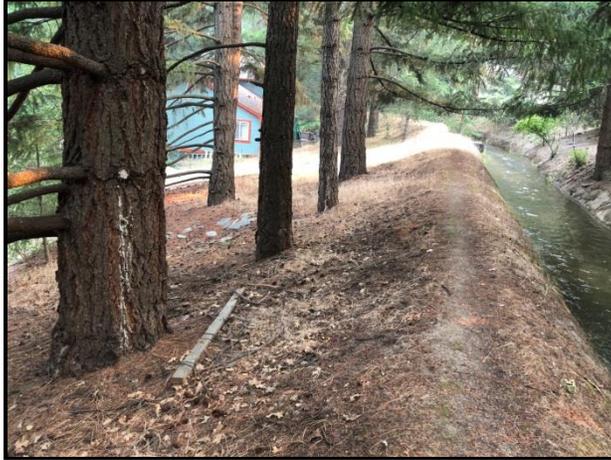
Segment 3: Large Douglas-fir Along Trail, at Risk with Change in Underground Water. Looking North

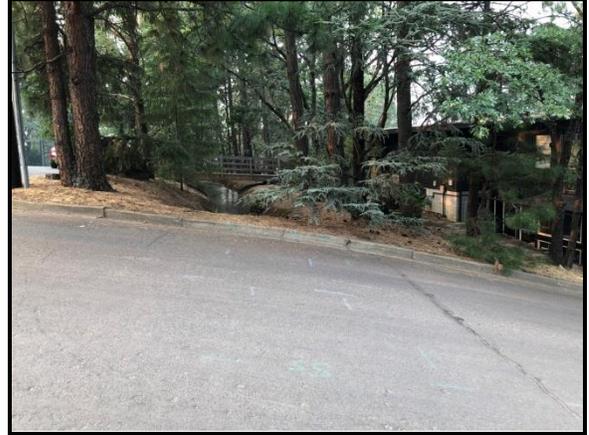
Segment #4 Start (mile 0.3), looking North

and scattered mature black oak. No obvious seepage/leakage or evidence of augmented underground water occurs in this segment. A private bridge crosses the canal as access to the front door of 1313 Leonard St. Additional private walking bridges cross the canal behind Pinecrest Terrace and Woodland St. homes. The canal liner is obviously broken in two locations, where large pines grow on the upslope edge.

Areas of Concern (AOC) 4.1. Mature Douglas-fir and Ponderosa pines on the canal or trail-side are likely to be impacted by construction

disturbance and may require removal. **AOC 4.2.** Mature sized Douglas-fir trees downslope of the canal, may be negatively impacted by a change in underground water. **AOC 4.3.** Landscape trees and shrubs near canal trail (dogwood, bamboo) may be impacted by construction disturbance and/or change in available water (if not irrigated).

Recommendations. AOC 4.1, 4.2, and 4.3: Construction steward and Rep should consult on probable outcomes and appropriate actions. Also meet with private landowners on respective issues. Where feasible, avoid damage, disturbance and/or removal of large conifers during construction. **2.** Monitor health of conifers following construction and prepare for mitigation techniques such as mulching where advised. Potentially supplement deep watering 2 or more times as necessary each month over the summer to help important trees transition from their water dependency to a more natural drought tolerant state. This process could easily require 10 years of supplemental watering for very large trees gradually reducing the frequency of watering. Thin young understory Douglas-fir trees near specimen trees for long-term vegetation health and resiliency. **Noxious Weeds Treatments.** Remove holly and hawthorn trees, and English Ivy prior to excavation to reduce infestation risks.

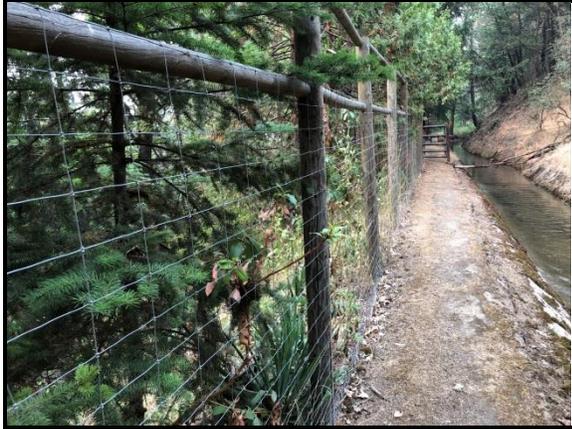
Areas of Concern (AOC) 6.1. Young to large Douglas-fir, located downslope of the canal, may be negatively impacted by a change in underground water. **Observation of Note.** Private fencing is located on the NW edge of the canal trail and may require measures to avoid construction disturbance and/or damage.

Segment 6: Private Fencing Trailside, looking NE

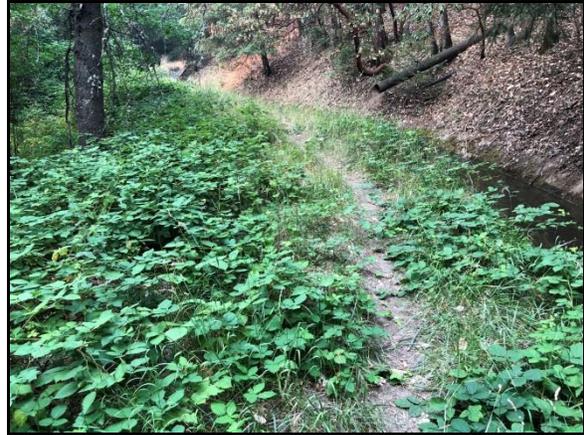
Segment 6: large blackberry infestation along trail, and metal culvert (top to right), looking NE

Recommendations. **AOC 6.1.** Thin small Douglas-fir trees adjacent to/downslope of canal to favor pines and oaks and to increase long-term vegetation health and resiliency. Monitor health of conifers (esp. Douglas-fir located downslope) in post-construction years; consider augmented watering. **Noxious Weeds.** **3.** Remove noxious weeds (hawthorn tree Himalayan blackberry, Scotch broom, vinca and broad-leaved sweet pea) prior to excavation to reduce and control infestations.

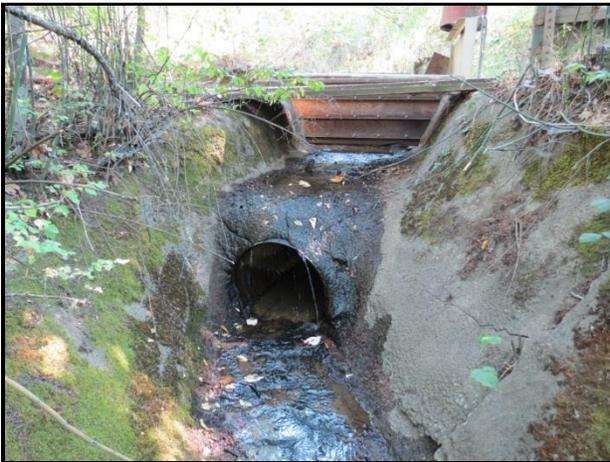
Areas of Concern (AOC) 7.1. When the augmentation of canal water to Roca Creek is stopped, riparian vegetation is likely to be

negatively impacted. Young and larger Douglas-fir are unlikely to survive this transition longterm. The moist site trees and shrubs (poplar, maple, dogwood, mock orange) and the wet creekside vegetation will likely die back, especially in drought years.

Segment 7: Flow of Water out of Canal to Roca Creek, looking SW

Recommendations. AOC 7.1. 1. End canal flow to Roca Creek by building a culvert at the Roca Creek crossing. **2.** Thin the young Douglas-fir downslope and adjacent to trail to favor pines and oaks and increase forest health and resiliency. **3.** Selectively thin multi-trunk oaks upslope to increase long-term

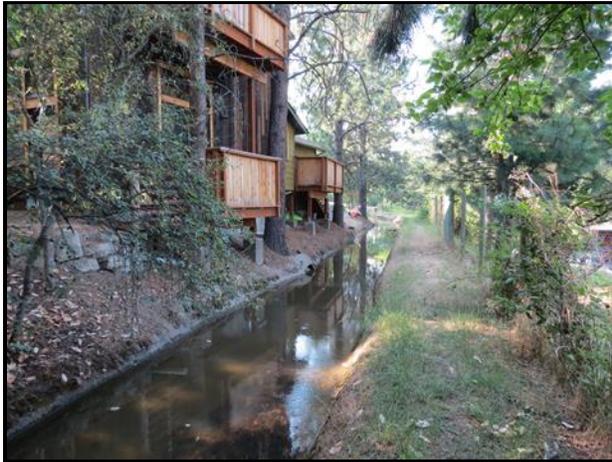
Areas of Concern (AOC) 8.1. Large pines occur on the canal edge and trailside, all within the construction footprint and will likely need to be removed; the pines provide shade and privacy.

Segment 8: Narrow Construction Corridor And Mature Trees Along Upper Slope Edge, Looking North

Recommendations. AOC 8.1. Where feasible, avoid damage, disturbance and/or removal of large pines during construction. Consult (construction steward and rep) on appropriate action. Monitor and mitigate as necessary if any are selected to protect. **Noxious Weed Treatment.** Remove the blackberry prior to excavation to avoid increased infestation.

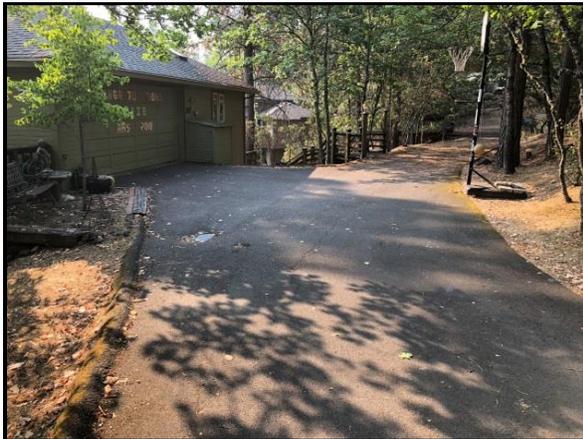
Segment #9 End (mile 0.9), looking SE

Areas of Concern (AOC) 9.1. Mature pines, and madrone, oaks, and manzanita occur within the construction corridor in the front yard of 1133 Emma St., (and additional pines along the corridor to the north); all will be significantly impacted, as roots and/or entire trees may be disturbed during excavation.

Recommendations. AOC 9.1. Consult among experts to refine the pipe replacement methods to ensure least impacts to selected portions of existing mature landscape, including large pines, oaks, madrones and manzanita along project corridor.

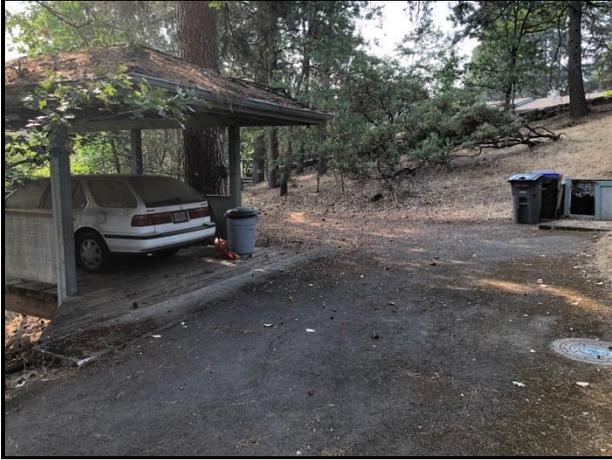
Segment 9: Carport Structure and Large Pine at Corner of Construction Footprint, Looking SE

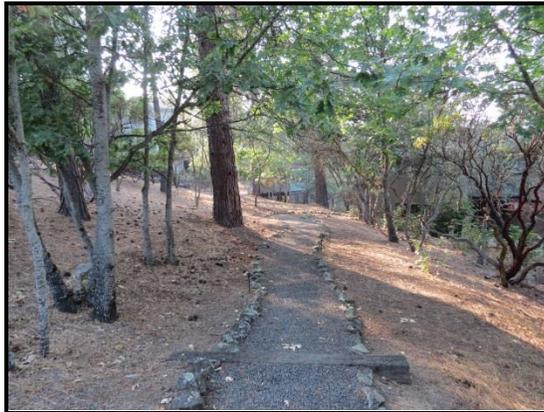
Segment 9: Large Pine in Yard, 1333 Emma St., Looking NW

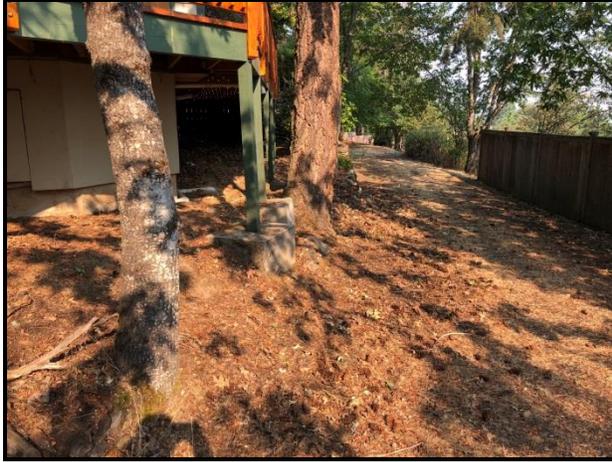
Areas of Concern (AOC). 10.1. Large specimen pines, a large Douglas-fir, mature oaks and a Deodar cedar occur in or near the construction/excavation zone and will likely risk root damage or removal. A large pine growing near Wildwood Way is at risk of damage or removal and is a shade/privacy tree.

**Segment 10: Large Conifers
Along Construction Corridor, Looking West**

Recommendations. AOC 10.1. Refine the pipe replacement methods to ensure least impacts to selected portions of existing mature landscape, including large pines, oaks, madrones and manzanita along project corridor. **2.** Monitor health of conifers, maple and deodar cedar in post-construction years; consider augmented watering. **3.** Thin young understory Douglas-fir trees and selectively thin oaks for long-term health and resiliency. **Noxious Weed Treatment.** Remove Himalayan blackberry and vinca, prior to excavation to avoid spread of infestation.

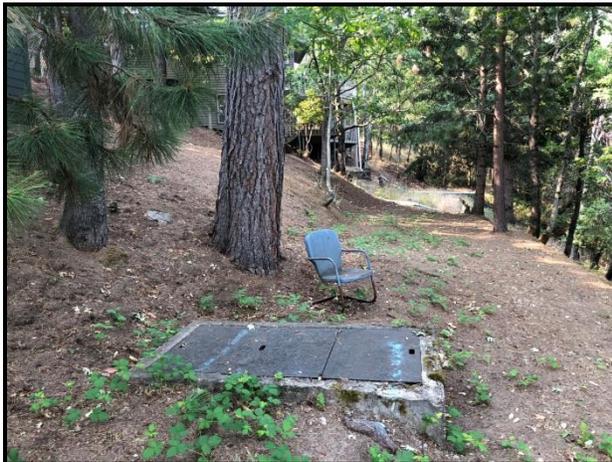
**Segment 9: 2nd Large Pine near Construction
Corridor, Looking SW**

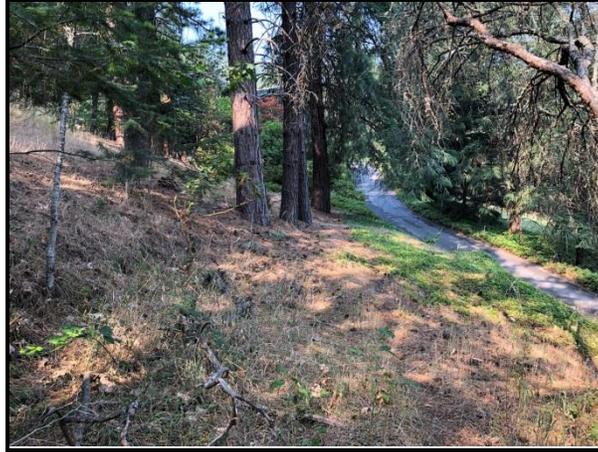
Areas of Concern (AOC) 11.1. One large Douglas-fir located downslope at the segment north end may be at risk for changes in underground water. **AOC 11.2.** Three large Ponderosa pine and one large Douglas-fir occur at the west end of this segment, near the front/side yard of 911 Beach St.; all four trees are within the construction/excavation zone and will likely risk root damage or may need to be removed.

**Segment 11: Four Large Conifers at West End,
In Construction Corridor, Looking West.**

Recommendations. AOC 11.1. Monitor health of conifers (especially the large Douglas-fir), oaks, madrones and remaining pines, after project completion. Consider augmenting irrigation to Douglas-fir. **11.2.** Thin young understory Douglas-fir trees for long-term vegetation health and resiliency. **Noxious Weed Treatments.** Remove Himalayan blackberry and Scotch broom prior to excavation to avoid infestation.

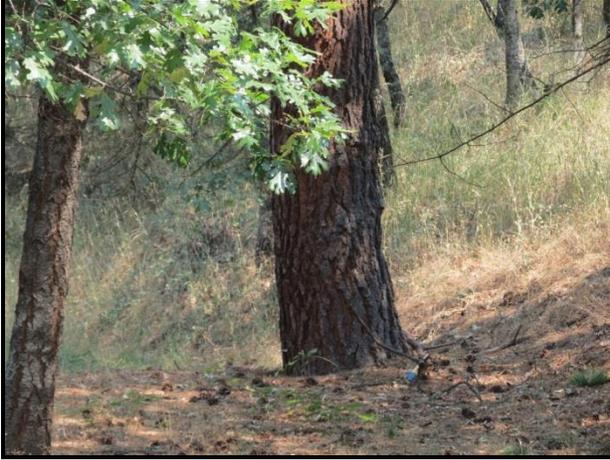
Segment 12: Large Pine along Canal Construction Corridor, Looking Northwest

Recommendations. AOC 12.1. Monitor health of trees in the riparian area after project completion. Consider adjusting to species appropriate to moistness of site following construction by removing those species not well suited including thinning of young understory Douglas-fir trees for long-term vegetation health and resiliency. **Noxious Weeds:** Remove Himalayan blackberry, Scotch broom and English Ivy prior to excavation to avoid spread of infestation.

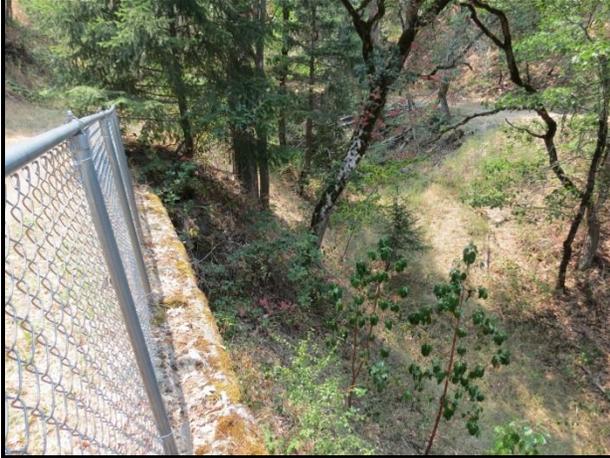
Areas of Concern (AOC) 13.1. One large Ponderosa pine occurs along the canal trail (east side), and may be at risk for root damage or removal. **AOC 13.2.** Vegetation in the riparian area below the construction/excavation zone may receive less moisture and certain species, Douglas-fir, shrubs, forbs, may be negatively impacted.

Segment 13: Trees below Concrete Wall on Steep Slope below Canal Corridor, Looking SW

Recommendations. AOC 13.1. Where feasible, avoid damage or disturbance to large conifers during construction. **AOC 13.2.** Monitor health of trees in/near the riparian area after construction; consider augmented water for trees near the trail. Thin young understory Douglas-fir trees for long-term vegetation health and resiliency. **Noxious Weed Treatments.** Remove Himalayan blackberry and Scotch broom prior to excavation to avoid spread of infestation.

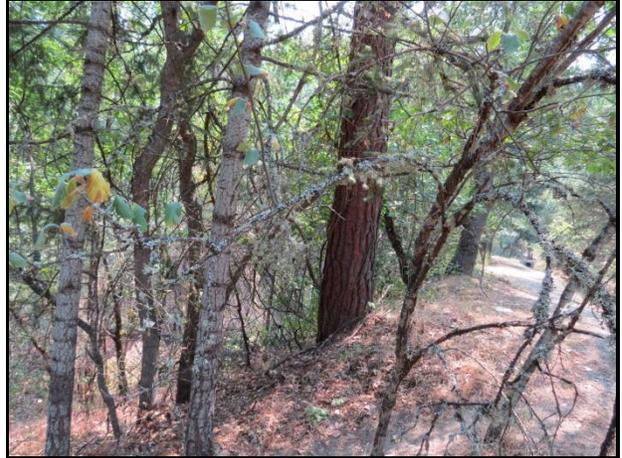
Segment 13: Large Pine Adjacent to Canal Construction Corridor, Looking East

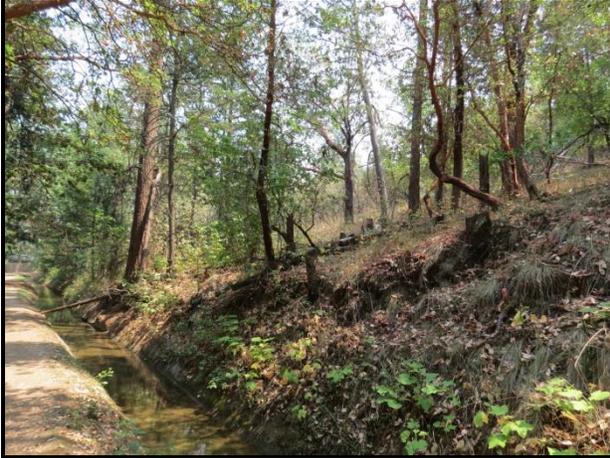
Areas of Concern (AOC) 14.1. One large Ponderosa pine occurs on the south edge over the canal, with previously cut roots; this tree is unlikely to tolerate construction and will need to be removed. **AOC 14.2.** Vegetation in the riparian area below the construction/excavation zone may receive less moisture and certain species (Douglas-fir, shrubs, forbs) may be negatively impacted.

**Segment 14: Large Pine on Canal Edge,
Looking East**

Recommendations. AOC 14.1. Consult (construction steward and rep) on appropriate action whether to remove or preserve large pines in this segment; follow up with monitoring if kept. Where feasible, avoid damage or disturbance to, and/or removal of the large pine during construction. **AOC 14.2.** Monitor health of trees in stand after project completion. Thin young understory Douglas-fir trees and selectively thin multi-trunk oaks, for long-term health and resiliency. **Noxious Weed Treatment.** Remove Himalayan blackberry, Scotch broom and English Ivy prior to construction/excavation to avoid spread of infestation.

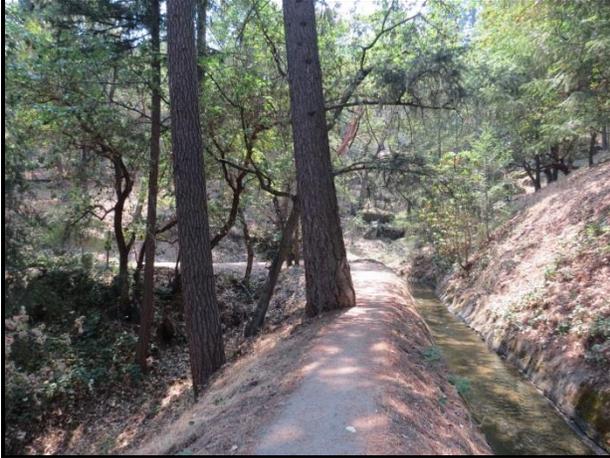
Areas of Concern (AOC) 15.1. Large Ponderosa pine and Douglas-fir trees growing in the trail are at risk for removal or construction disturbance. The large pines in the yard of 769 Lisa Lane are of particular concern. **AOC 15.2.** Larger Douglas-fir growing downslope of the canal and near the upslope canal may be impacted by reduced underground water post project.

Segment 15: Large Pine on and Near Canal Edge, Looking South

Recommendations. AOC 15.1. Consult (construction steward and rep) on appropriate actions which trees to remove or preserve; follow up with monitoring and prepare for mitigation measures. **AOC 15.2.** Monitor health of conifers downslope of canal within private yards, and upslope/near the canal- especially larger Douglas-fir-in post-construction years; consider augmenting irrigation to Douglas-fir. Thin young Douglas-fir understory and selectively thin multi-trunk madrone for long-term vegetation health and resiliency. **Noxious Weed Treatment.** Remove Himalayan blackberry prior to construction to avoid spreading infestation.

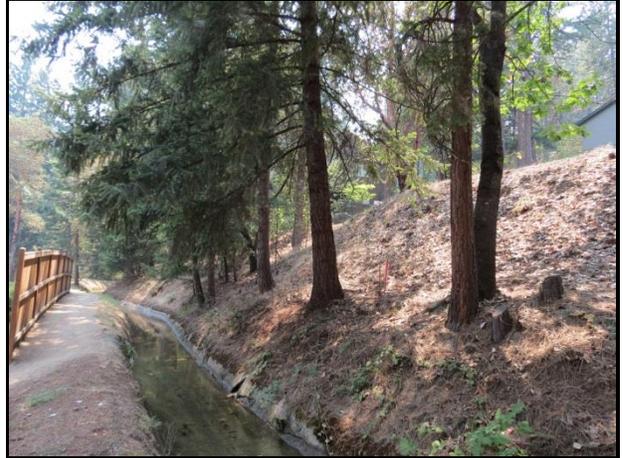
Segment 15: Douglas-fir and Pines Upslope of Canal, Looking South

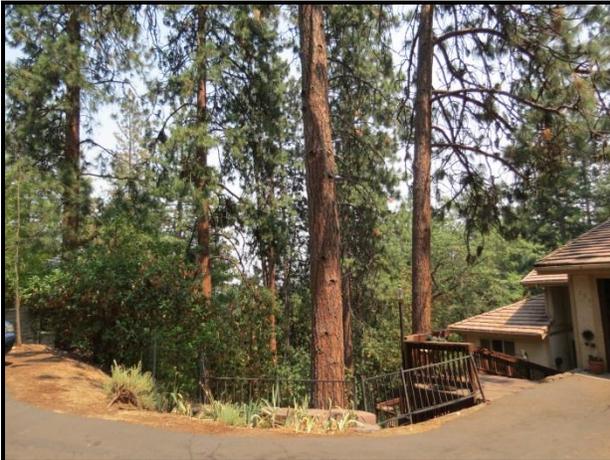
Segment 15: Large Pines at 769 Lisa Lane, Looking Northeast

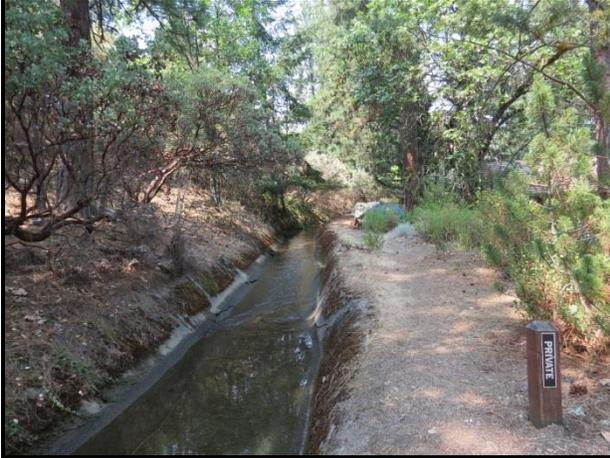
Areas of Concern (AOC) 16.1. A few pines are located in or near the canal construction corridor and roots may be negatively impacted by excavation.

Segment 16: Pines Along Canal Trail and Upslope Canal Edge, Looking North

Recommendations. AOC.16.1. Where feasible, avoid damage or disturbance to, and/or removal of large conifers during construction. **2.** Monitor health of conifers along canal and within private yards in post-construction years; consider augmenting irrigation to any larger Douglas-fir downslope of canal and/or in private yards. **3.** Thin young understory Douglas-fir and selectively thin small diameter pines upslope, to maintain long-term vegetation health and resiliency. **Noxious Weed Treatment.** Remove English Ivy prior to construction/excavation to reduce spread of infestation.

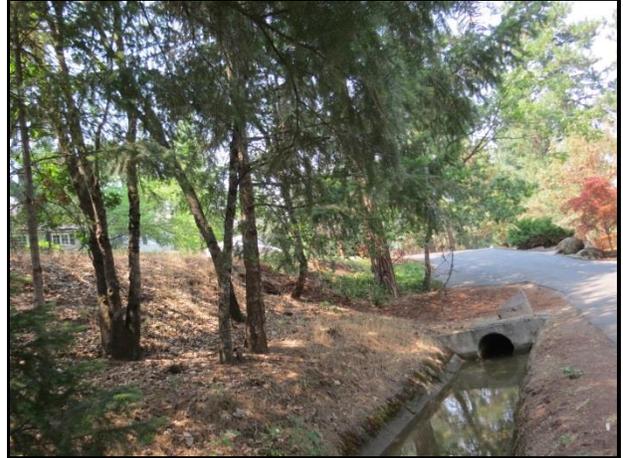
Segment 16: Douglas-fir Upslope and Sub-mature Pine In Construction Corridor at 769 Lisa Lane, Looking North

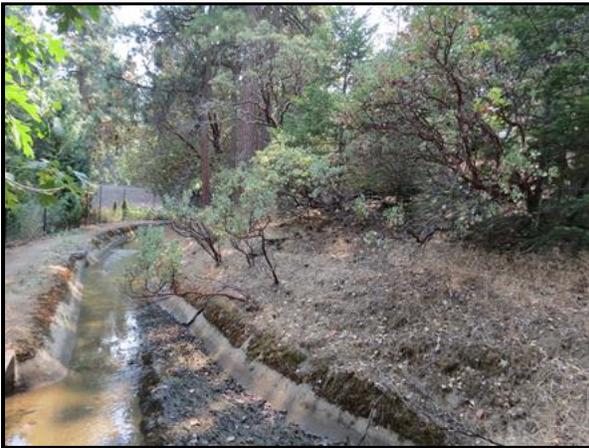
Segment 16: Pines Near/Upslope of Canal (background), Looking South

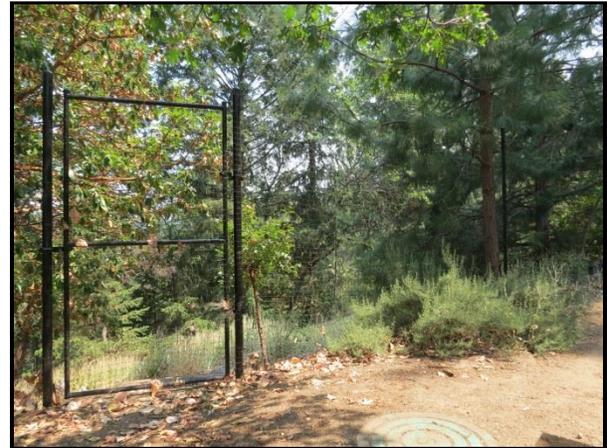
Segment 16: Douglas-fir (background) Downslope of Canal, Looking East

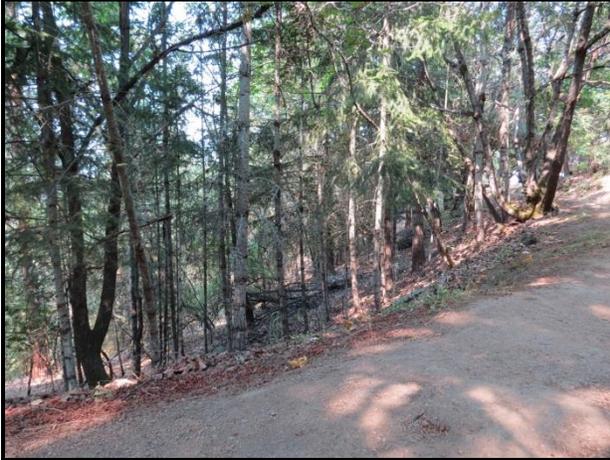
Areas of Concern (AOC) 17.1. Douglas fir encroachment in the much older black oak and madrone woodlands.

AOC #1: Segment 17: W End below canal into the dense stand requiring thinning around specimen trees, looking east

Recommendations. AOC 17.1. This stand would benefit from thinning, to reduce competition in favor of the larger, older hardwoods, and to create a more fire safe wildland/ urban interface. Generally, thinning should generate larger canopy gaps above the canal as this zone is already predisposed to gaps. The lower slope shouldn't be as radically altered in one treatment. Thin around the bigleaf maples to provide them room from branch entanglement and competition for water and resources. **Noxious Weed Treatments.** Remove blackberry prior to thinning and construction as both forms of disturbance will encourage rapid growth and expansion of this patchy population. Follow up treatments should happen on a regiment with the other weed treatments across this project.

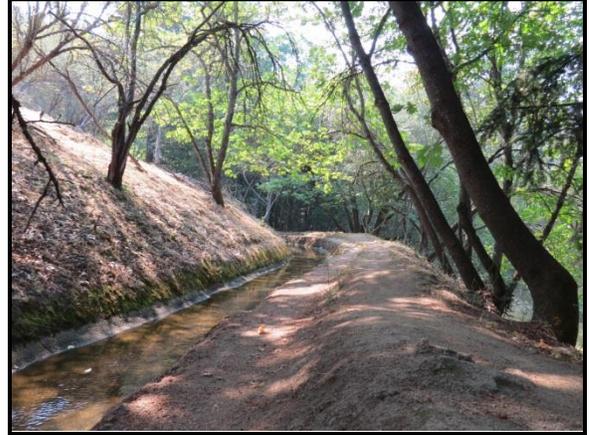
the trail below and overhanging the canal (pictured above). These trees are presumably tapping in to the canal water through the liner and will be difficult to avoid damaging during construction. No visible seepage or leakage could be seen in this segment.

Areas of Concern (AOC) 18.1. Large bigleaf maple trunks overhanging the canal are at risk from construction damage. **AOC 18.2.** Encroaching young conifers beneath much older and larger hardwoods represent a pattern of overdue underburning from periodic wildfire. Left to progress, this encroachment leads to decline of the older hardwoods from competition for light and water by the more vigorous conifers.

Recommendations. (AOC) 18.1 Assess the risk potential of the overhanging bigleaf maples to interfere with and become damaged by construction. This process should be conducted by the construction steward in collaboration with the construction representative that can evaluate the construction requirements in light of the maples and help decide what is practical. Potentially select the best specimens to protect through the construction process. **AOC 18.2.** Include this forested area in a thinning program to enhance selected trees, in this case the larger hardwoods, while removing the

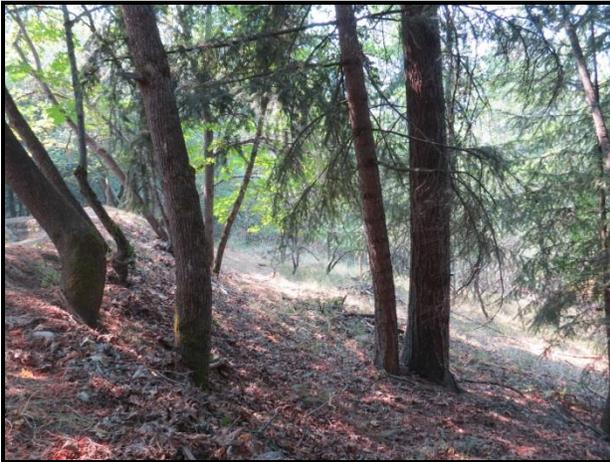
Segment 18: East end, Looking west downslope of the canal. Photo represents some thinning opportunity with a large open slope beyond.

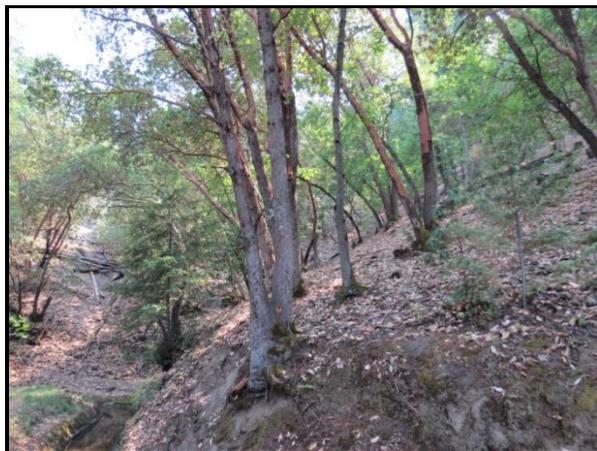
Segment 18: West end above the ditch, looking eastward. This photo illustrates steep slopes and a multi-trunked madrone perched just above the ditch that presents challenges to preserve during construction. Many trees like this line the canal that will require on site evaluations between the construction steward and construction team representative.

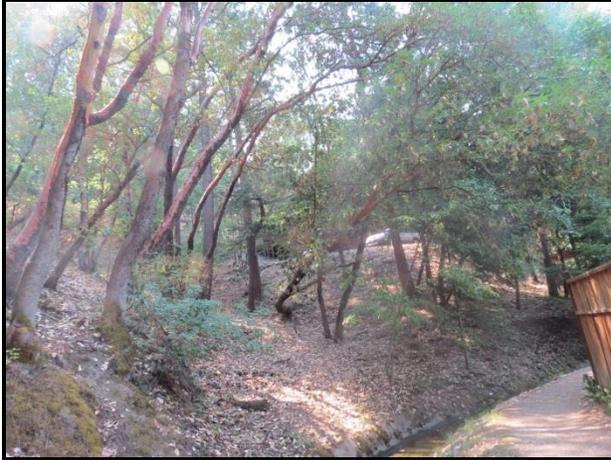
Segment 19: East end above ditch, looking west. Thinning Opportunity on Wildlands-This forest stand is a good candidate for strategic thinning of encroaching conifers and smaller hardwoods around selected specimen trees to create greater wildfire resilience, enhance long term stand health, and to promote a mature stand aesthetic, valued along the ditch. Multi-trunked hardwoods can be thinned down to 1-2 trunks to restore their growth towards legacy tree form and improve canopy gaps.

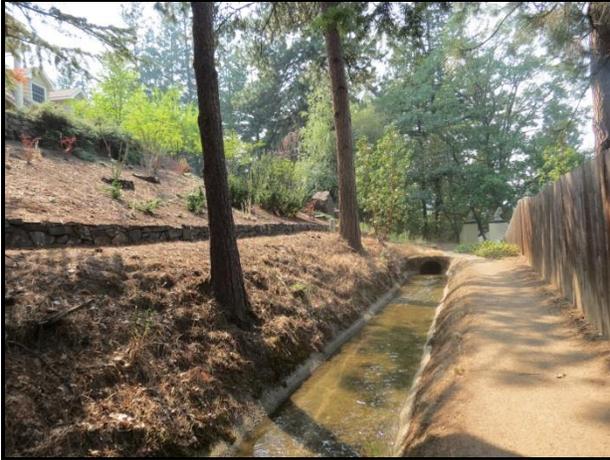
Areas of Concern (AOC) 20.1. There are large pines above the canal that pose construction hazards as well as being at risk from construction damage through direct contact with machinery and/or root damage during liner removal. In addition, it is likely they are receiving substantial water augmentation throughout the summer having root systems that surround the moist soil horizon of the (leaky) canal. For this reason, canal piping will further put these trees at risk.

Segment 20: AOC #1: Two ponderosa pines perched above the canal pose risks during construction. These trees require evaluation on best approach.

Recommendations. AOC 20.1. The construction steward and construction representative need to assess the pines above the canal to decide which trees should be left or removed. The private landowner should also be involved in the discussion since these trees will be impacted by the piping project. These trees should be part of a monitoring program to evaluate at risk trees and stands for impacts and follow up treatments. We also suggest thinning of native landscapes to promote stand health and favor specimen hardwoods and conifers on site. **Noxious Weed treatments.** The blackberry and scotch broom patches should be treated as soon as possible to prevent their increase during disturbance activities. Those areas should be including in the project weed monitoring to ensure they are permanently eliminated from the site, especially since seeds can germinate and reintroduce plants after the parents have been removed.

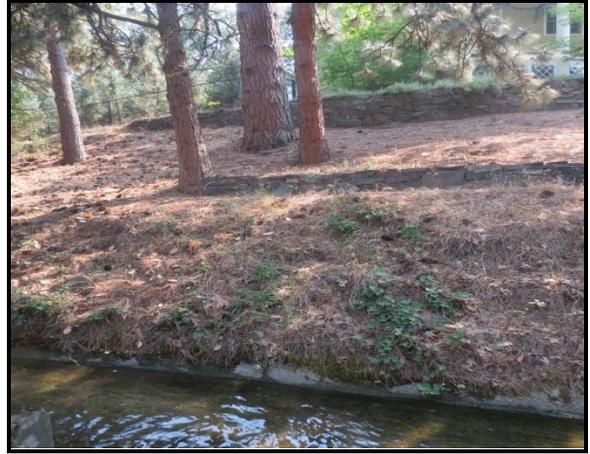
Segment 20: AOC #1: A large ponderosa pine above canal is at risk following piping due to changes in available groundwater during summer. This tree will require monitoring following construction for impacts and possible mitigation measures.

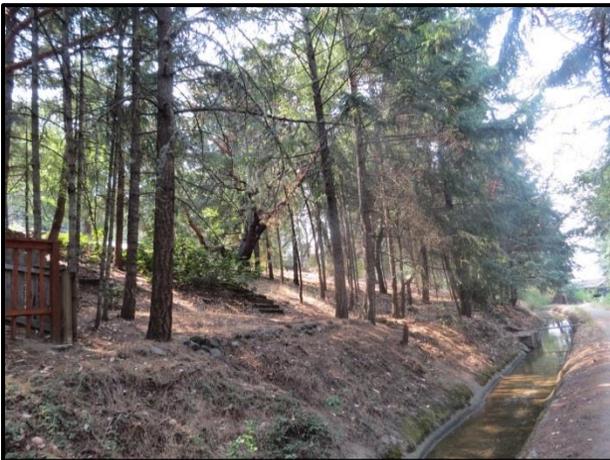
Segment 20: Wildland portion above the ditch-demonstrates typical encroachment of young conifers without periodic wildfire, which crowds specimen trees that will benefit from a thinning prescription.

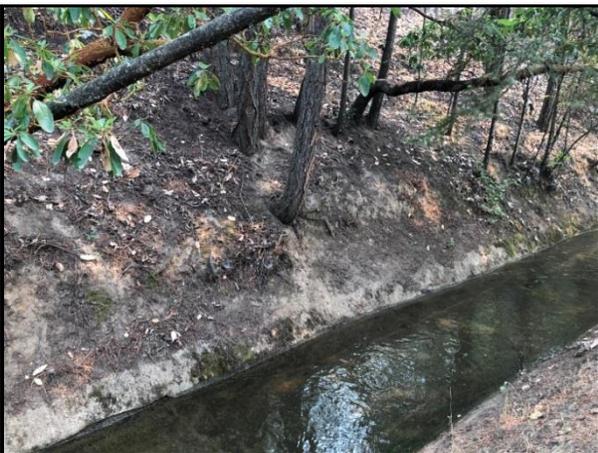
Areas of Concern (AOC). **1.** Large downslope mature Douglas-fir, and younger Douglas-firs downslope and upslope/near the canal, may be at risk for moisture stress after the canal is piped. **AOC 2.** Conifer and hardwoods growing along and above the steep south canal edge will not survive construction disturbance and will need to be removed. **AOC 3.** Large pines and Douglas-fir growing on the downslope trail edge may experience significant disturbance to roots from construction and may need to be removed. **Observation Note:** The drainage pipe will create surface runoff and/or erosion and will need to be buried.

Segment 21: Small Conifers on Steep South Canal Edge, Looking South

their extensive engagement with the liner and moist soil around the canal. **AOC 2.** Monitor the health of the conifers (esp. Douglas-fir) along and downslope of the canal in post-construction years and include these trees in mitigation measures where the priority is to preserve them. The preferred treatment is mulching with wood chips surrounding their root systems. The landowner may also consider periodic deep watering during the first few years following construction to prevent moisture stress during a transition period into eventual reliance on only natural rainfall. This should happen through the evaluation of need by the monitoring team of arborist/ forester that is overseeing monitoring for the whole project. This team will be familiar with signs of tree stresses and mitigation measures appropriate to treat them **AOC 3.** Thin out young understory Douglas-fir to maintain long-term stand health and resiliency. **Noxious Weeds.** **4.** Remove vinca, Himalayan blackberry and English ivy prior to construction to reduce spread of infestation.

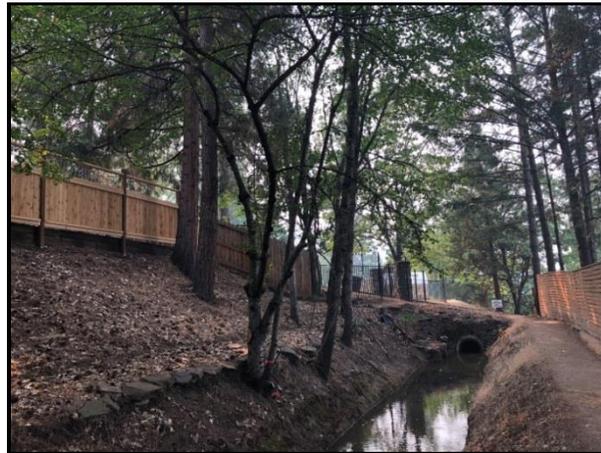
Segment 21: Hardwoods on Steep South Canal Edge, Looking South

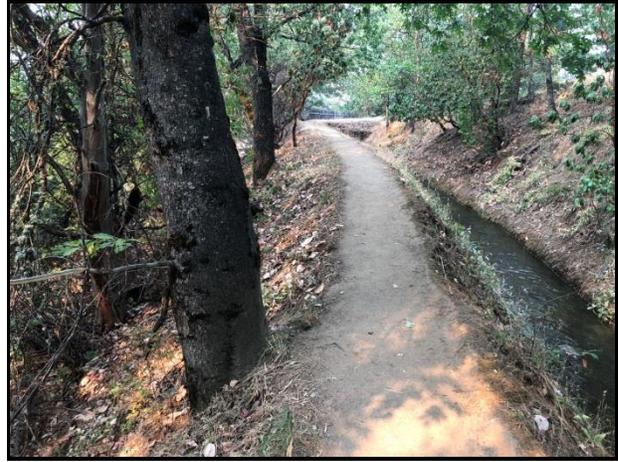
Segment 22: , Large Oaks on Trail Edge, Construction Disturbance Risk, Looking East

22.3	Specimen oaks on canal trail at risk of construction damage	On north side of canal trail	Assess best approach to protect specimen oaks during construction
Segment #23 (mile 2.2 – 2.3)

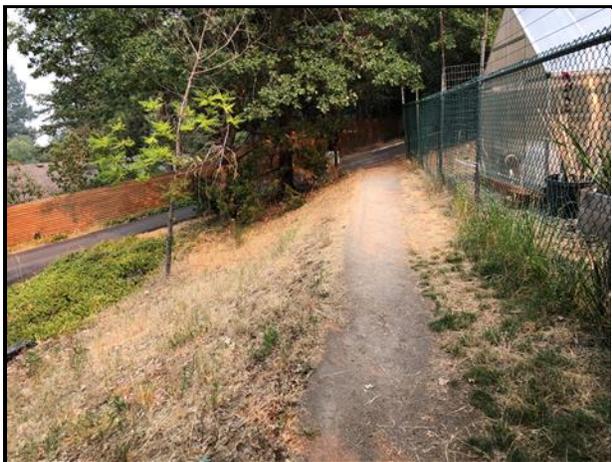
Areas of Concern (AOC) 22.1. The corridor between the private greenhouse/ garden to the south, and the short downslope to the north, is a problematic narrow passage. The greenhouse/garden area is

likely be temporarily impacted during construction; similarly, the visible roots from a trailside downslope incense cedar risks significant impact from construction. **AOC 22.2.** Farther along, in the west of this segment, the south upslope side of the canal will likely be problematic during construction: all trees and woody vegetation on the slope immediately above the canal's south side will need to be removed before construction; larger pines upslope and out of the construction footprint are at risk from construction disturbance to roots as well as increased drying from anticipated slope unravelling on the steep granitic soils.

Segment 22: , Narrow Corridor between Private Greenhouse & Downhill Slope, Looking East

Recommendations. 1. Develop a plan to thread the construction disturbance footprint to avoid damage and disturbance to the private greenhouse/fence/garden area above 390 Ashland Street. Alternatively,

develop a plan to move private structures and maintain the level ground, fencing, and gardening area, and/or re-build where necessary. **AOC 22.1.** Avoid damage to incense cedar where roots exposed in trail. **AOC 22.2.** Regarding the south slopes along the open canal: remove woody vegetation and trees along and immediately above the canal's south edge before construction; create a more stable slope with a combination of riprap and vegetation restoration of the slope. In addition monitor the health of larger pines farther upslope after construction and consider feasibility of removing these trees vs. creating a more stable slope bank to protect larger upslope trees. **AOC 22.3.** During construction avoid damage to roots of large mature oaks along the northside of the canal trail and to cedar roots near greenhouse/garden fencing (see photos). Where oaks are maintained, monitor the health of oaks in post-construction years. **Noxious Weeds.** Remove the broad-leaved sweet pea prior to construction/excavation to reduce spread of infestation.

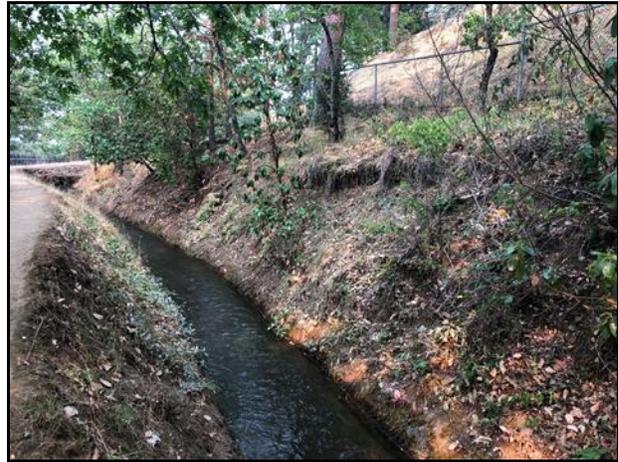
Segment 22: Steep Slope Upslope of Canal, Looking SE (see Pine Upslope)

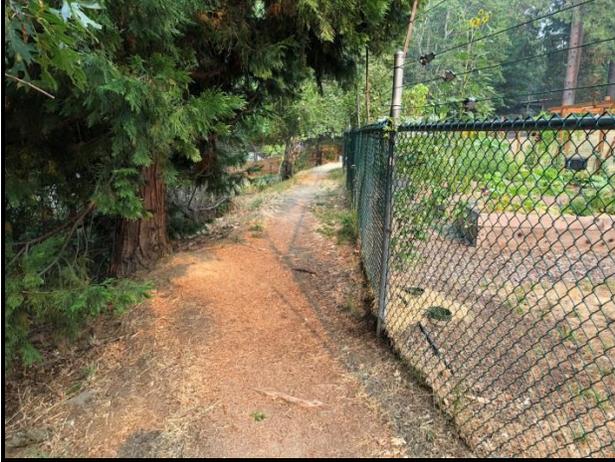
Segment 22: Incense Cedar at Risk of Construction Disturbance, Looking East

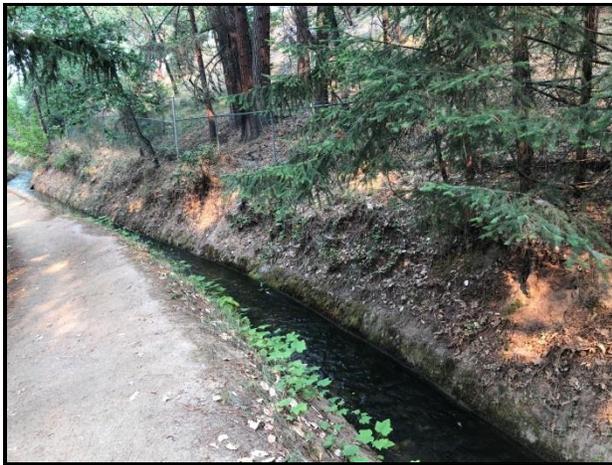
the canal's south edge and may need to be removed before construction. **AOC 23.2.** Larger pines upslope and out of the construction footprint, are at risk from construction disturbance to roots and from increased drying from anticipated slope unravelling on the steep granitic soils.

Segment 23: Short Steep Upslope of Canal, Looking Southeast (see Pine Upslope)

Recommendations. AOC 23.1 Where feasible protect trail-side trees and avoid damage to roots, particularly pines and oaks, along the northside of the canal trail; where trees are maintained, monitor tree health in post-construction years. **23.2:** Thin out small douglas firs from around uphill pines and hardwoods, allowing for canopy gaps. Consider slope stability above the canal along the south edge before construction and take measures to increase slope stability where helpful. In addition, monitor the health of larger pines farther upslope after construction and consider mitigation measures to support them.

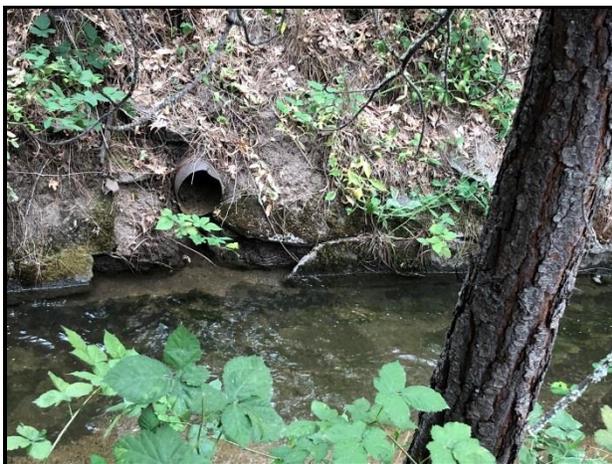
out of the canal's south slope just above the waterline. No visible seepage or leakage occurs in this segment. The presence, however, of the Douglas-fir trees in this drier pine-dominant forest suggests that trees do receive some level of augmented underground water.

Segment 23: Metal Culvert Above South Canal Slope, Looking SW
