CONDITION ASSESSMENT AND RECOMMENDATIONS

Butler-Perozzi Fountain Lithia Park

Ashland Parks Foundation / July 26, 2022, Rev. 01 October 05 2022

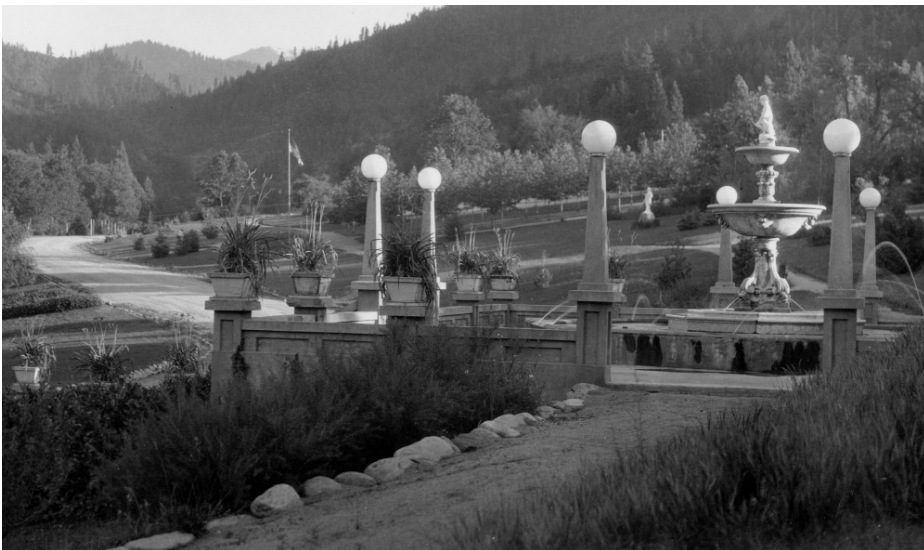
Butler-Perrozzi Fountain, undated. Note the water feature that spouts water from the outer rim of the fountain pool, toward the lower bowl. No sign of this feature is currently visible.

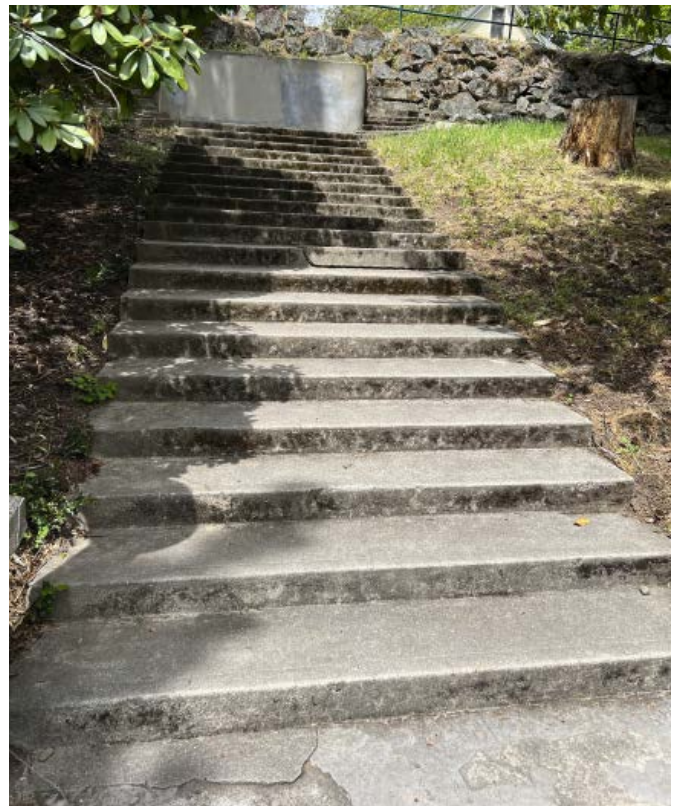
*Staircase to Granite Street, to the west of the terrace.
Note that this is not a signed or publicized pathway.*
