THE CARTER MEMORIAL FOUNTAIN, ASHLAND, OR HISTORY AND OPTIONS FOR REHABILITATION

for the City of Ashland, Oregon

Prepared by George Kramer, M.S., HP
Kramer & Company, Ashland

April 2015

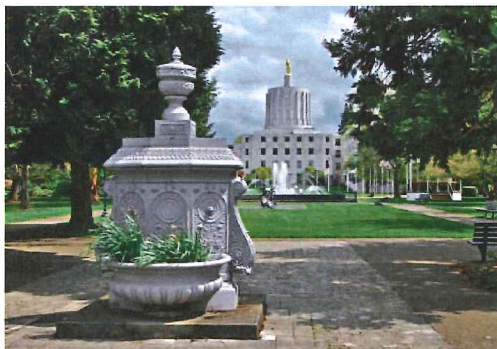
The City of Salem retained the cast iron base of the Breyman Fountain after the statue was damaged in 1917. Located on what are now the grounds of the Oregon State Capitol and under the management of the Oregon Parks and Recreation Department, the Breyman base remains as a rather odd remnant of the original design, without any water supply, obvious function, or interpretation.

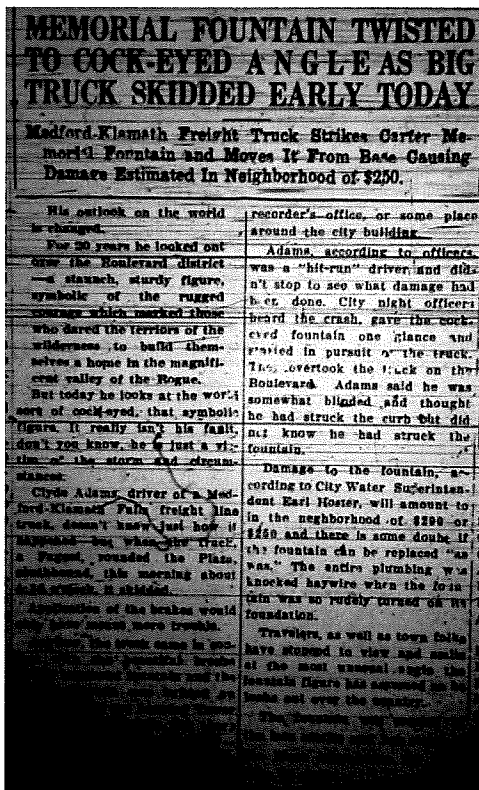
Figure 4. *Ashland Tidings*, December 28, 1931

In late 1931 a truck skidded over the curb around the Plaza island and struck the Carter Fountain.¹¹ The "...pioneer {was} knocked into a cockeyed position" and "had an entirely new outlook on life" as it was spun around on its foundation (*Ashland Tidings*, 28-December-1931). Several months later the fountain was repaired and some change occurred. "Repairs are Complete. Plaza fountain equipped with four new type bubblers, a reduction from the original sixteen bubblers (sic) to four...of the modern type" (*Ashland Tidings*, 26-February-1932).¹²

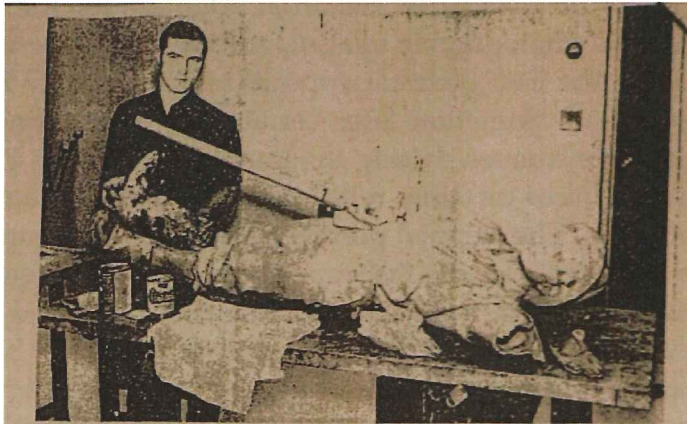
BACK BY SUMMER — The statue will be back on top of the fountain on Ashland's Plaza by summer, Ron Reinmiller, graduate student at Southern Oregon College who is working to restore it, said. (Bayley Photo)

Working with fiberglass and epoxy, Reinmiller is building a new boot and part of an arm, and repairing the rifle. The statue was made of pot metal, and it is difficult to strengthen and restore, he said.

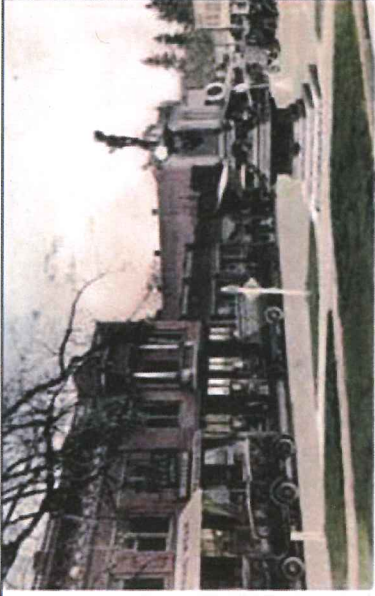
<p>Circa 1926 (Prior to Lithia Fountain installation)</p>	<p>Note change in Plaza grade, partial encapsulation of granite plinth.</p>

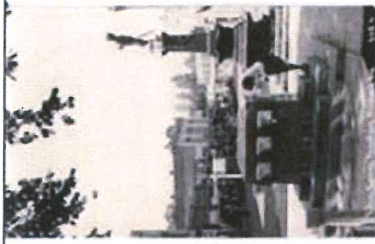
<p>Circa 1936s</p>	<p>Note change to four bubblers, down from twelve (one per side, not three), changes to Plaza included more concrete (Neon sign will be installed in 1937)</p>
