145 North Main Street

Appeal of Conditions of Approval from PA-T1-2019-00080
recommended by Historic Commission
and Ashland Department of Community Development Department

City of Ashland Planning Exhibit

Exhibit # P-001
PA APPEAL-2019-00010/T1-2019-00080
Date 1-14-20
Staff ng

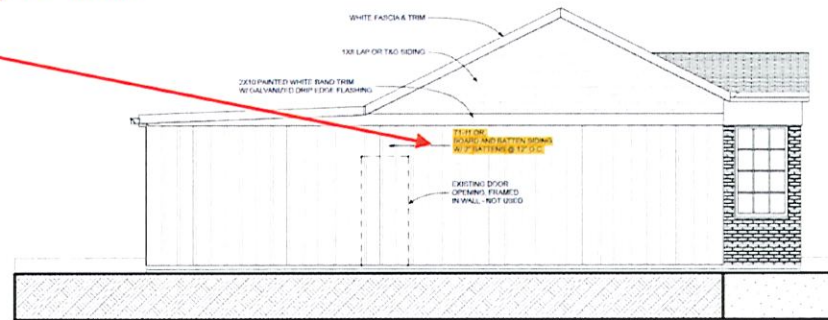
1
A-1.1

Compatible New Siding to match original, T1-11 OR,
BOARD AND BATTEN SIDING W/ 2" BATTENS @ 12" O.C.

SOUTH EAST ELEVATION-NEW

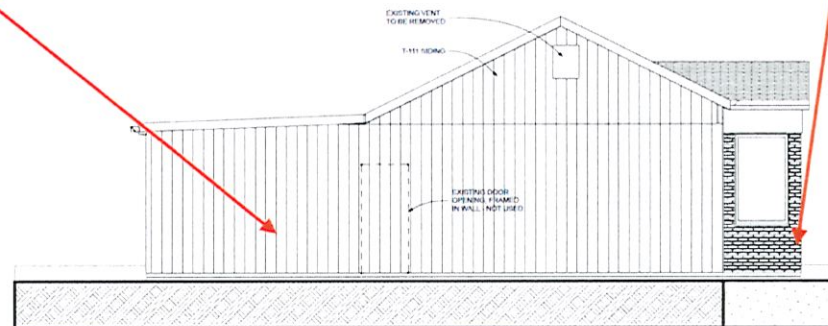
2
A-1.1

NO SIDING PRESENT ON THE OFFICE

Original T1-11 vertical siding

SOUTH EAST ELEVATION-EXISTING

The City's Community Development Department and the Historic Commission did not effectively review the plans nor the evidence submitted which illustrated that the original siding is a combination of vertical metal siding and vertical T1-11 siding.

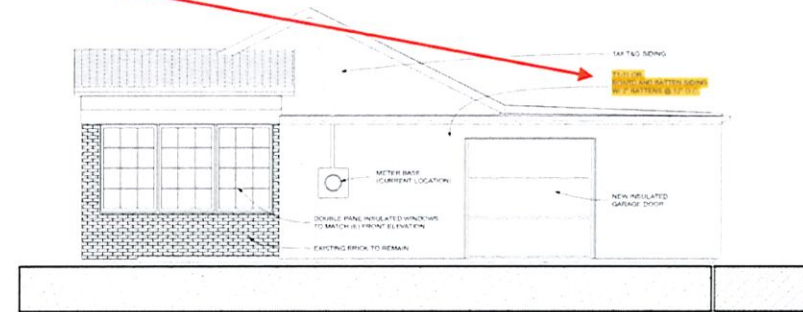
1
A-1.4

**Compatible New Siding to match original, T1-11 OR,
BOARD AND BATTEN SIDING W/ 2" BATTENS @ 12" O.C.**

NORTH WEST ELEVATION-NEW

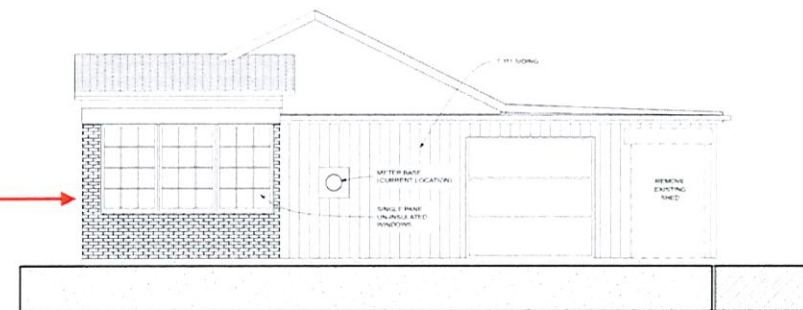
3
A-1.4

NO SIDING PRESENT ON THE OFFICE

NORTH WEST ELEVATION-EXISTING

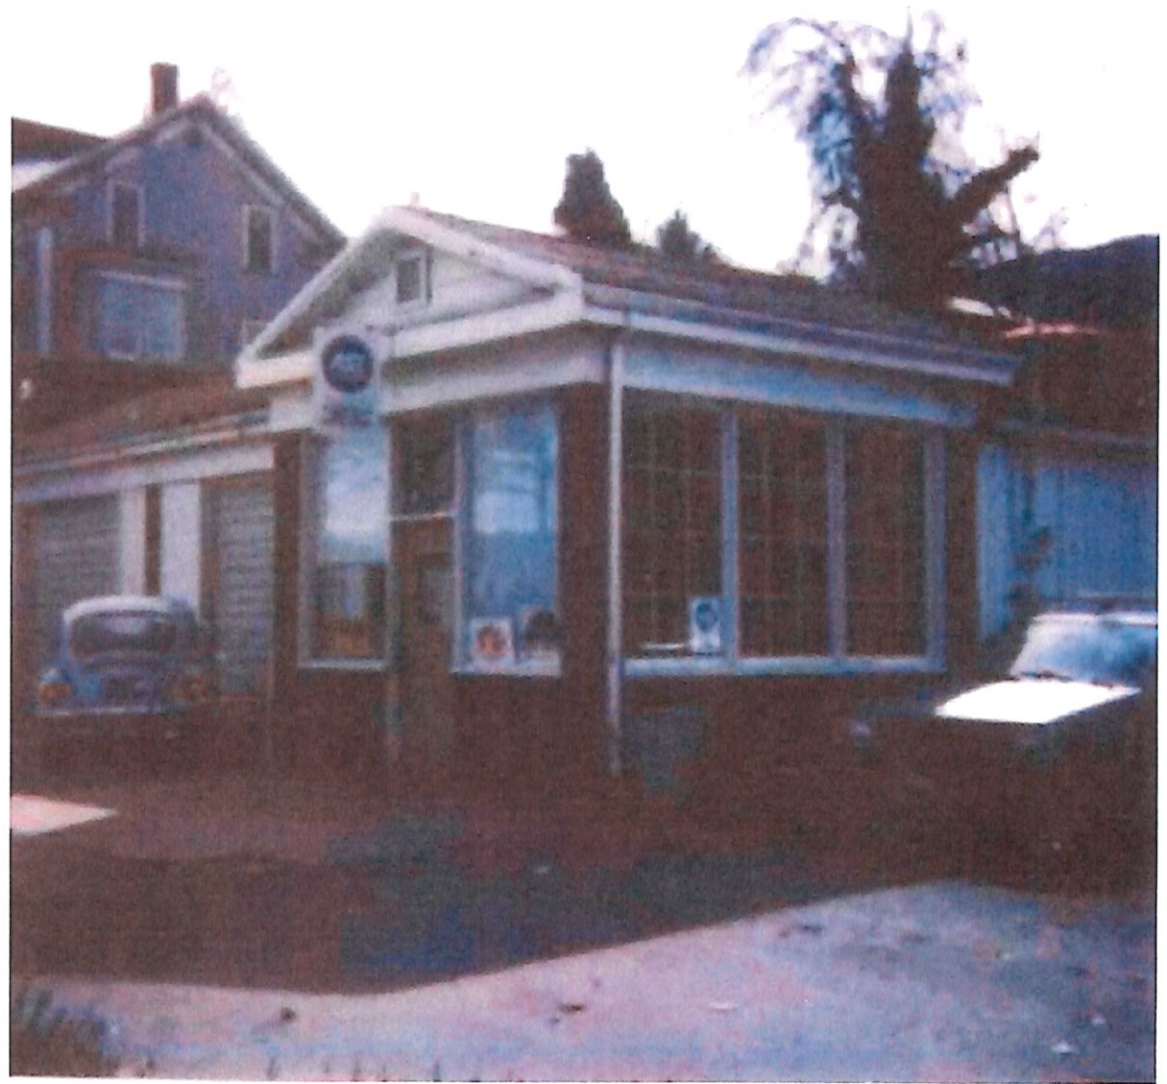
Photo 2. Viewed from the corner of North Main Street and Bush Street

Reference
photo provided
by the Community
Development
Department to
applicant

- a. The applicant shall restore or duplicate the entablature (horizontal architectural details under the eave line of the roof), including the enclosed soffit, along the entire North Main Street façade of the building and along the original office structure (i.e. brick entry feature) on the Bush Street façade. (Rehabilitation Standard AMC 18.4.2.050.C.2.b. & c. See Photos 1 and 2 above).

- d. The windows on the original office structure (i.e., the brick entry feature) shall be true divided lights (i.e. with the glass divided into small panes) on the North Main Street and Bush Street facades to match the original windows. (Rehabilitation Standard AMC 18.4.2.050.C.2.g. See Bush Street side of the building in Photo 2, above).

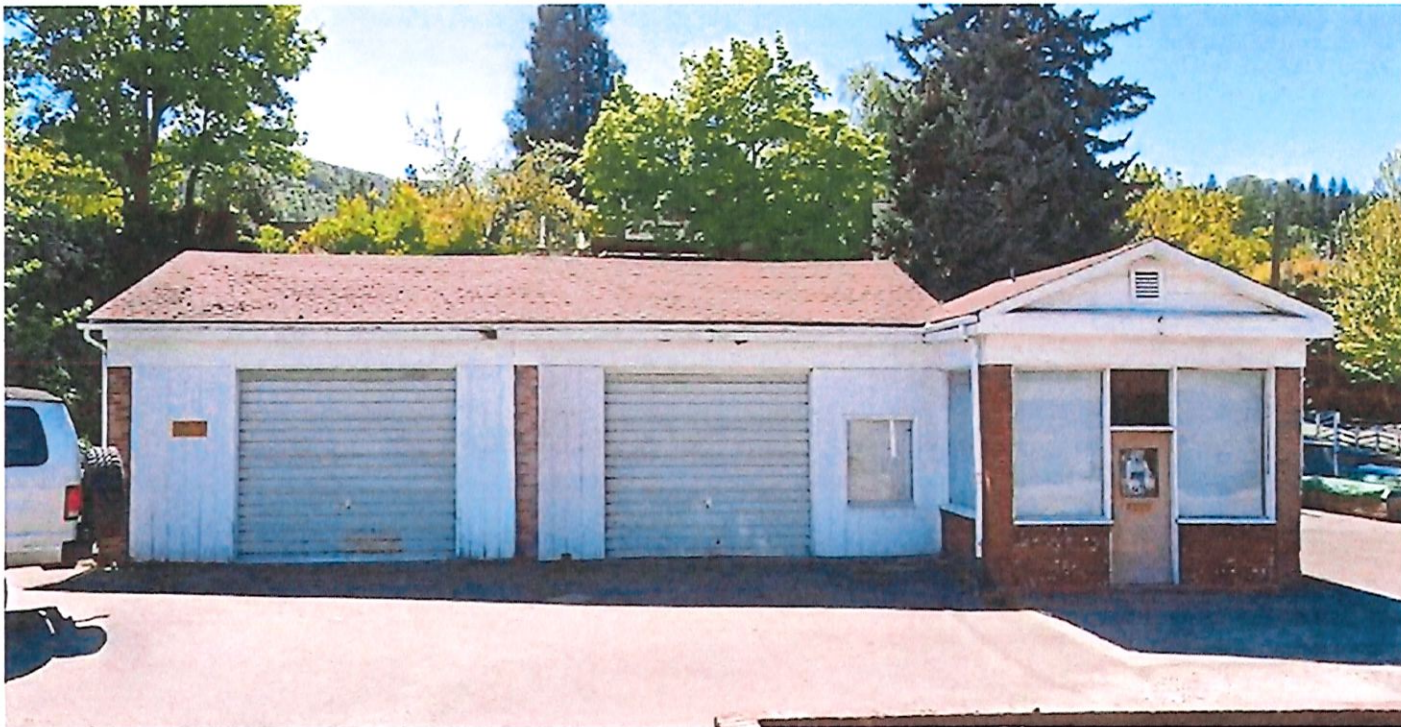
Photo 1. Viewed from North Main Street

Reference photo provided
by the Community Development Department
to Applicant

NO, to the entire N. Main facade having an enclosed soffit, this detail was added in 1980 as a support for the gutter system only. Gutter and associated support were rotten and rusted, gutters to be replaced.

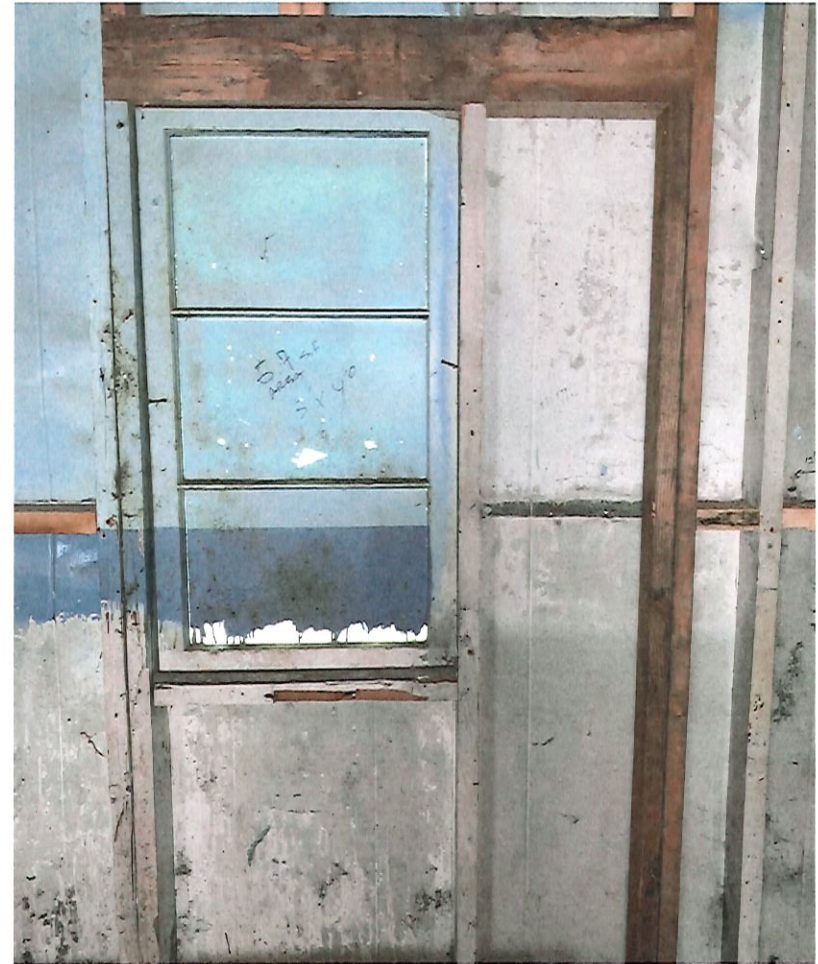
HISTORIC EVIDENCE OF ORIGINAL Vertical Metal Siding

photo was provided to the City's
Planning and Development
Department and denoted on
plans submitted by applicant

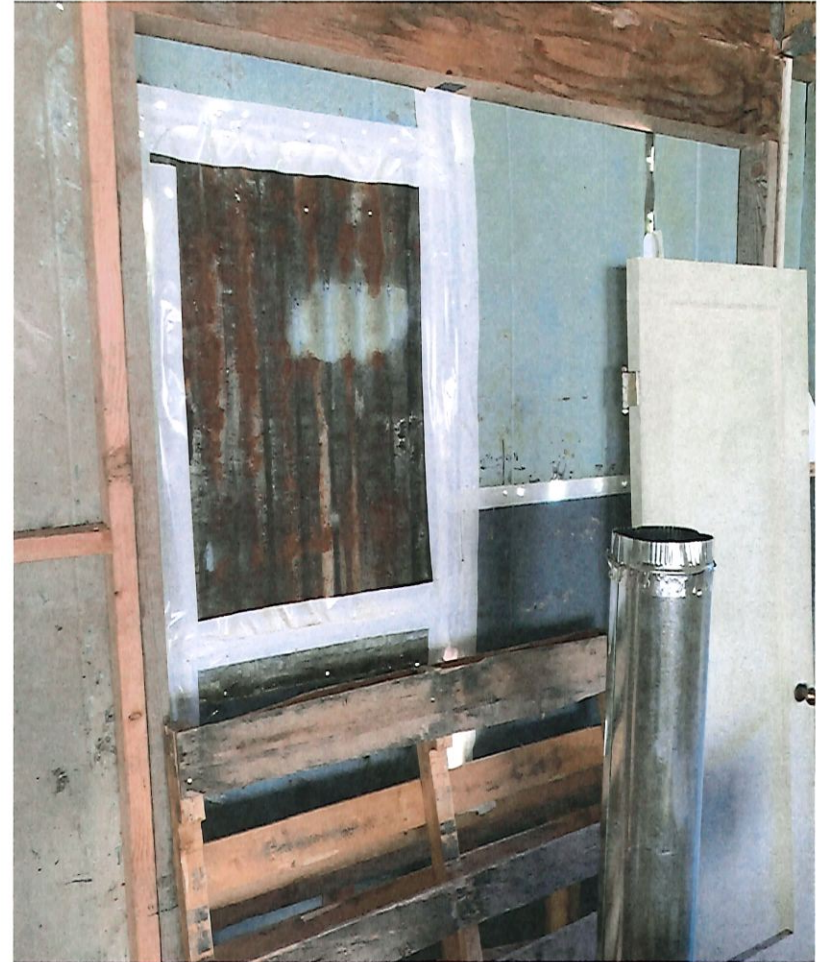
HISTORIC EVIDENCE OF ORIGINAL Vertical Metal Siding

photo was provided to the City's
Planning and Development
Department and denoted on
plans submitted by applicant

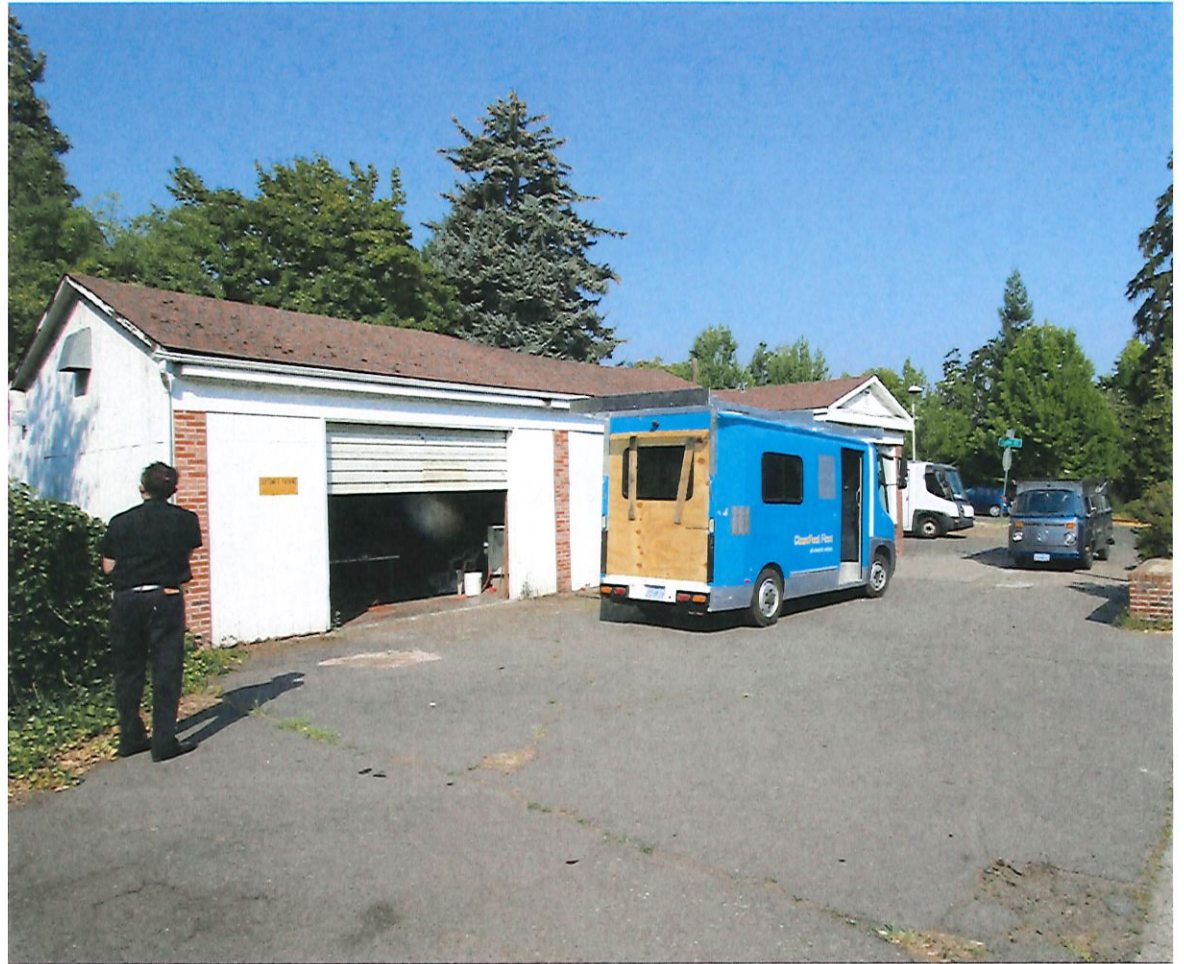
HISTORIC EVIDENCE OF ORIGINAL T1-11 SIDING
